DEKRA's commission No. : PKOL(W)/LODZ/75388/25/10/03  
commission/ damage No. : 23/047265  
Date of commission: 03-10-2025

| Manufacturer | FIAT |
| Type / version | 500 23.8kWh Icon |
| Registration /record No. | WU3438R |

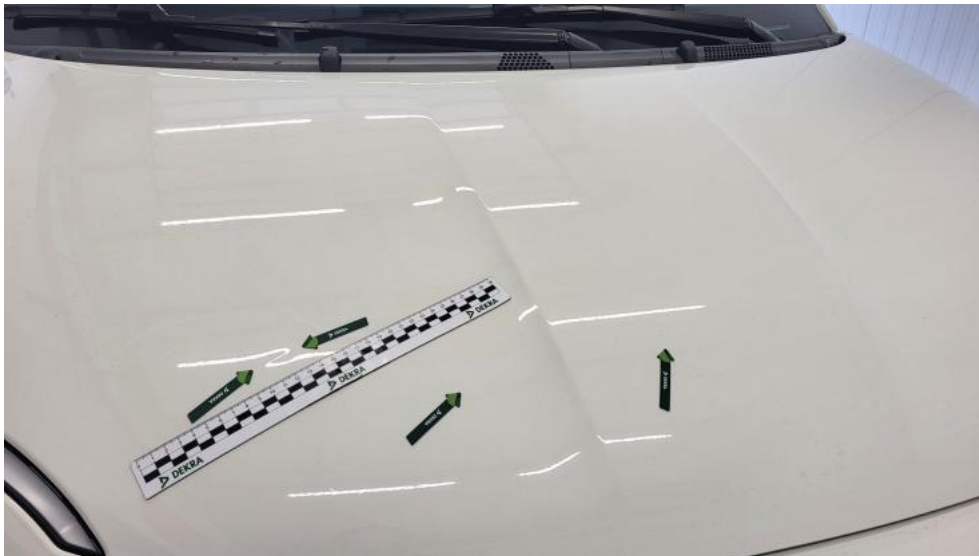
**Photo 47.**

Pokrywa komory silnika - Wgniecenie/odkształcenie 1

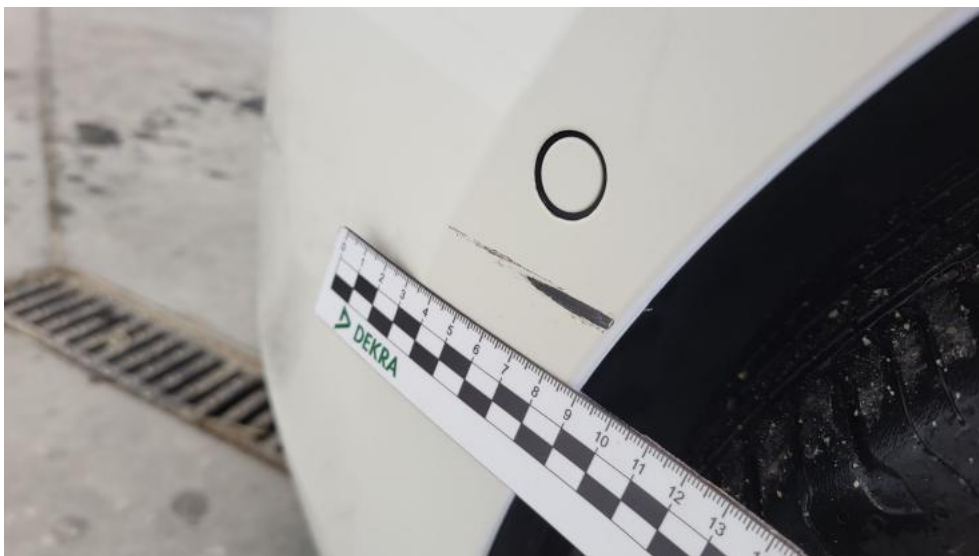
**Photo 48.**

Zderzak - Rysa/odprysk 1

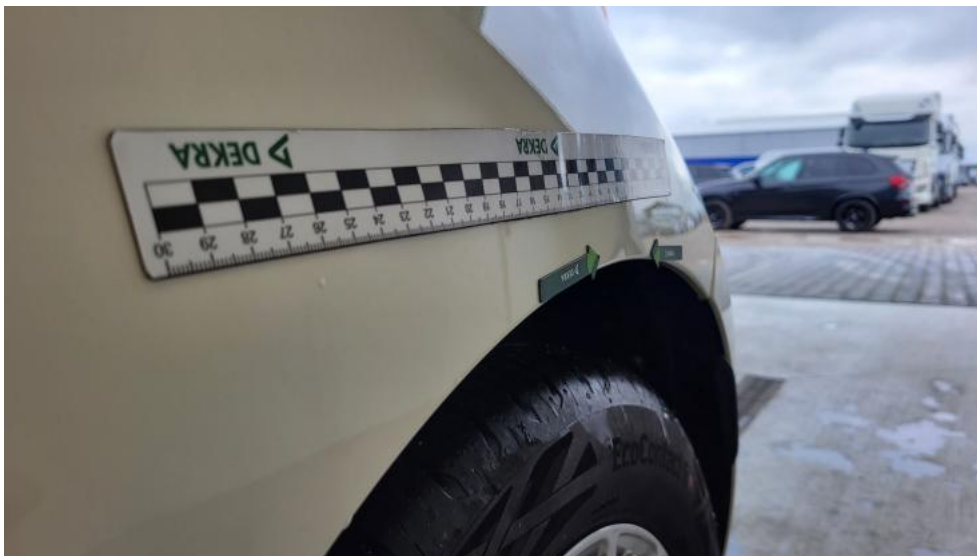
**Photo 53.**

Błotnik tylny L / Ściana boczna L - Wgniecenie/odkształcenie 1

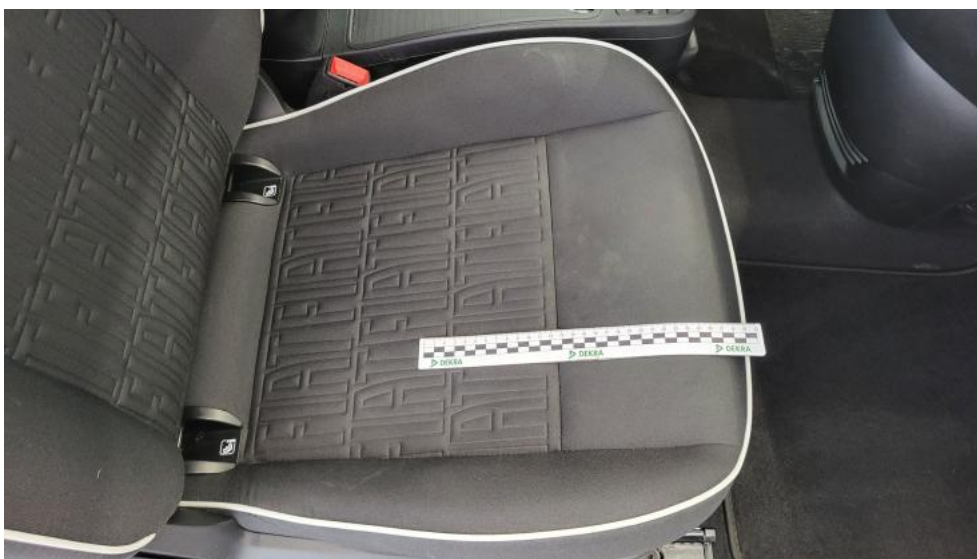
**Photo 55.**

Fotel prz. praw. - Inne 1
