DEKRA's commission No. : PKOL(W)/LODZ/48154/25/07/02  
commission/ damage No. : 23/011954  
Date of commission: 02-07-2025

**DEKRA Poland - Headquarters**  
02-673 Warszawa, ul. Konstruktorska 12A

| Manufacturer | FIAT |
| Type / version | 500 1.0 Hybrid Cult |

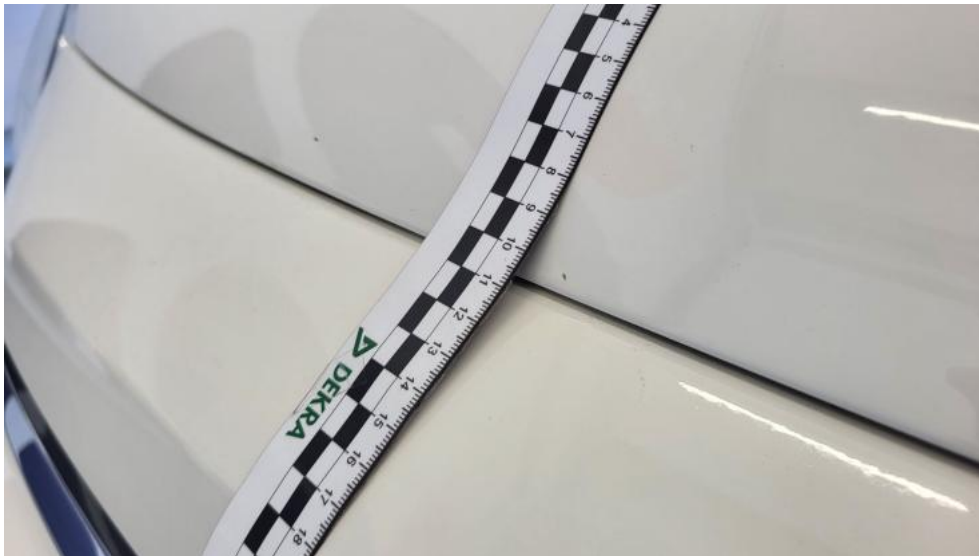
**Photo 35.**

Pokrywa komory silnika - Rysa/odprysk 1

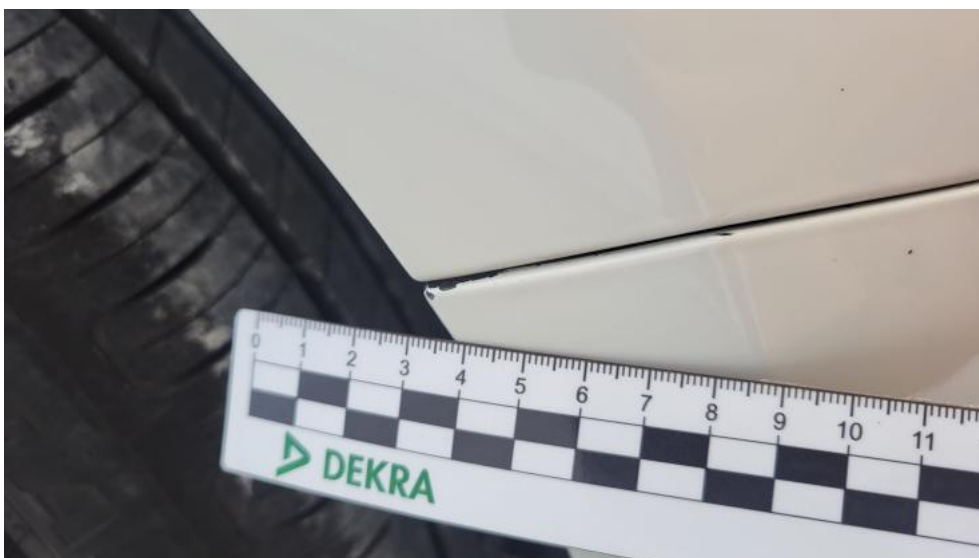
**Photo 36.**

Zderzak - Rysa/odprysk 1

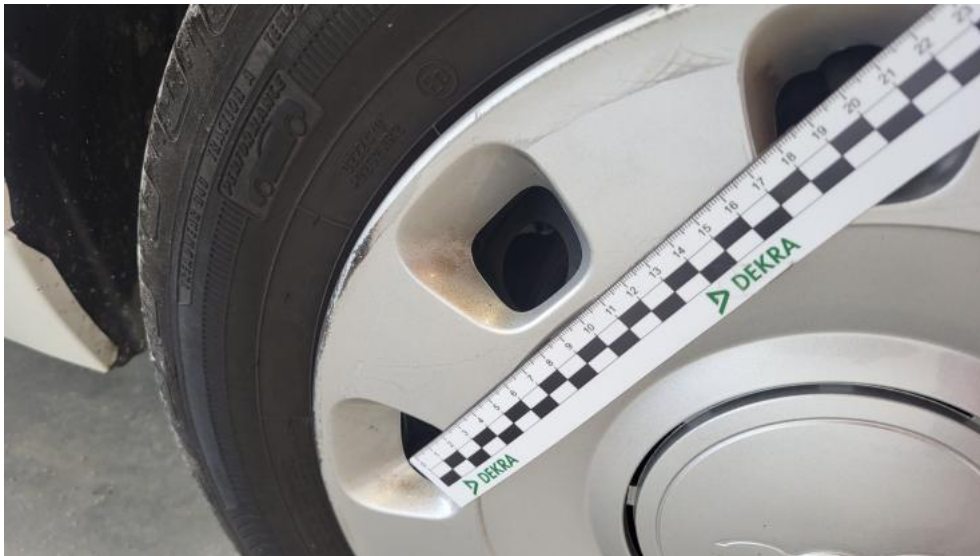
**Photo 37.**

Kołpak przedni P - Rysa/odprysk 1

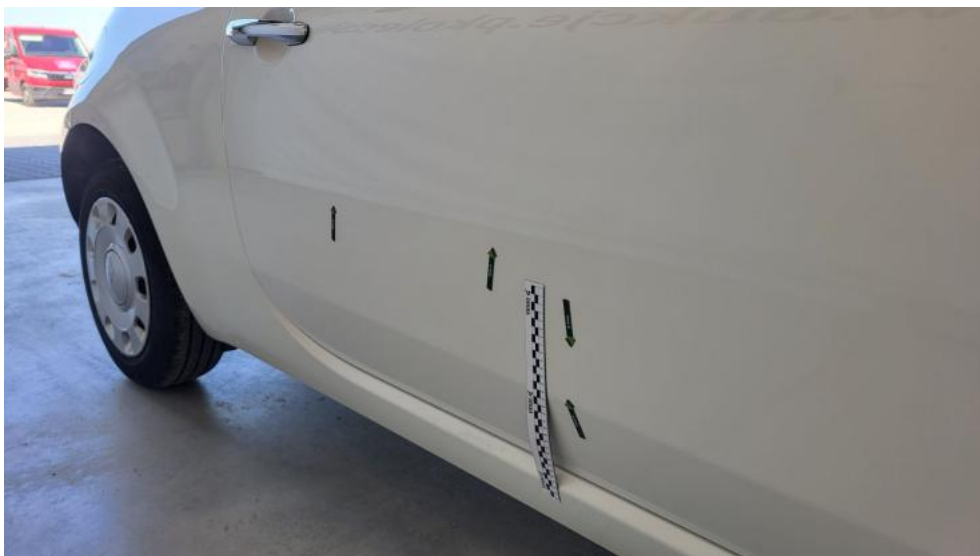
**Photo 38.**

Drzwi przednie P - zdjęcie poglądowe 1

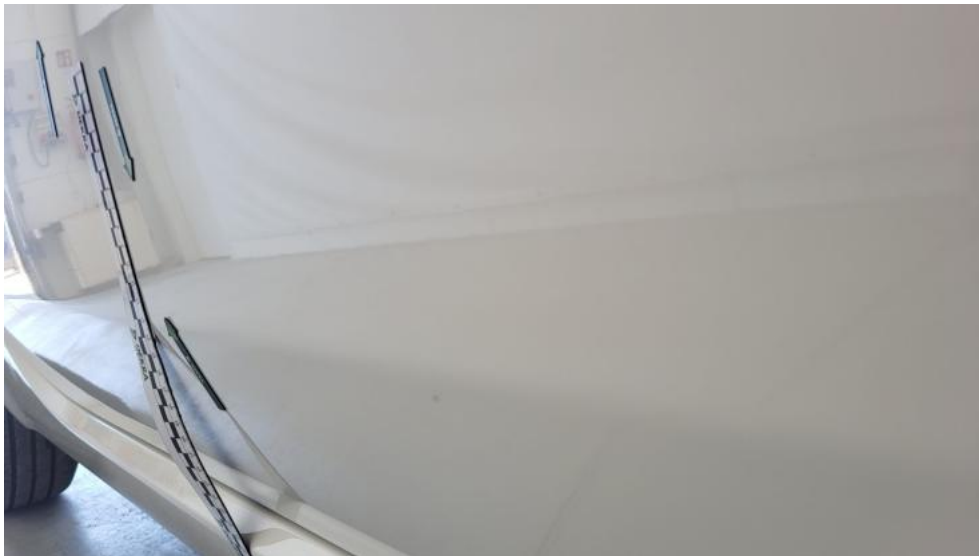
**Photo 39.**

| No. of controlled item | Controlled item | Measured range of thickness of the lacquer coat [ $\mu\text{m}$ ] |
|---|---|---|
| 15 | Front right door | 150 - 500 |

Drzwi przednie P - Wgniecenie/odkształcenie 1

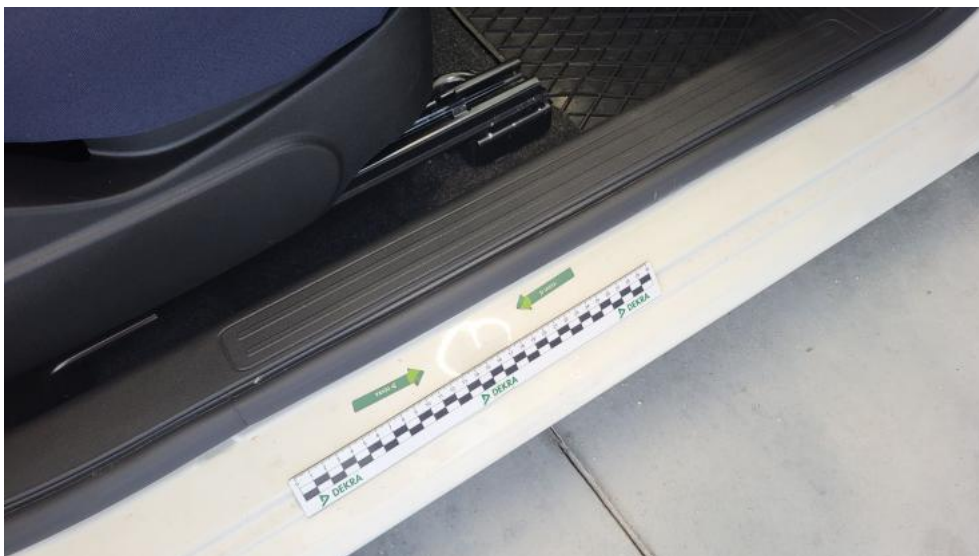
**Photo 40.**

Próg P - Wgniecenie/odkształcenie 1

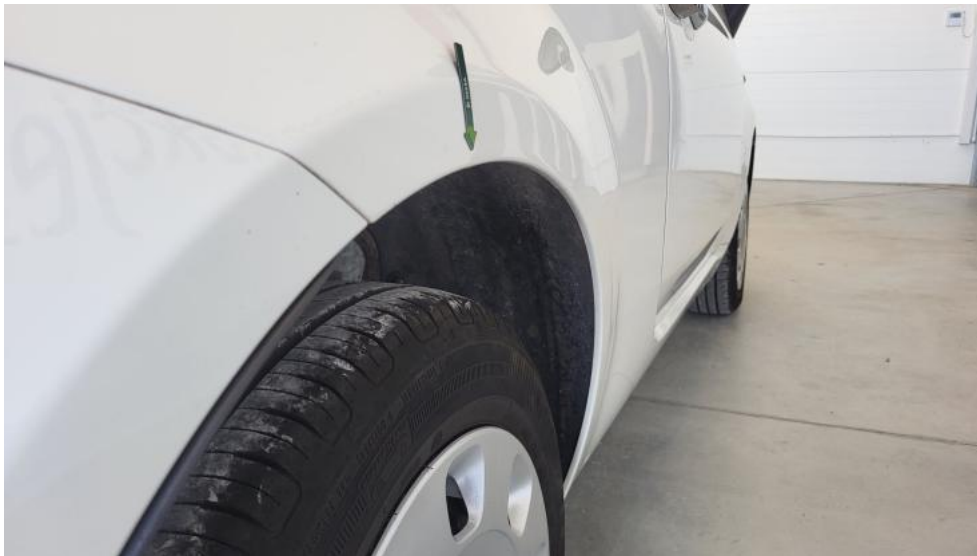
**Photo 41.**

Błotnik tylny P / Ściana boczna P - Wgniecenie/odkształcenie 1

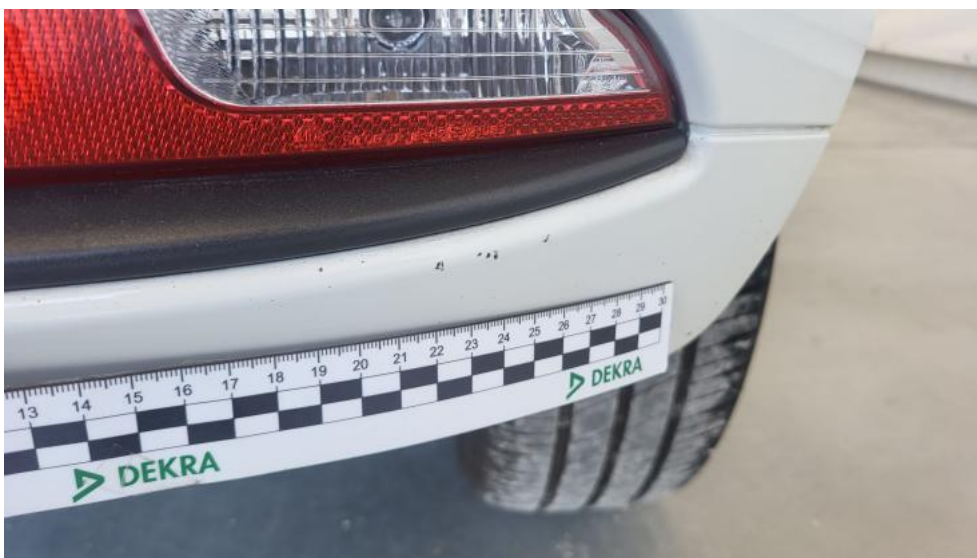
**Photo 42.**

Zderzak tylny - Rysa/odprysk 1

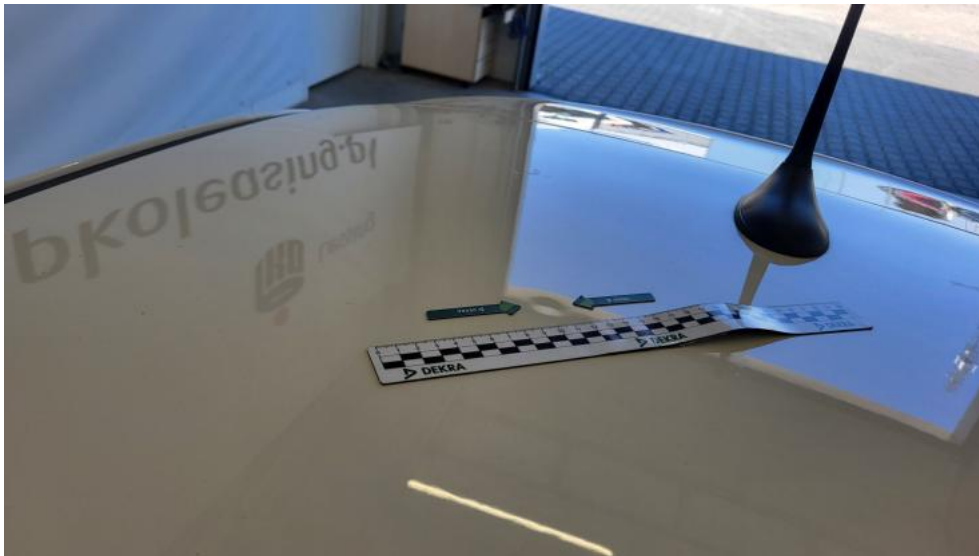
**Photo 43.**

Dach - Wgniecenie/odkształcenie 1

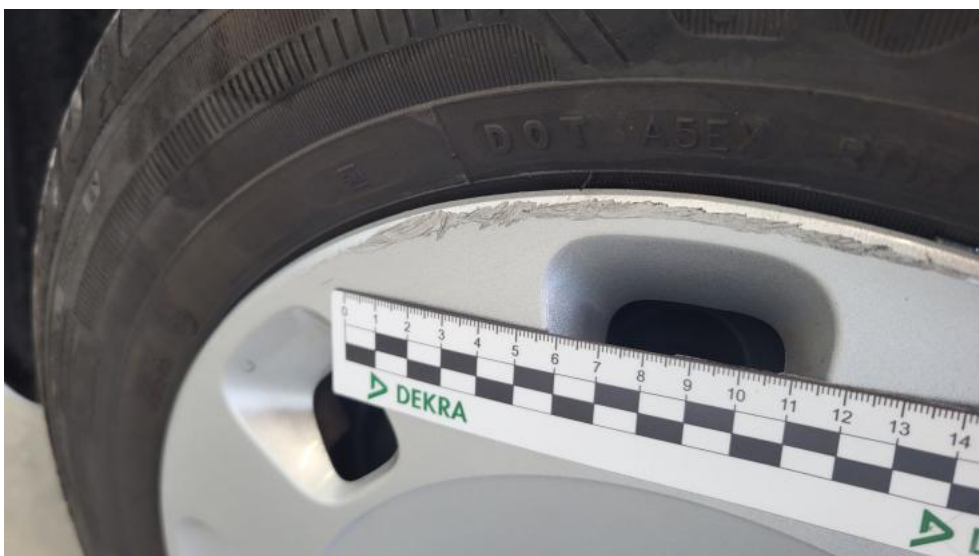
**Photo 44.**

Kółpak przedni L - Rysa/odprysk 1

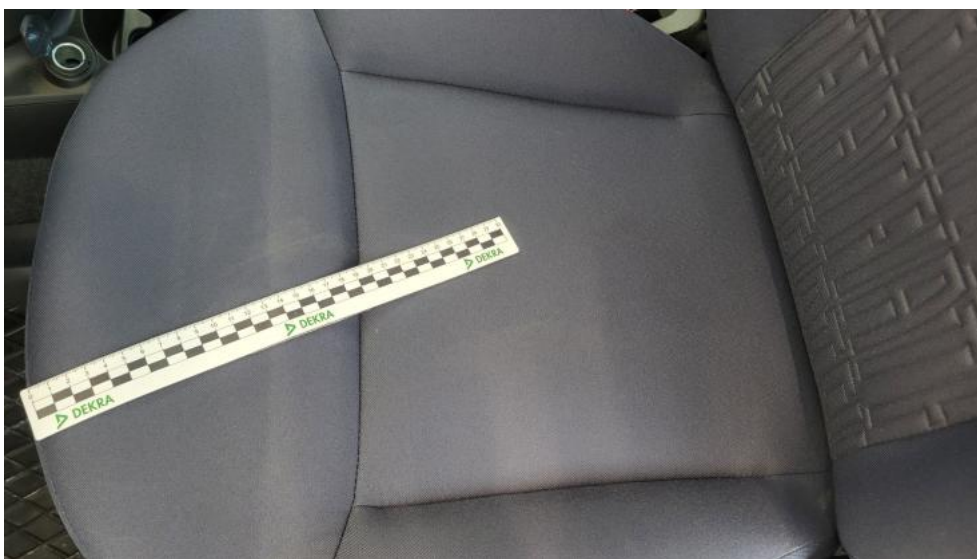
**Photo 45.**

Fotel prz. lew. - Inne 1

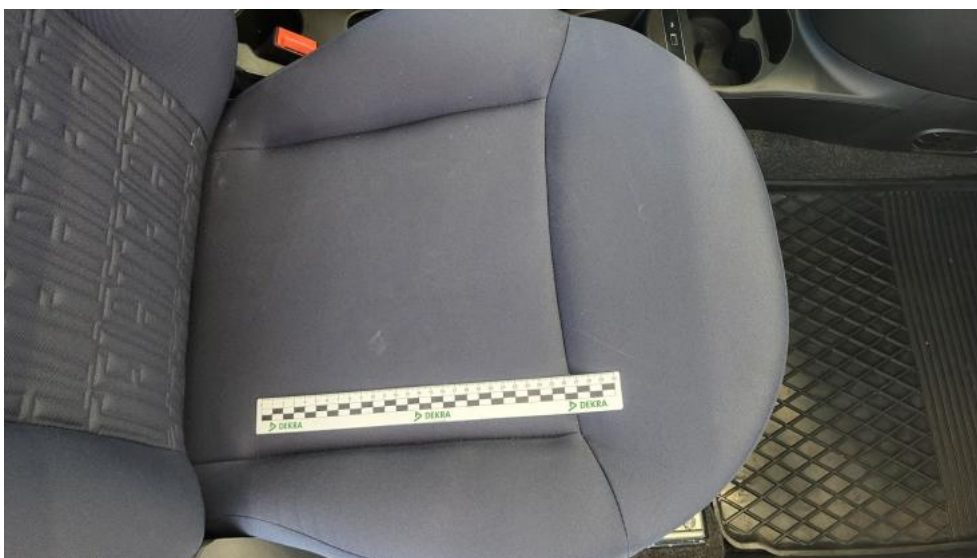
**Photo 46.**

Fotel prz. praw. - Inne 1

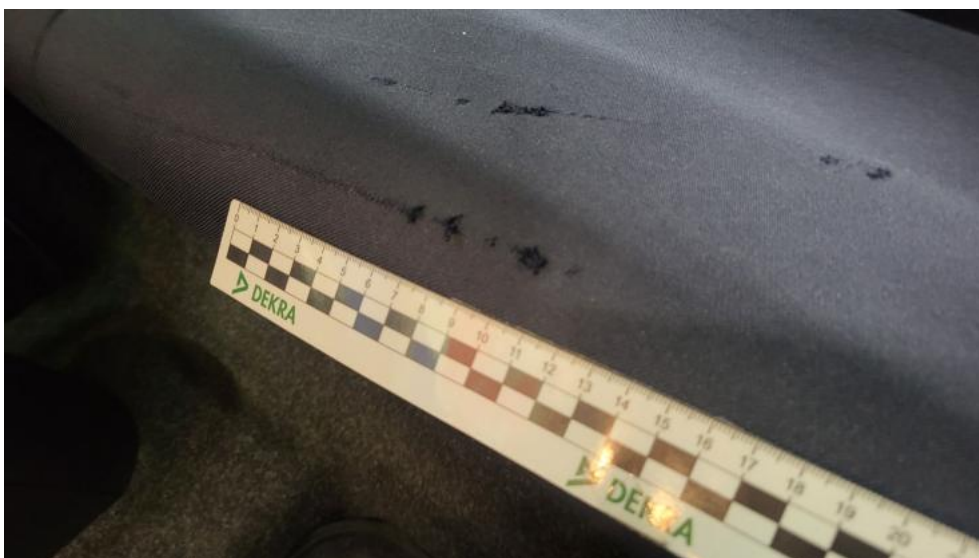
**Photo 48.**

Kanapa tyl. - Rysa/odprysk 1
