DEKRA's commission No. : PKOL(W)/LODZ/45897/25/06/25  
commission/ damage No. : 22/036399  
Date of commission: 25-06-2025

| Manufacturer | BMW |
| Model | Seria 5 [G30/F90] 20-23 |
| Registration /record No. | WU3347P |

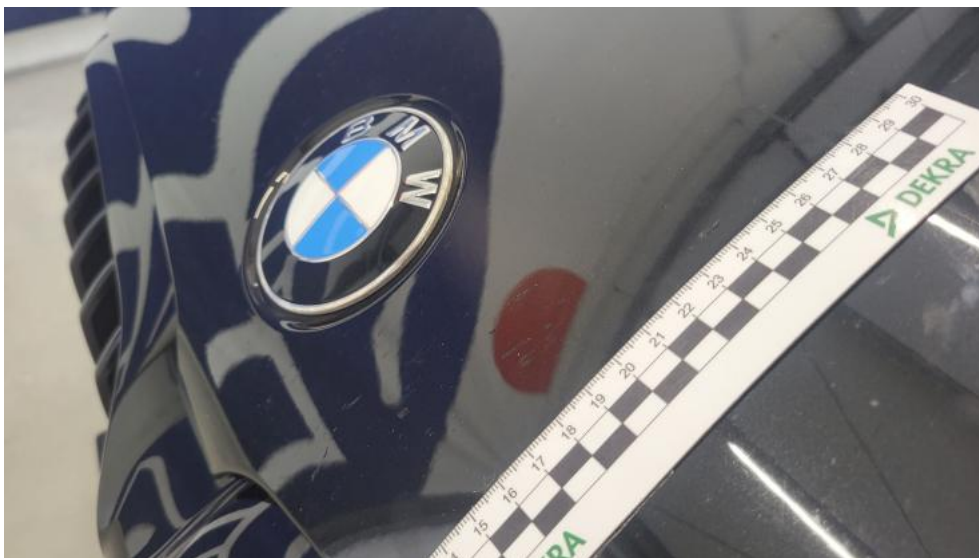
**Photo 38.**

Pokrywa komory silnika - Rysa/odprysk 1

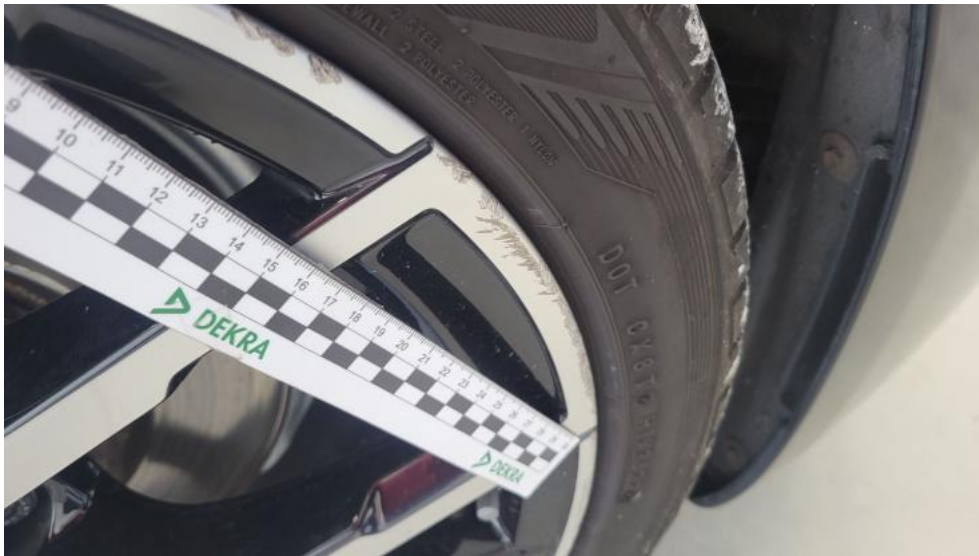
**Photo 39.**

Felga aluminiowa przednia P - Rysa/odprysk 1

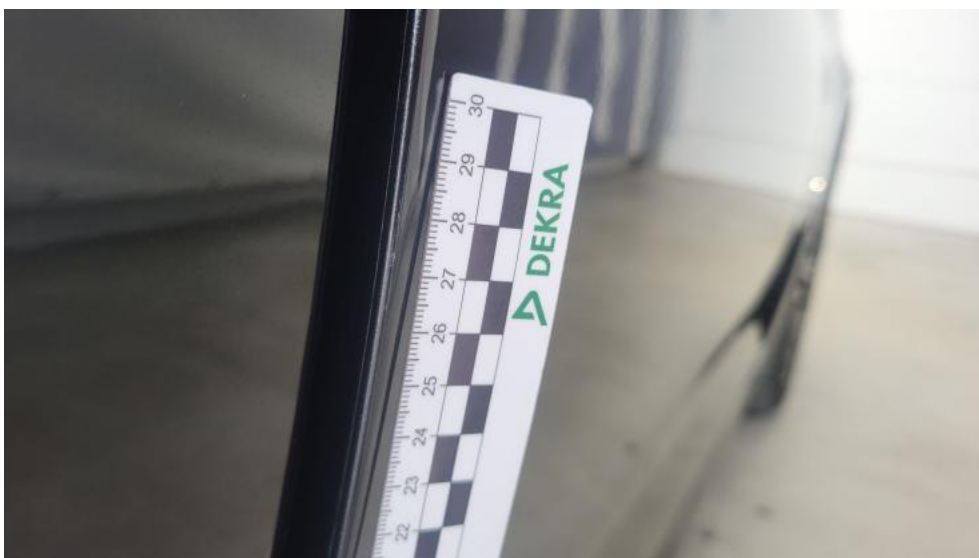
**Photo 40.**

Drzwi przednie P - Rysa/odprysk 1

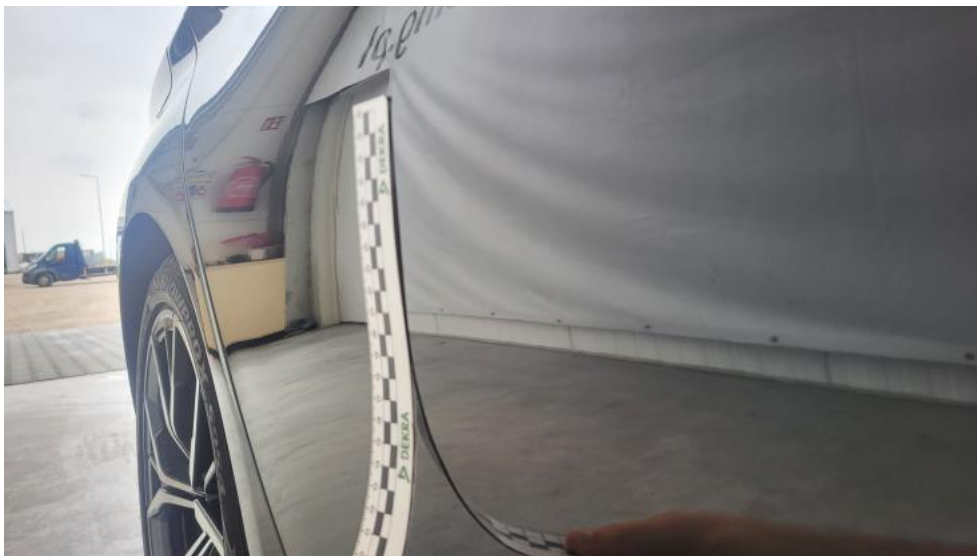
**Photo 41.**

Drzwi tylne P - Wgniecenie/odkształcenie 1

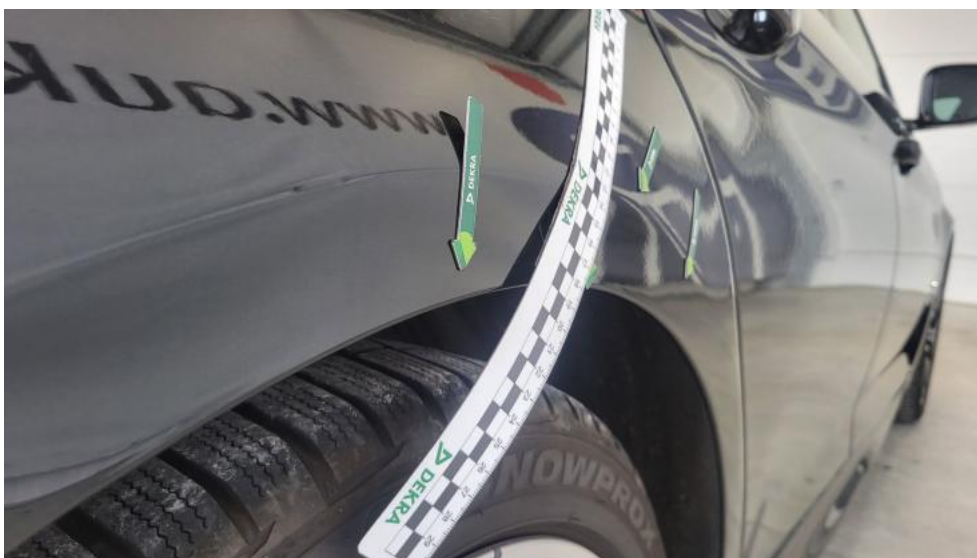
**Photo 42.**

Ścianka tylna P / Ścianka boczna P - Wgniecenie/odkształcenie 1

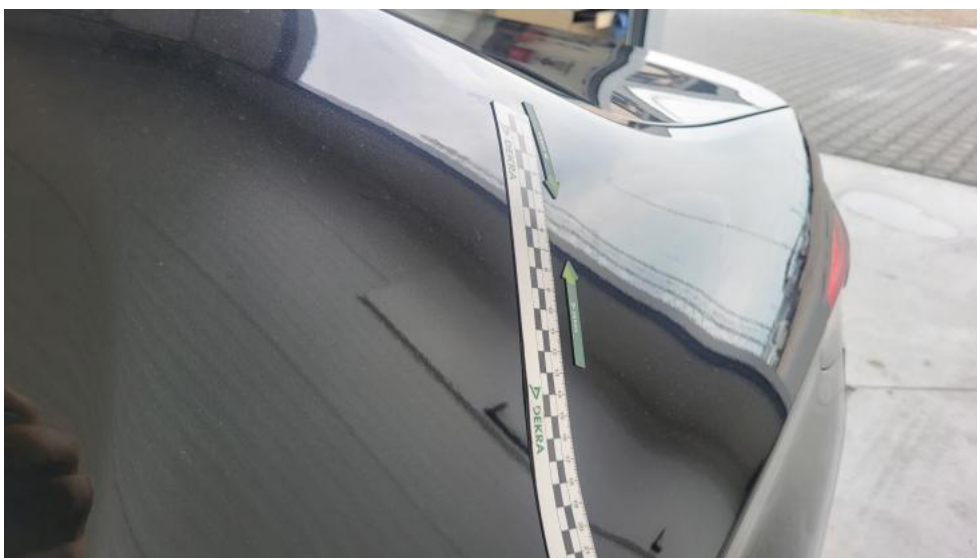
**Photo 44.**

Błotnik tylny L / Ściana boczna L - Wgniecenie/odkształcenie 1

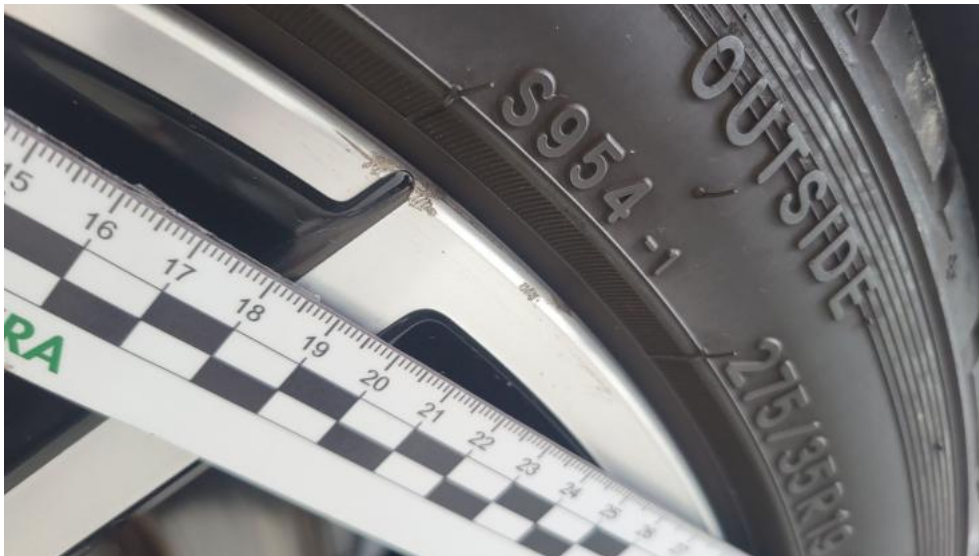
**Photo 45.**

Felga aluminiowa tylna L - Rysa/odprysk 1

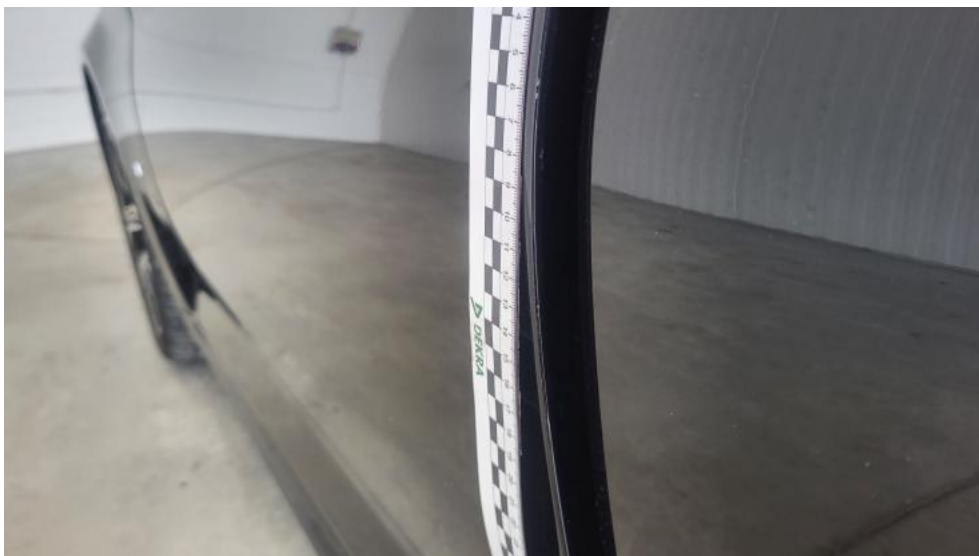
**Photo 46.**

Drzwi przed L - Rysa/odprysk 1

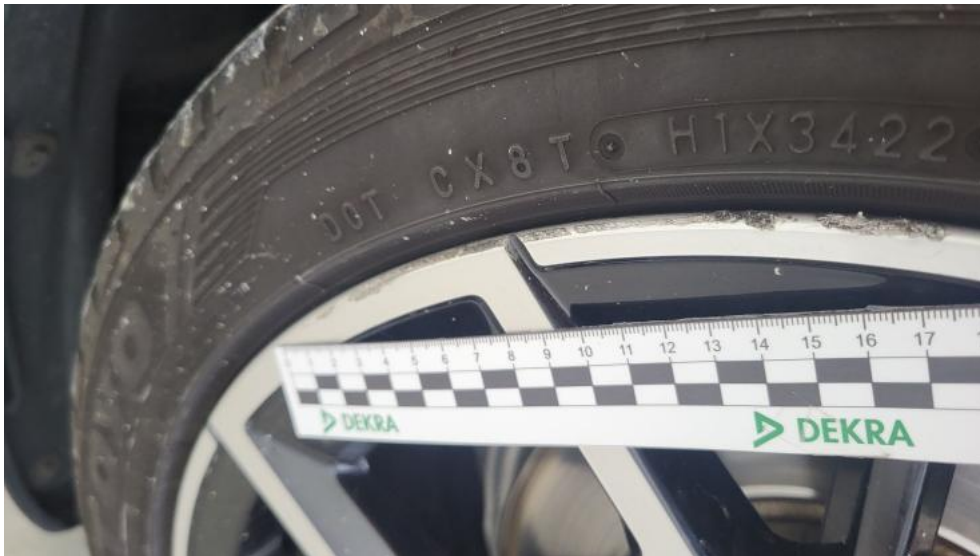
**Photo 47.**

Felga Aluminiowa przednia L - Rysa/odprysk 1

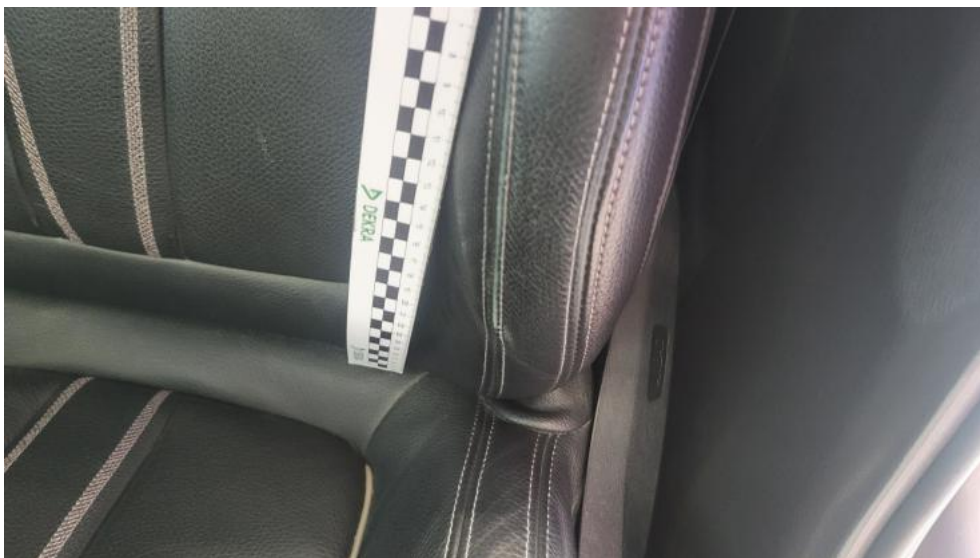
**Photo 48.**

Fotel prz. lew. - Inne 1

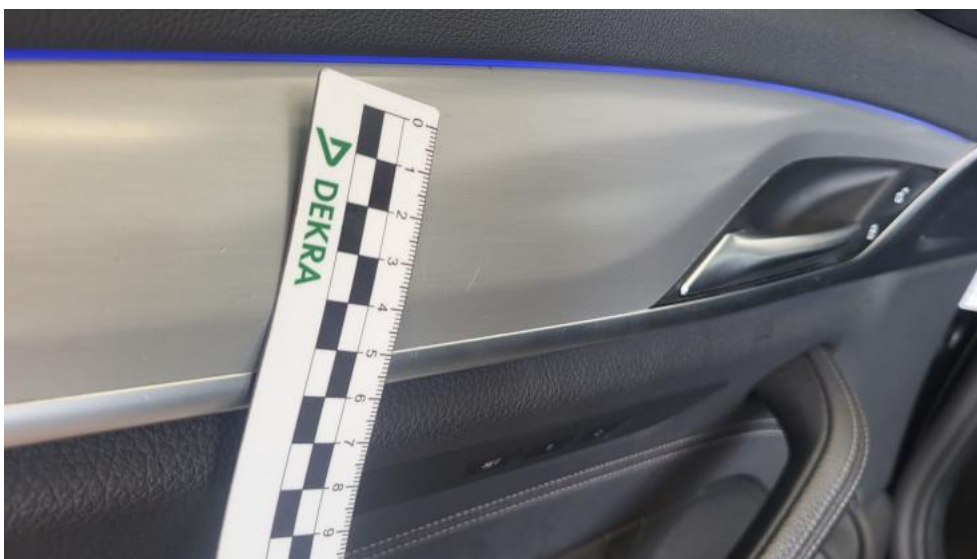
**Photo 49.**

Tapicerka drzwi przednich L - Rysa/odprysk 1
