DEKRA's commission No. : PKOL(W)/LODZ/80666/24/10/17  
commission/ damage No. : 23/019977  
Date of commission: 17-10-2024

**Vehicle data**

PHOTOGRAPHIC DOCUMENTATION

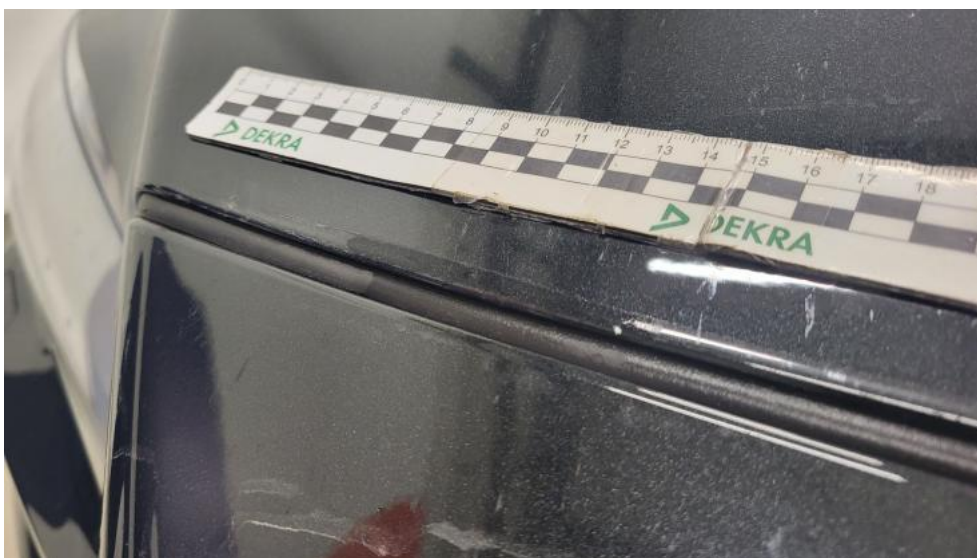
**Photo 40.**  
Pokrywa komory silnika - Rysa/odprysk 1

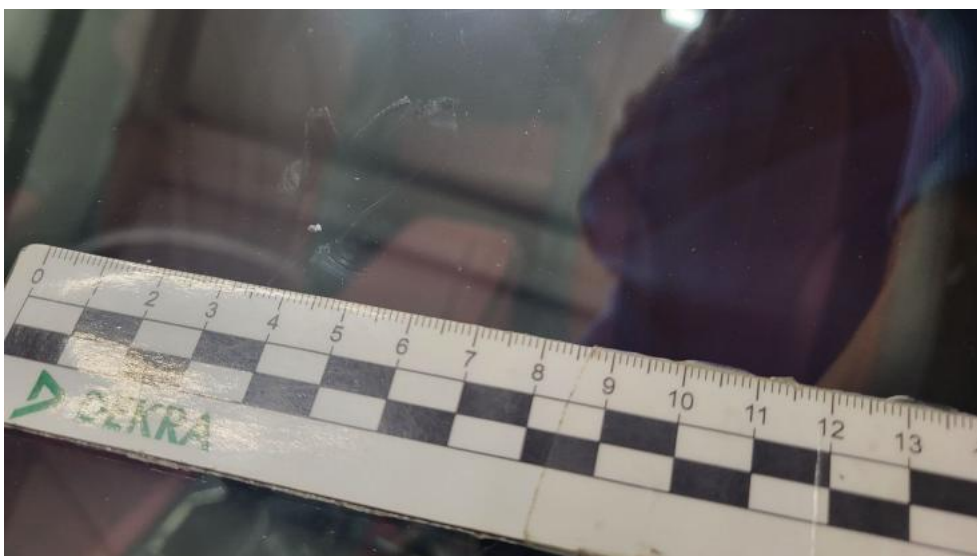
**Photo 42.**  
Szyba czołowa - Rysa/odprysk 1

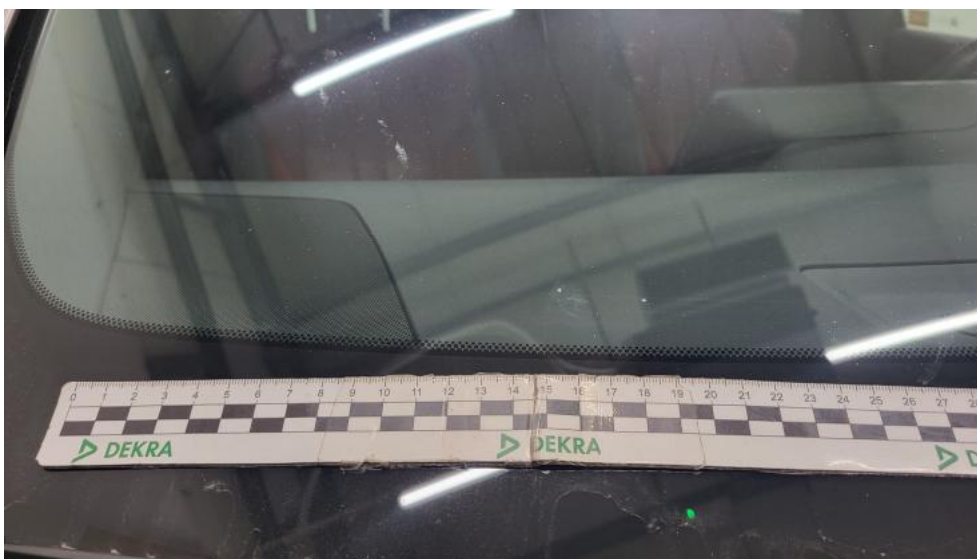
**Photo 43.**  
Szyba czołowa - Rysa/odprysk 2

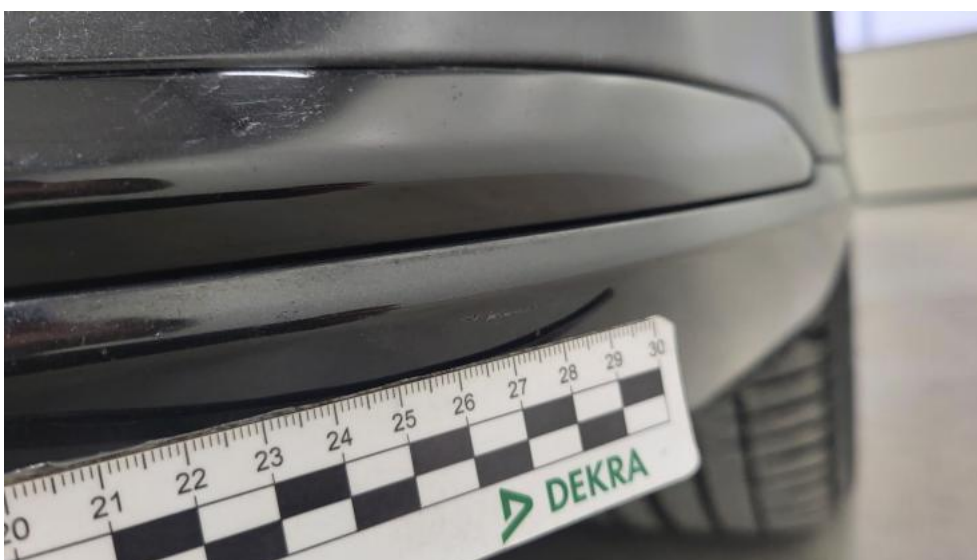
**Photo 44.**  
Zderzak - Rysa/odprysk 1

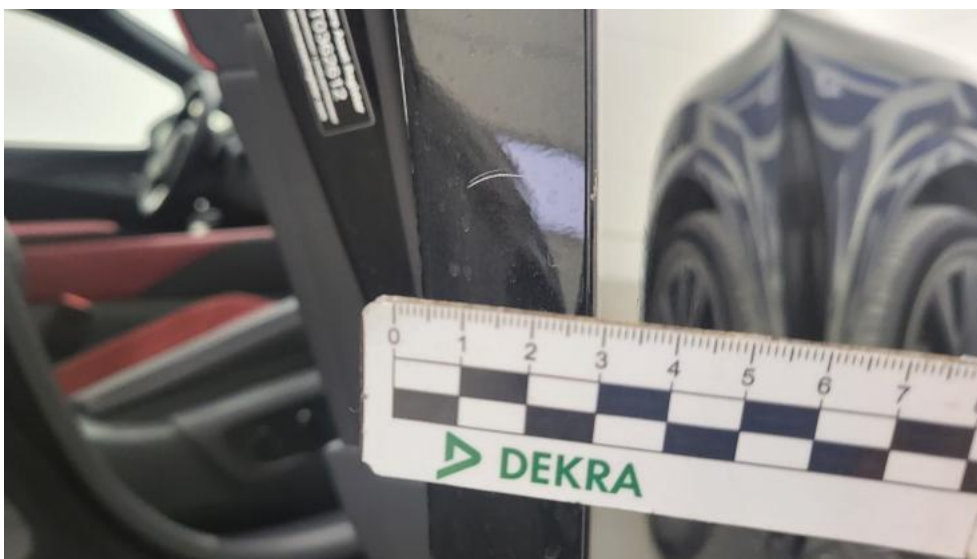
**Photo 45.**  
Drzwi przednie P - Rysa/odprysk 1

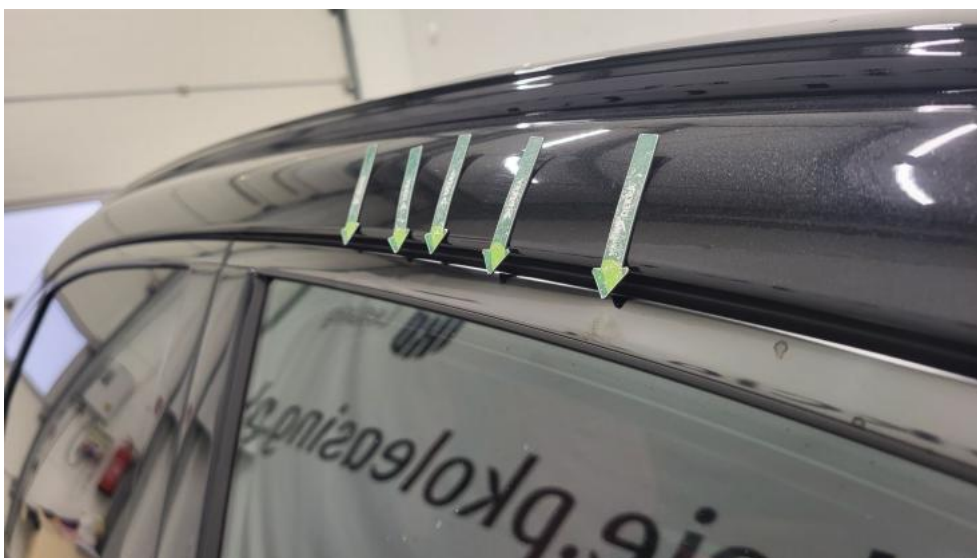
**Photo 46.**  
Drzwi przednie P - Wgniecenie/odkształcenie 1

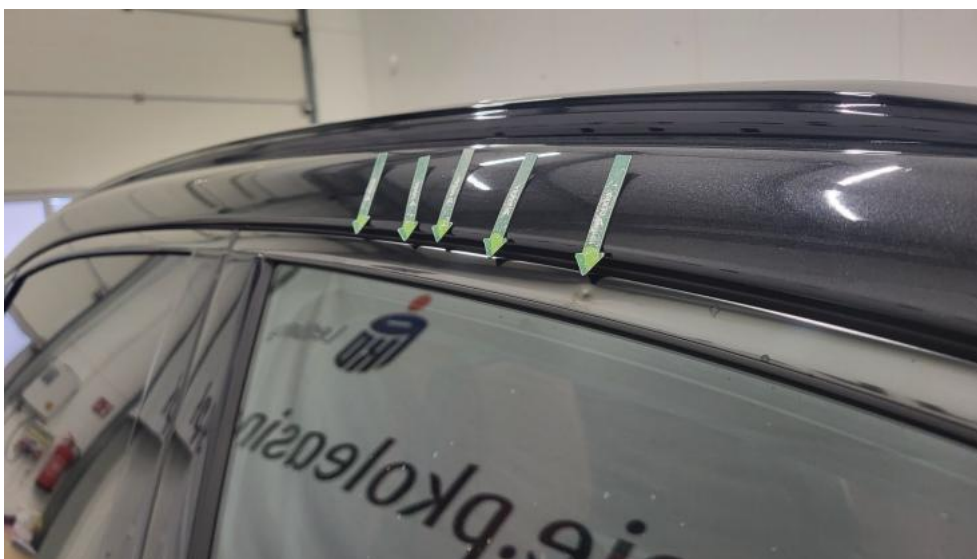
**Photo 47.**  
Drzwi przednie P - Wgniecenie/odkształcenie 2

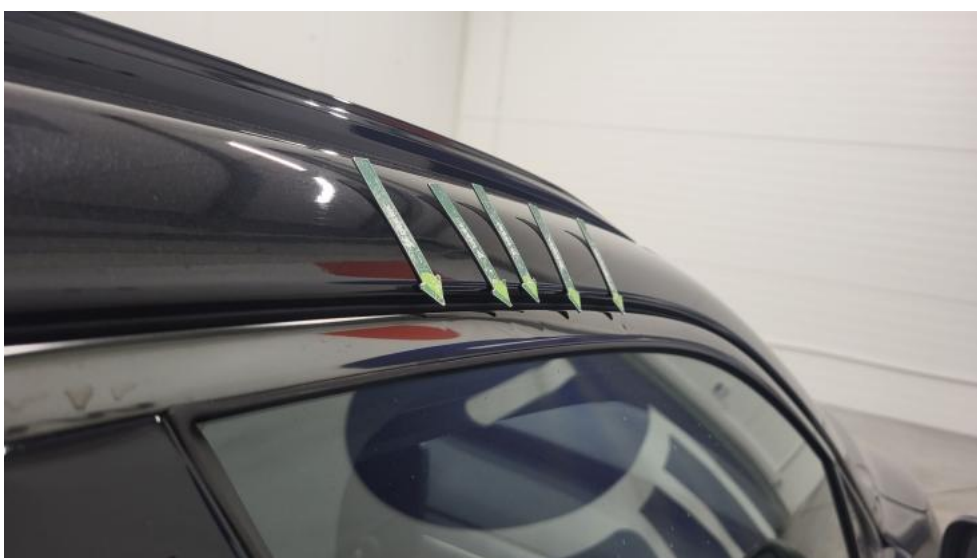
**Photo 48.**  
Drzwi przednie P() - Wgniecenie/odkształcenie 3

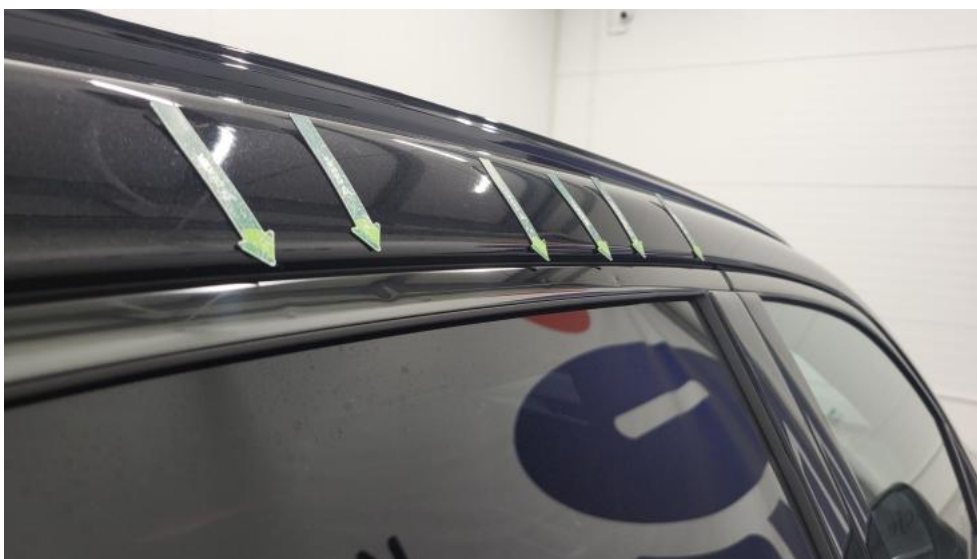
**Photo 49.**  
Drzwi tylne P - Wgniecenie/odkształcenie 1

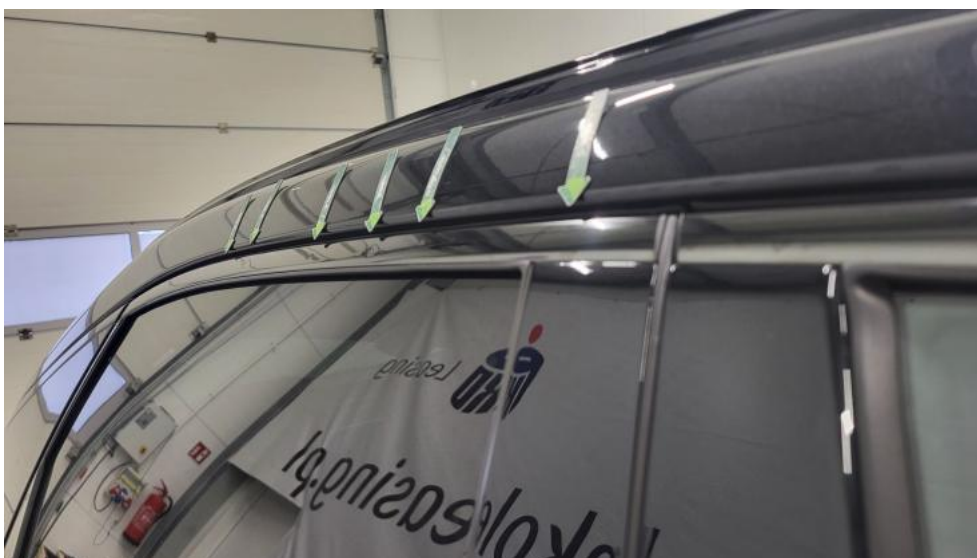
**Photo 50.**  
Drzwi tylne P - Wgniecenie/odkształcenie 2

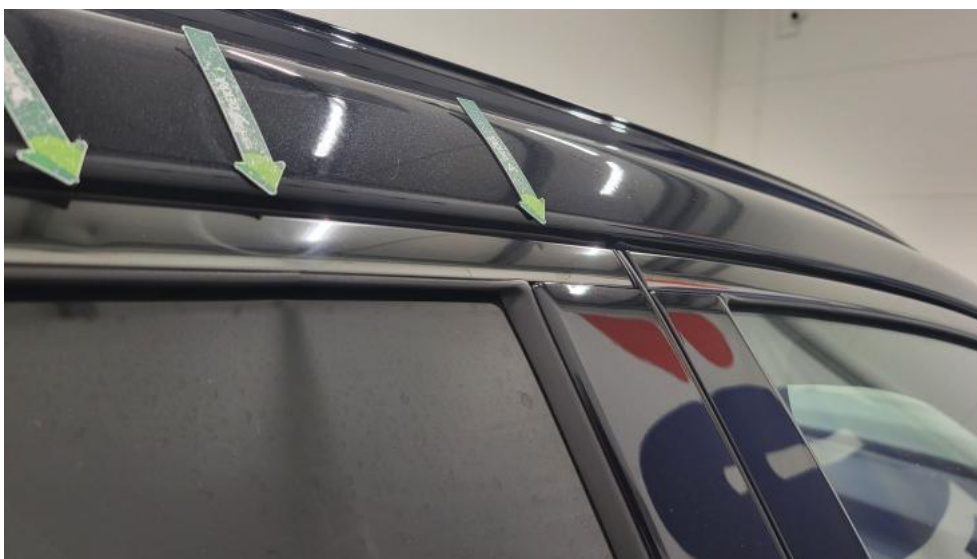
**Photo 51.**  
Drzwi tylne P() - Wgniecenie/odkształcenie 3

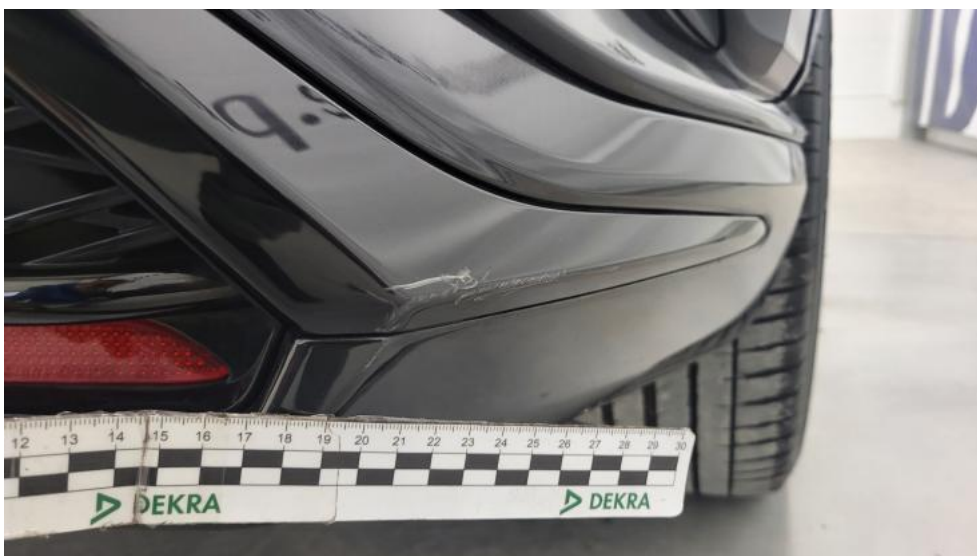
**Photo 52.**  
Zderzak tylny - Rysa/odprysk 1

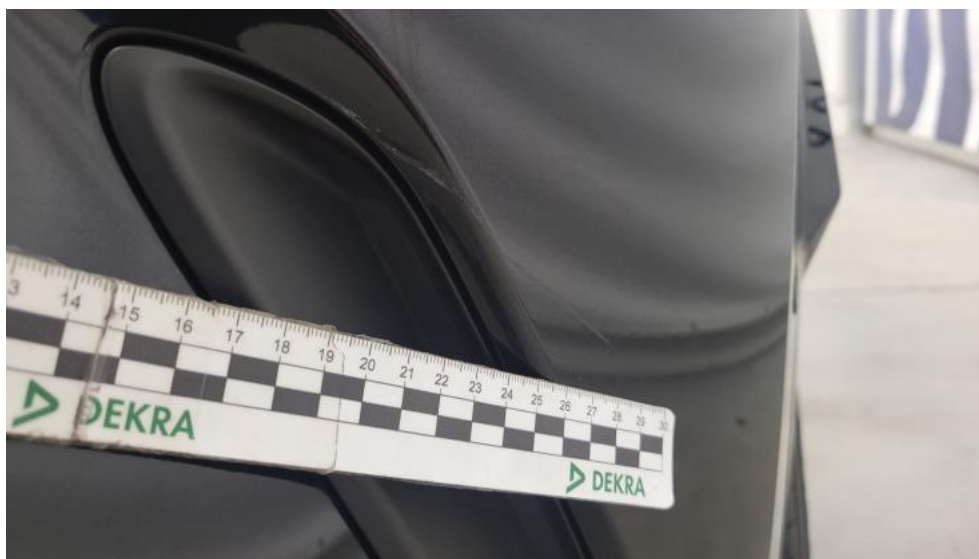
**Photo 53.**  
Zderzak tylny - Rysa/odprysk 2

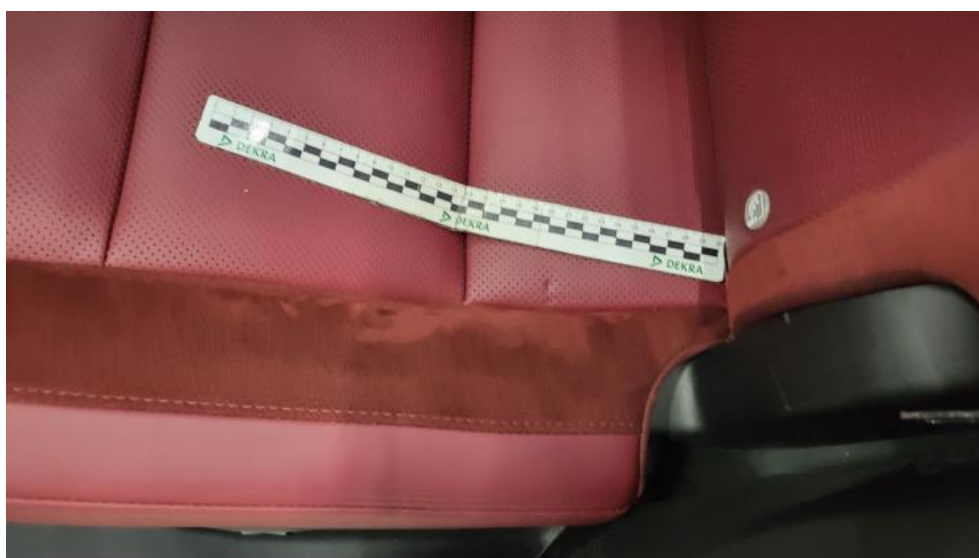
**Photo 54.**  
Kanapa tyl. - Wgniecenie/odkształcenie 1

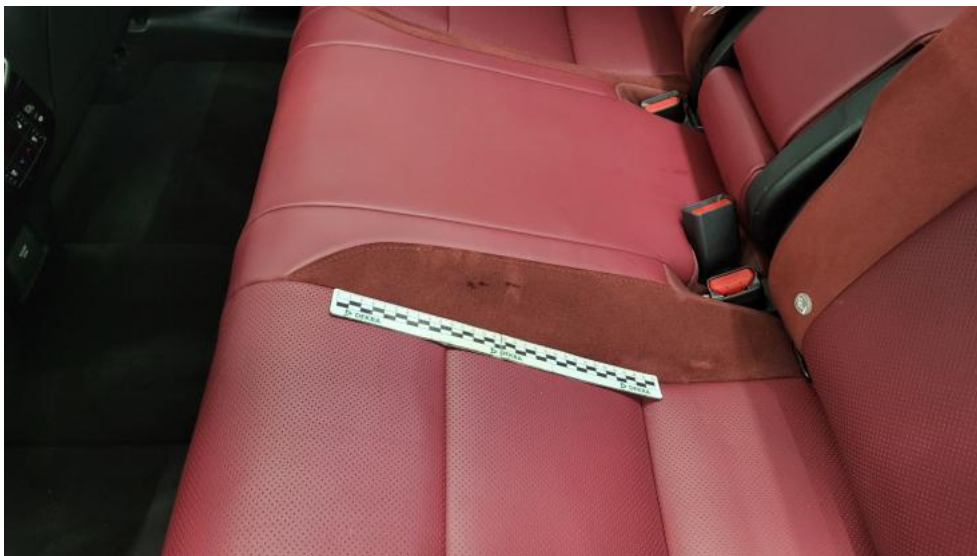
**Photo 55.**  
Kanapa tyl. - Inne 1

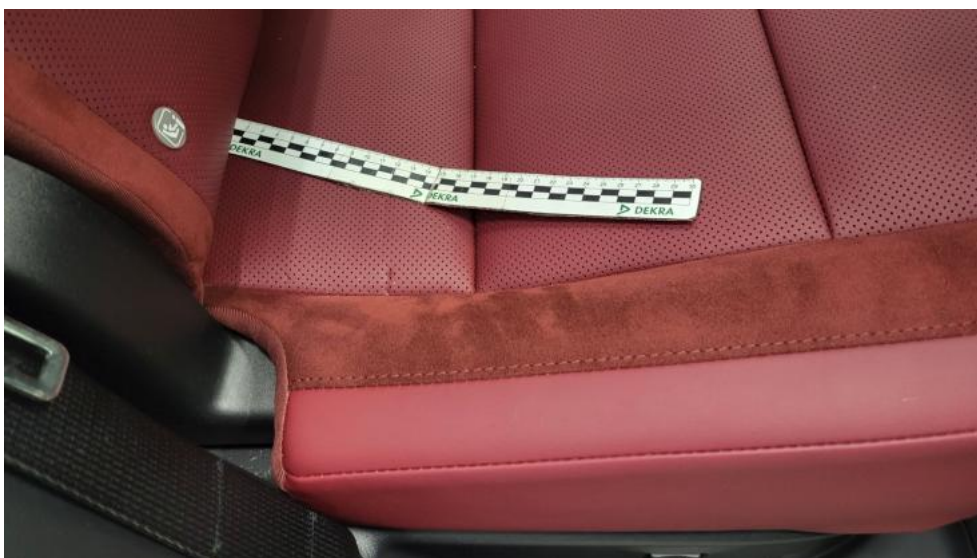
**Photo 56.**  
Kanapa tyl. - Inne 2

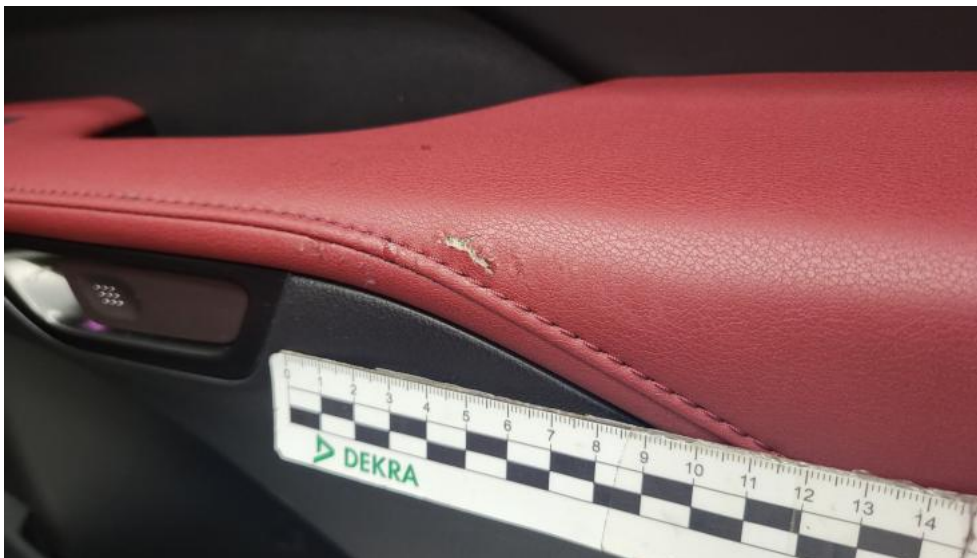
**Photo 57.**

Tapicerka drzwi tylnych P - Pęknięcie/rozerwanie 1
