DEKRA's commission No. : PKOL(W)/LODZ/83840/24/10/29
commission/ damage No. : 22/016986
Date of commission: 29-10-2024

Vehicle data

Group of objects (Eurotax)	cars
EC code (Eurotax)	0123825
Manufacturer	BMW
Model	Seria 5 [G30/F90] 16-20
Type / version	520d xDrive M Sport sport-aut
Body type	sedan
Number of doors / seats	4/5
Curb weight [kg]	1620
Gross vehicle weight [kg]	2325
Wheelbase 1/2	2975
Engine type	Automatic ignition
Supercompression	turbocompressor with intercooler
Pollution reduction system	DPF
Emission standard	EURO 6
Engine capacity [ccm]	1995
Engine Power [hp/kW]	190/140
Gearbox	automatic 8- gear
Registration /record No.	SK271XN
VIN / serial number	WBAJC51030WB86900
Date of first registration	15-02-2018
Date of next. tech. test	23-02-2025
Readout [km]	252 425 (read)
Body color / type of coating	black/METALIK

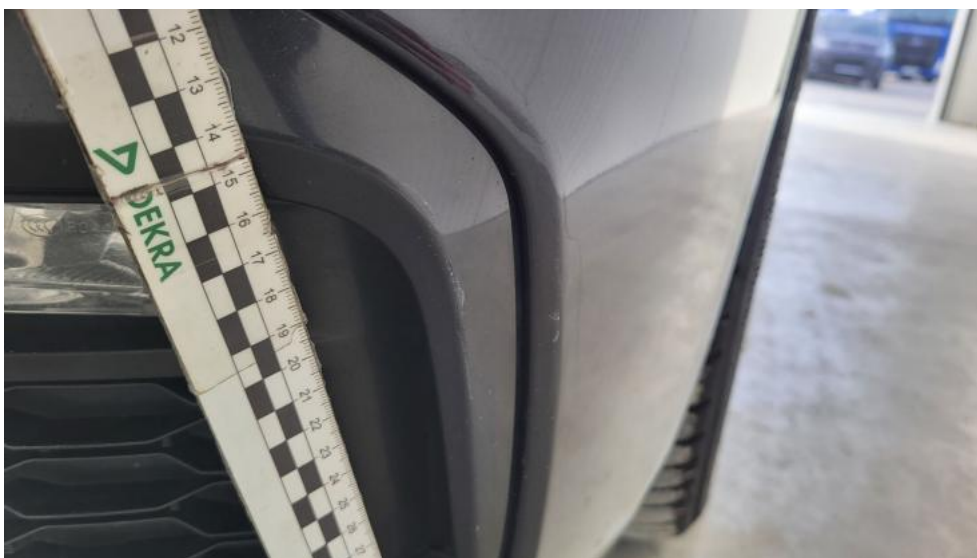
Photo 48.
Atrapa przednia - Rysa/odprysk 1

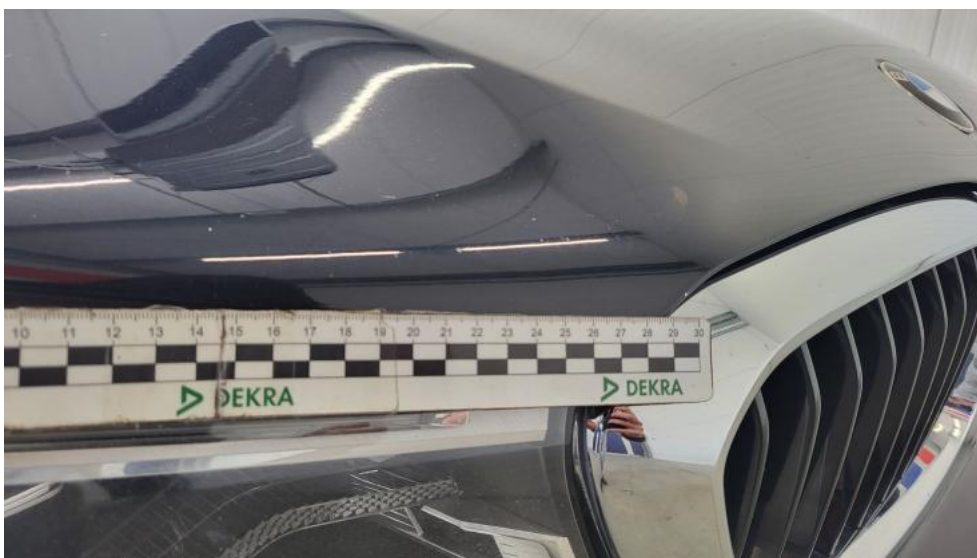
Photo 50.

Pokrywa komory silnika - Rysa/odprysk 2

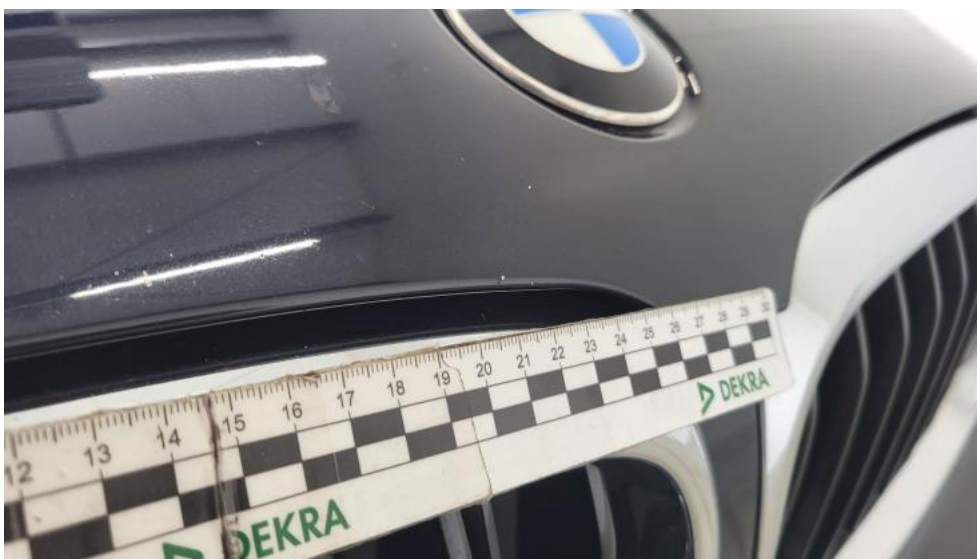
Photo 51.
Pokrywa komory silnika() - Rysa/odprysk 3

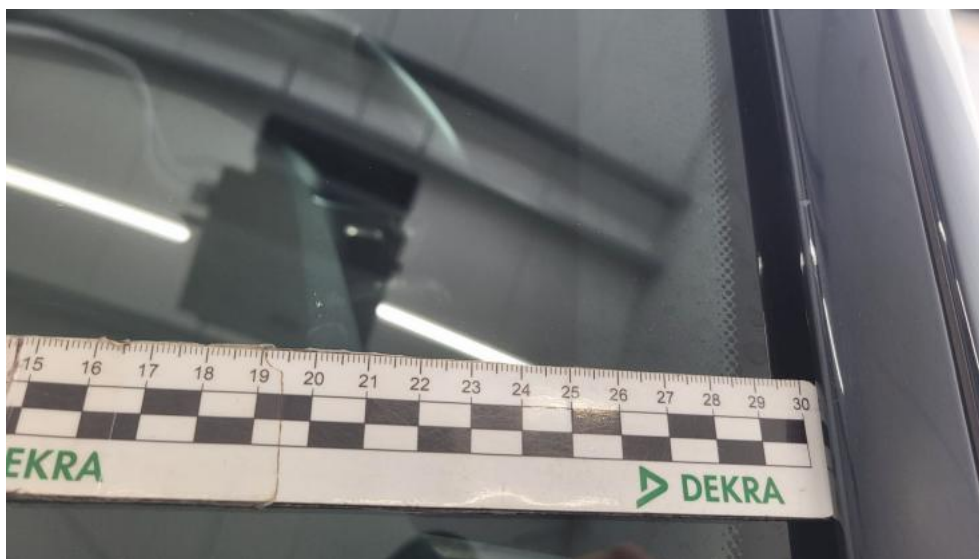
Photo 53.
Szyba czołowa - Rysa/odprysk 1

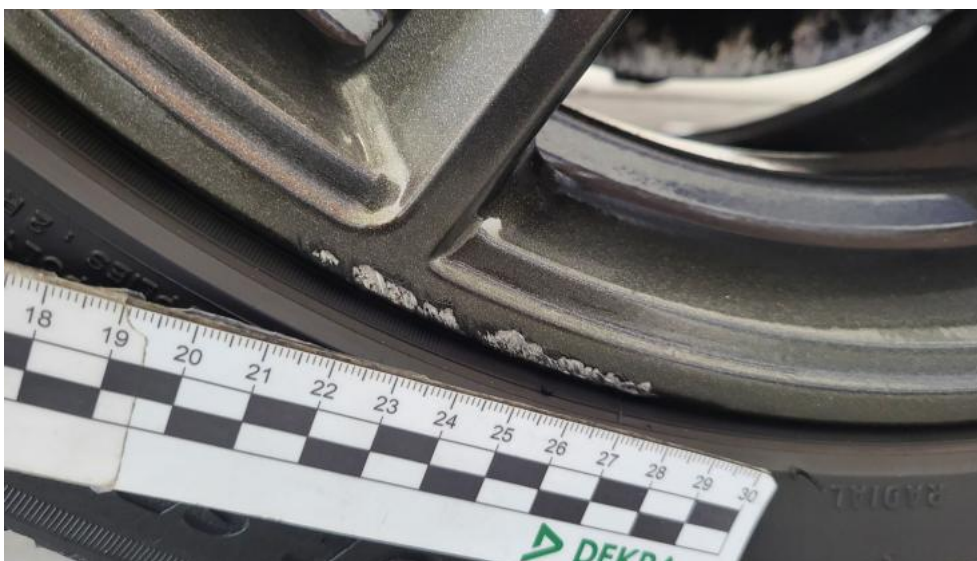
Photo 61.
Felga aluminiowa przednia P - Rysa/odprysk 1

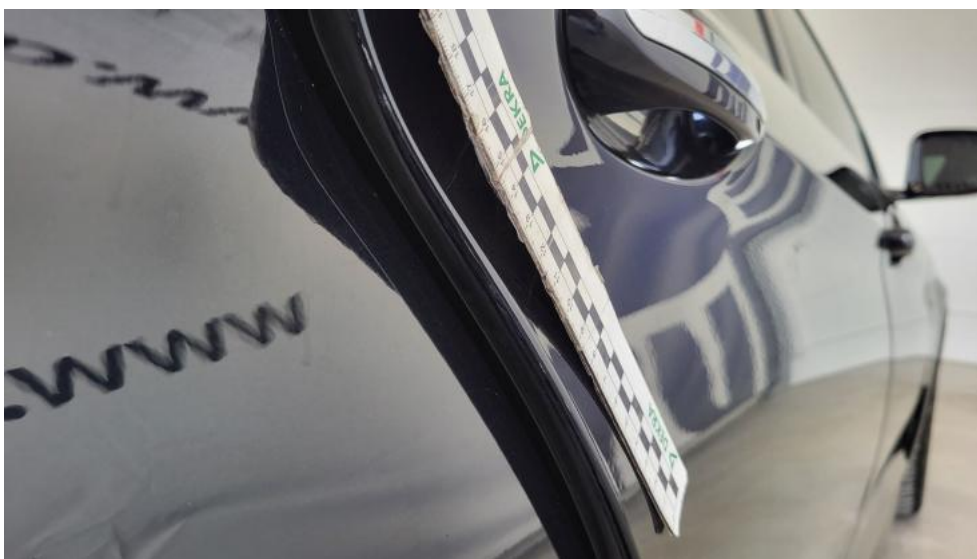
Photo 65.

Drzwi tylne P() - Rysa/odprysk 3

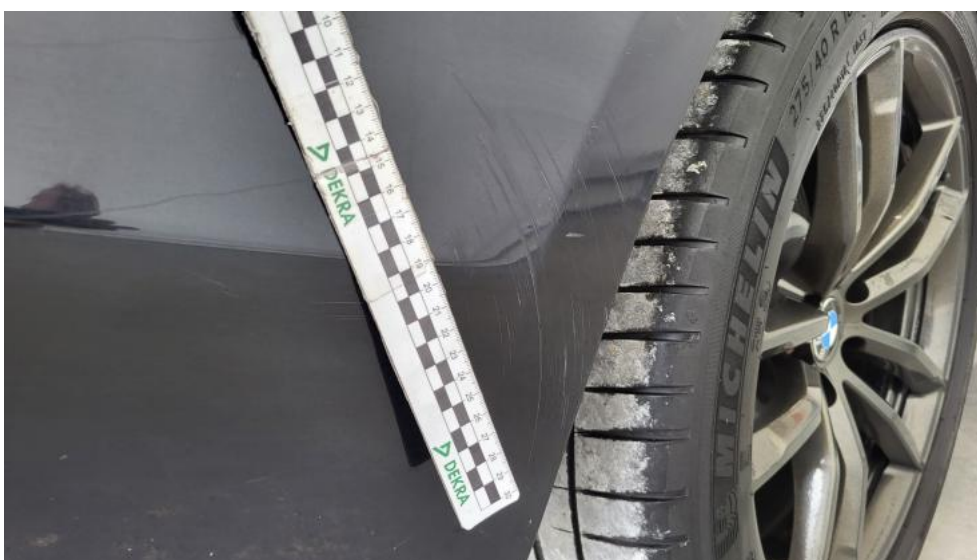
Photo 74.
Zderzak tylny - Rysa/odprysk 2

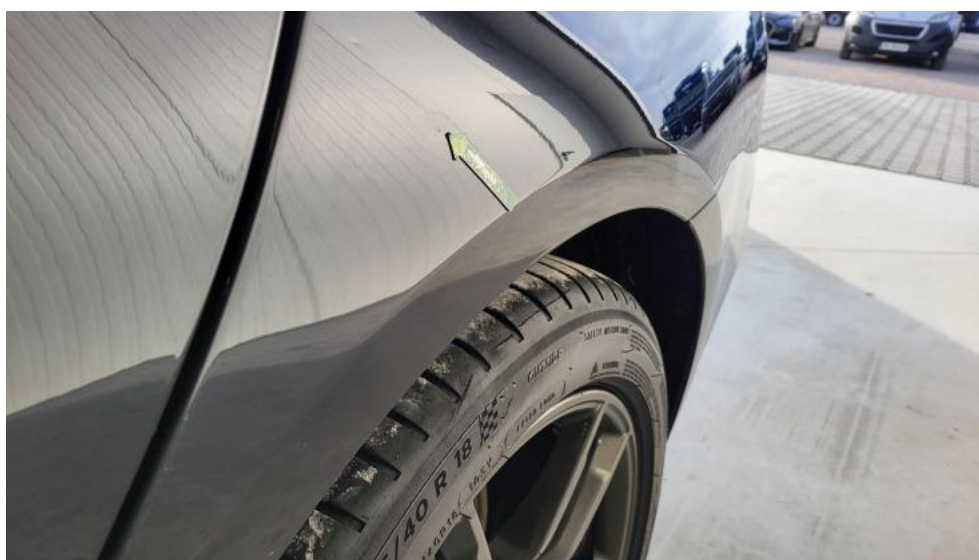
Photo 80.
Błotnik tylny L / Ściana boczna L - Wgniecenie/odkształcenie 1

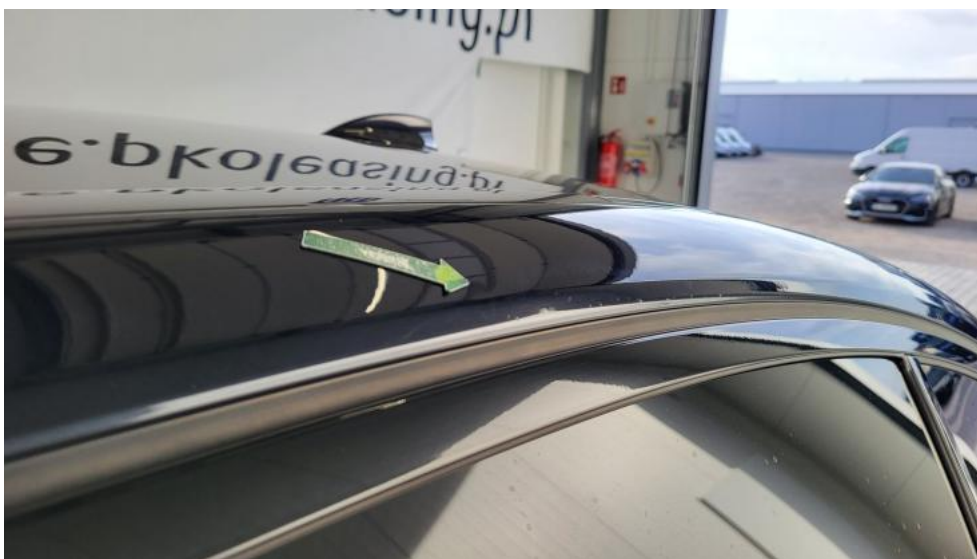
Photo 81.
Błotnik tylny L / Ściana boczna L - Wgniecenie/odkształcenie 2

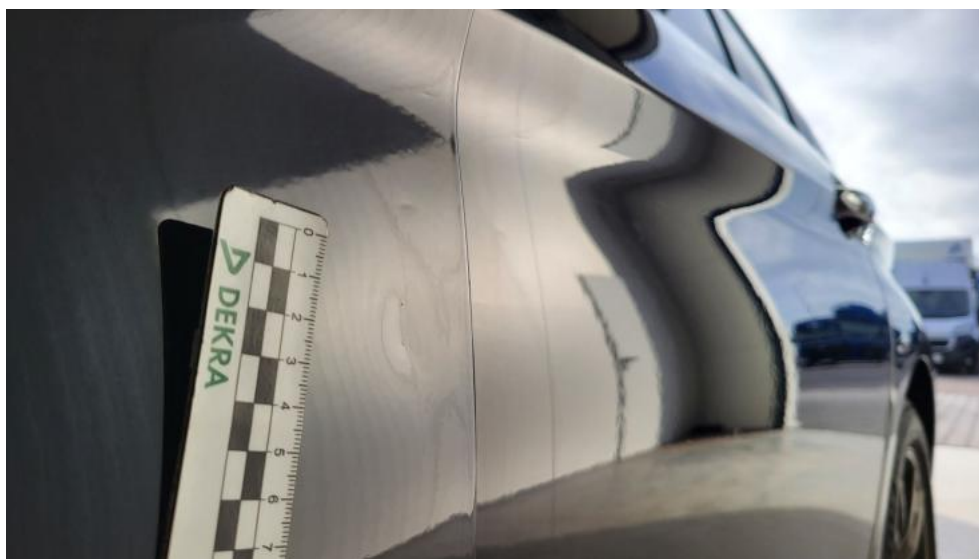
Photo 85.
Drzwi przed L - Wgniecenie/odkształcenie 1

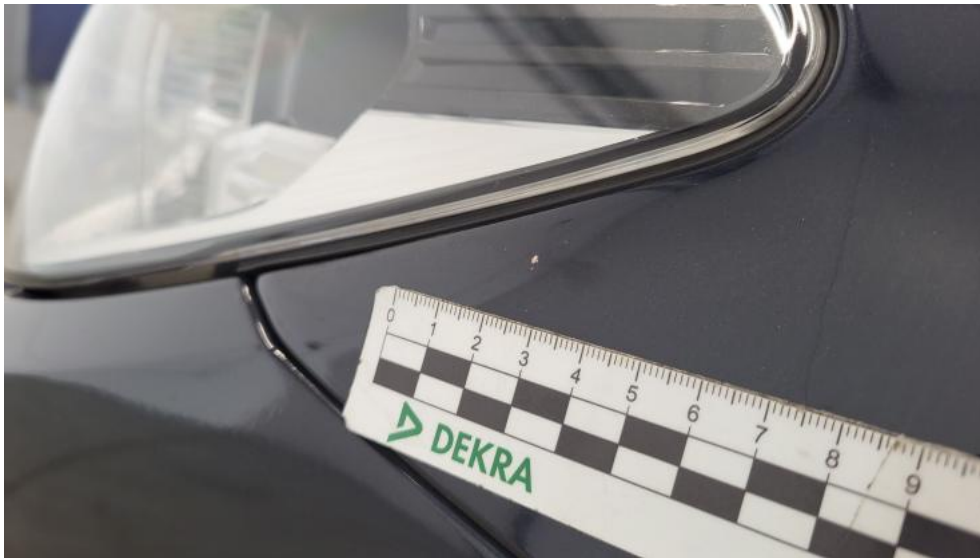
Photo 93.

Błotnik przedni L() - Rysa/odprysk 3

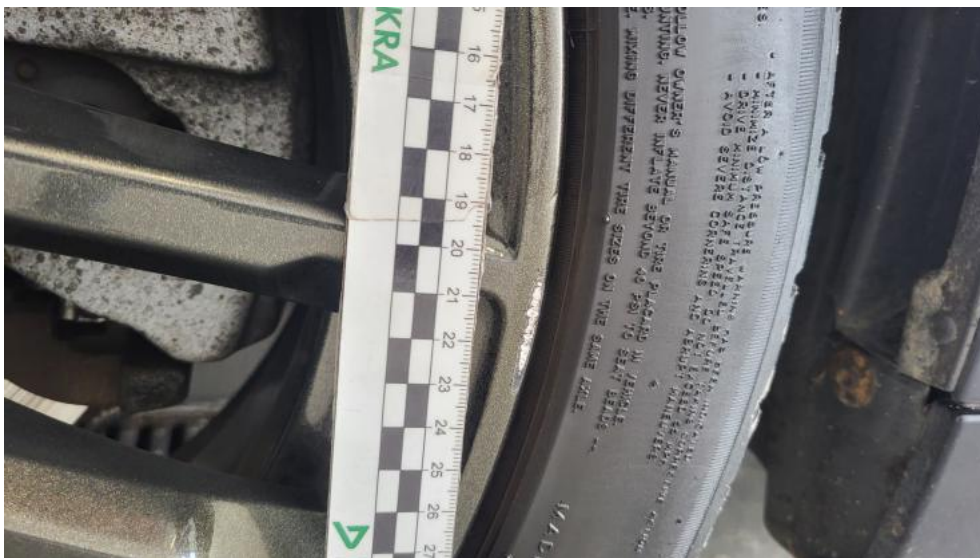
Photo 94.

Felga Aluminiowa przednia L - Rysa/odprysk 1
