DEKRA's commission No. : PKOL(W)/LODZ/74679/24/09/27
 commission/ damage No. : PS22/02377
 Date of commission: 27-09-2024

PKO Leasing SA
 Świętokrzyska 36
 00-116 Warszawa

Vehicle data

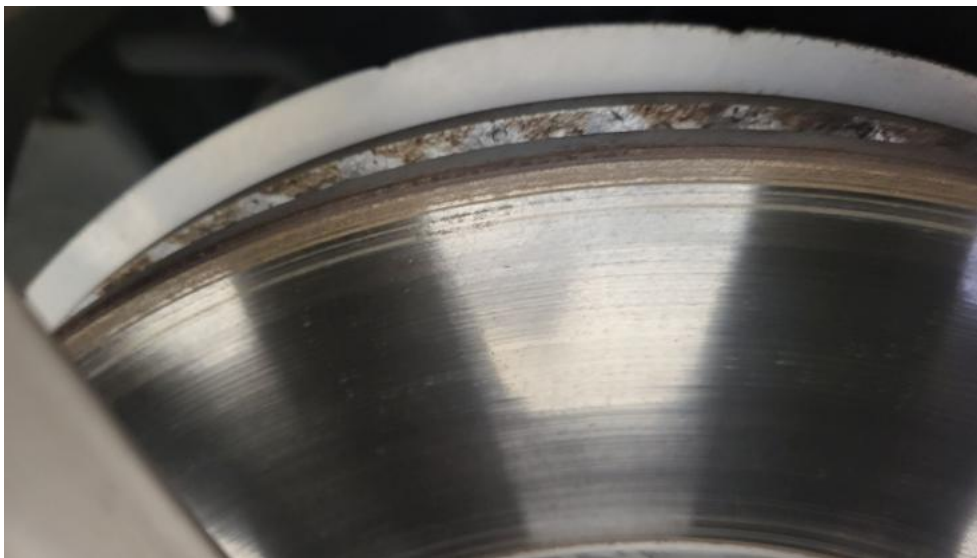
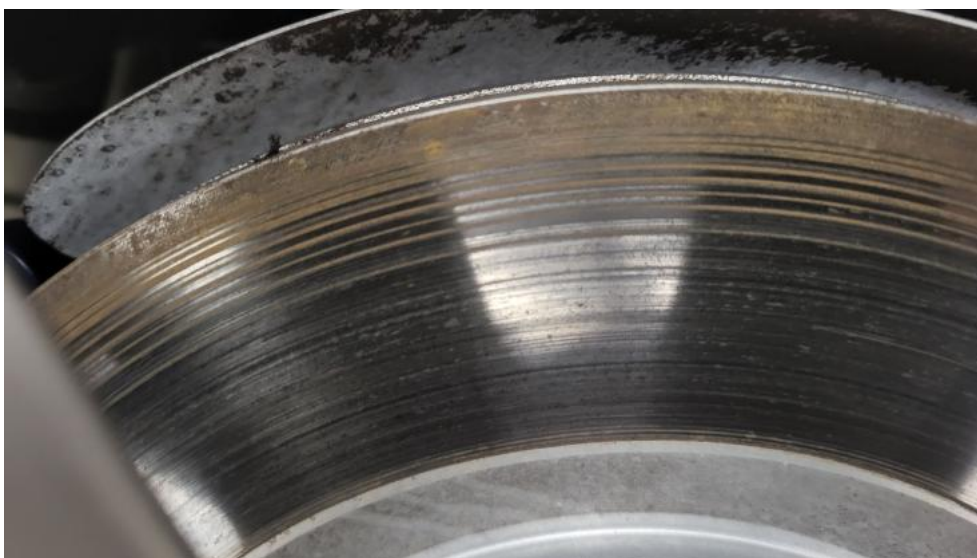
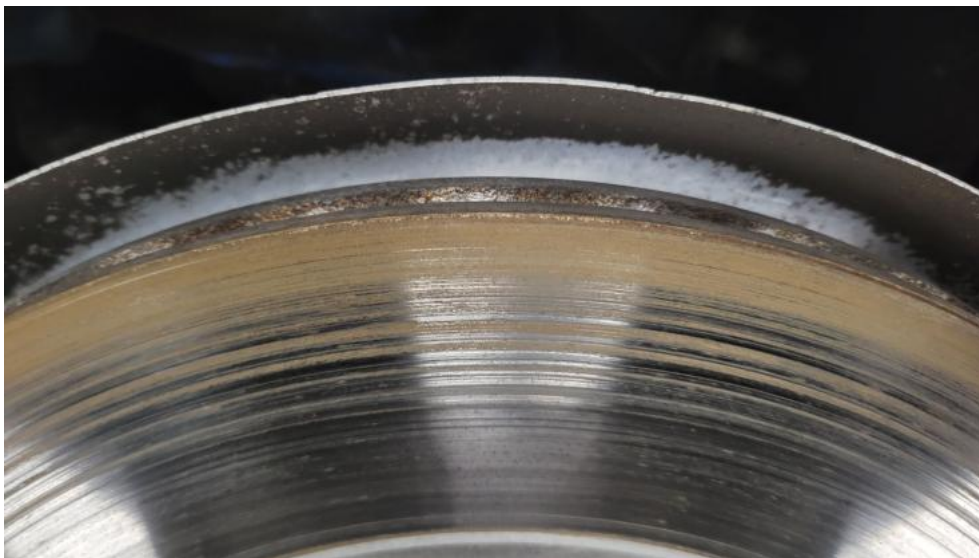
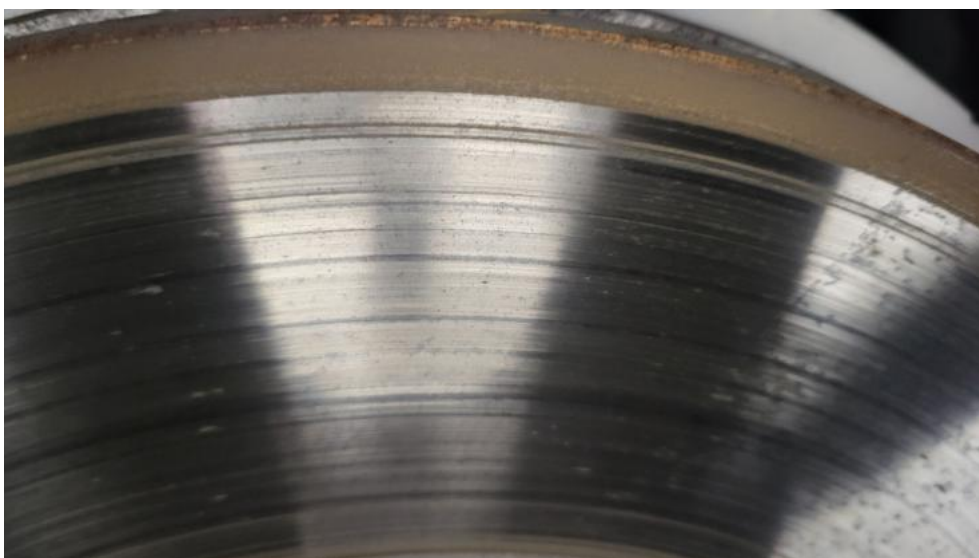
Photo 15.
Tarcza hamulcowa przednia prawa

Photo 16.
Tarcza hamulcowa tylna prawa

Tarcza hamulcowa tylna lewa

Tarcza hamulcowa przednia lewa

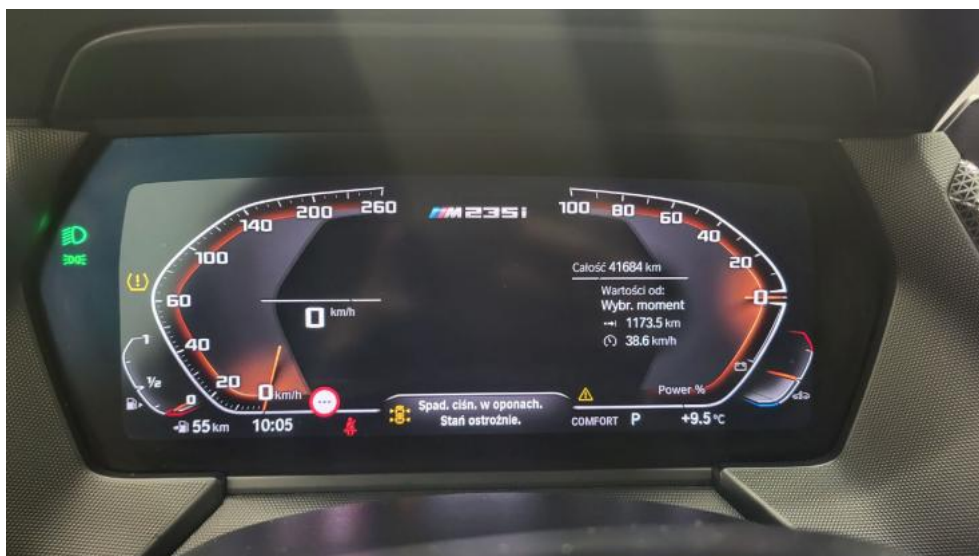
Photo 24.
Zestaw wskaźników - przebieg

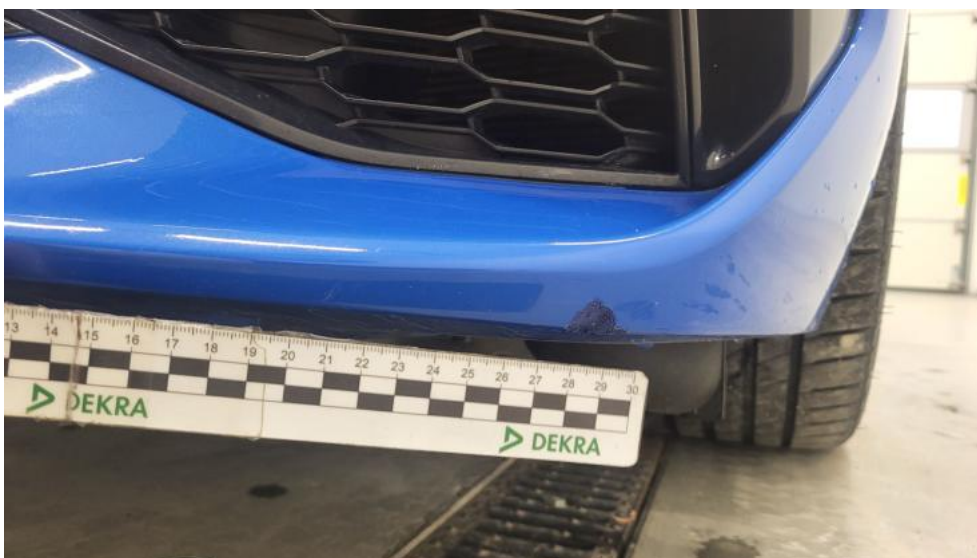
Photo 44.

Zderzak - Rysa/odprysk 1

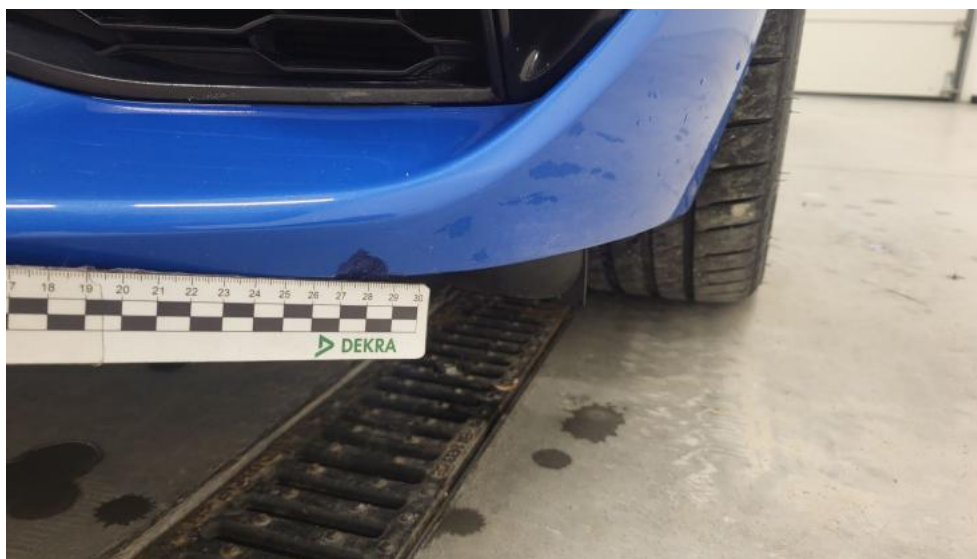
Photo 45.
Zderzak - Wgniecenie/odkształcenie 1

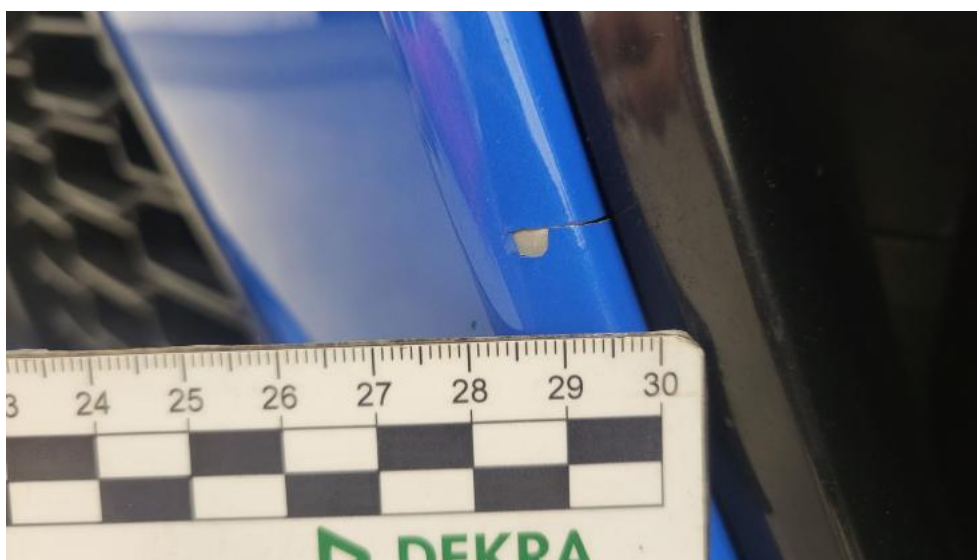
Photo 46.
Zderzak - Pęknięcie/rozerwanie 1

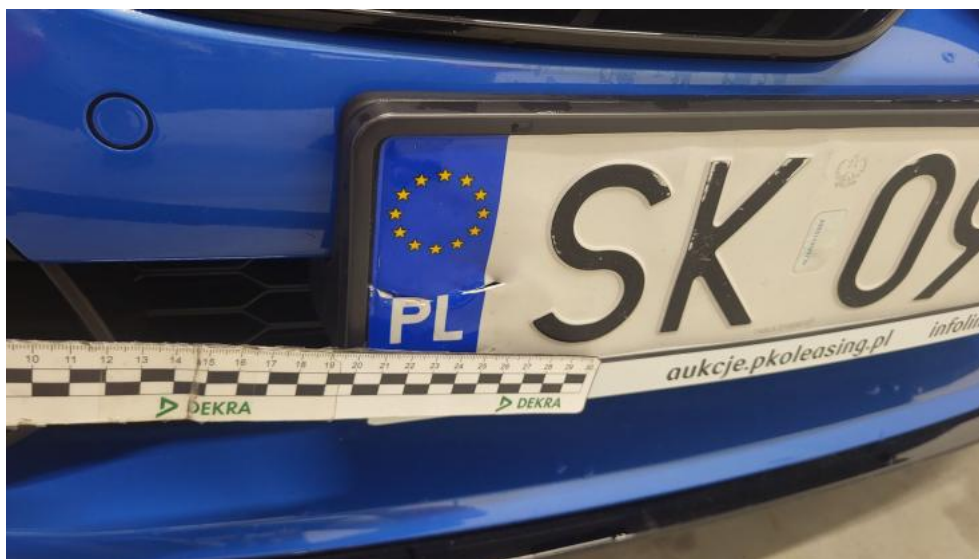
Photo 47.
Tablica rejestracyjna- Pęknięcie/rozerwanie 2

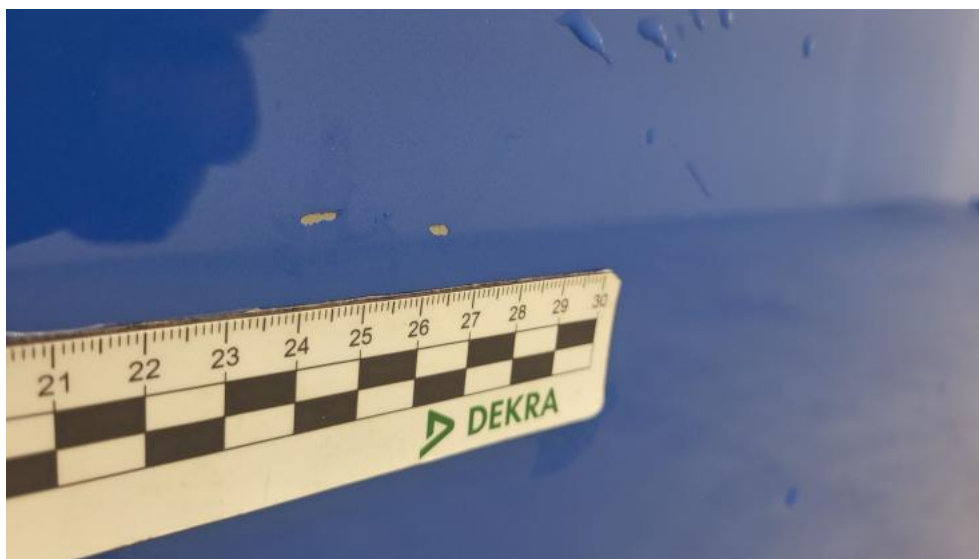
Photo 49.

Drzwi przed L - Rysa/odprysk 1

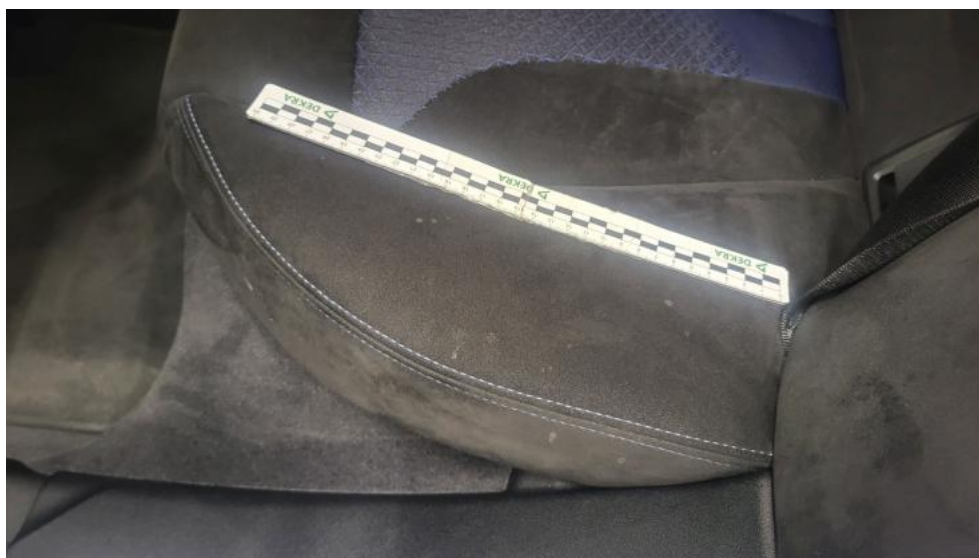
Photo 50.

Kanapa tyl. - Inne 1
