DEKRA's commission No. : PKOL(W)/LODZ/87484/26/09/17  
commission/ damage No. : 23/007880  
Date of commission: 17-09-2026

**DEKRA Poland - Headquarters**  
02-673 Warszawa, ul. Konstruktorska 12A

| Manufacturer | BMW |
| Model | Seria 8 Gran Coupe [G16] 19-22 |

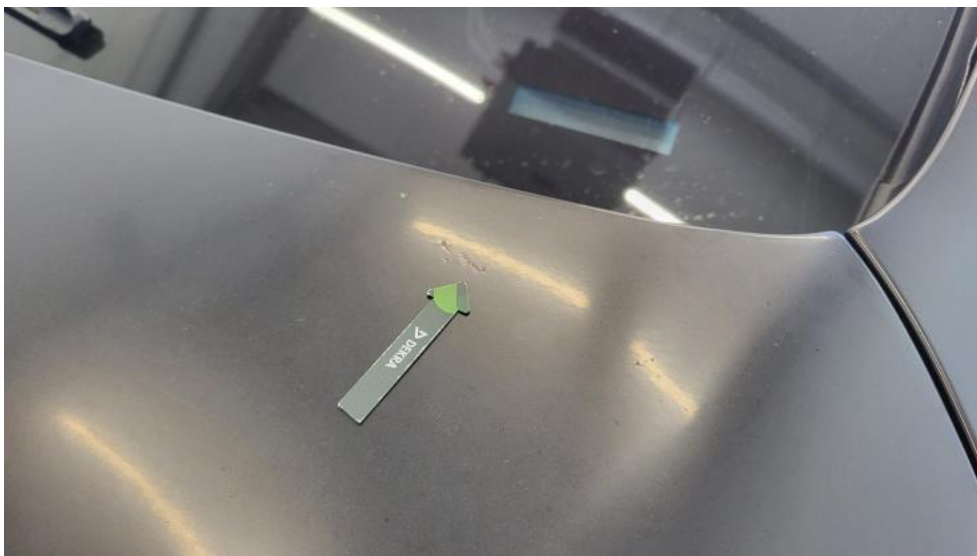
**Photo 55.**

Pokrywa komory silnika - Wgniecenie/odkształcenie 1

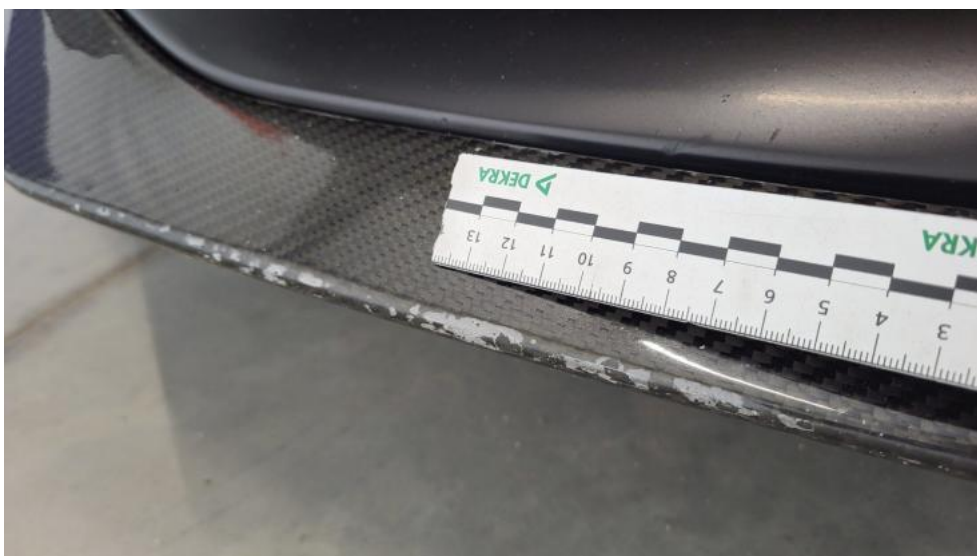
**Photo 56.**

Spoiler zderzaka przedniego - Inne 1

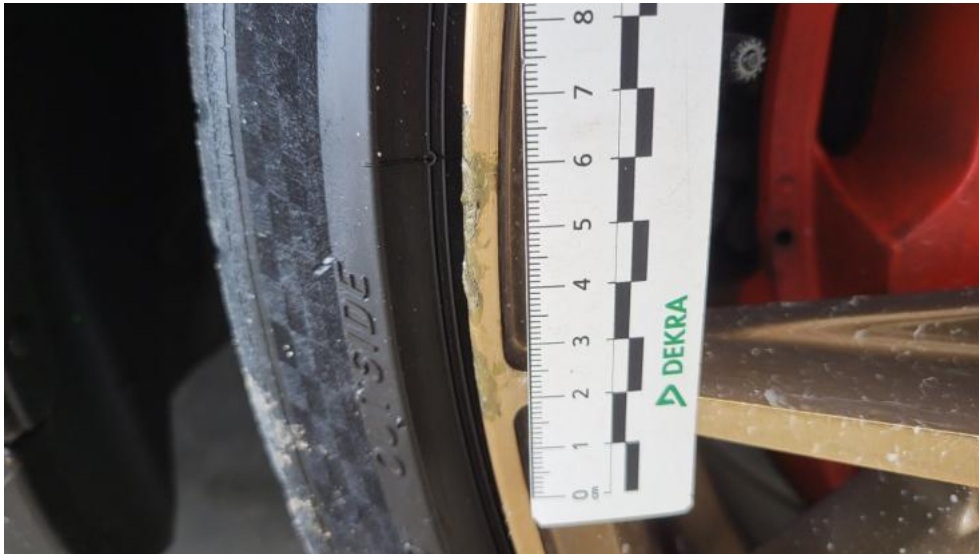
**Photo 59.**

Felga aluminiowa przednia P - Rysa/odprysk 1

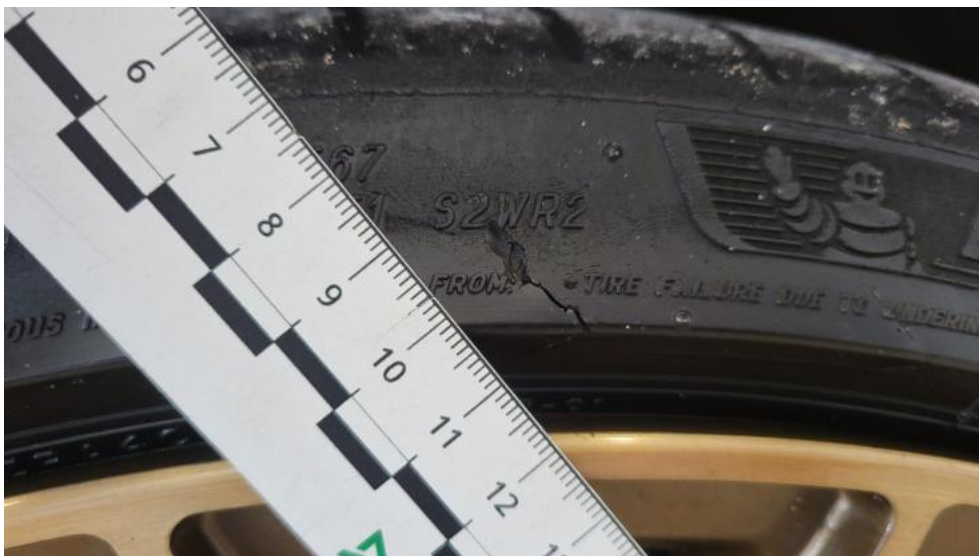
**Photo 60.**

Opona przednia P - Pęknięcie/rozerwanie 1

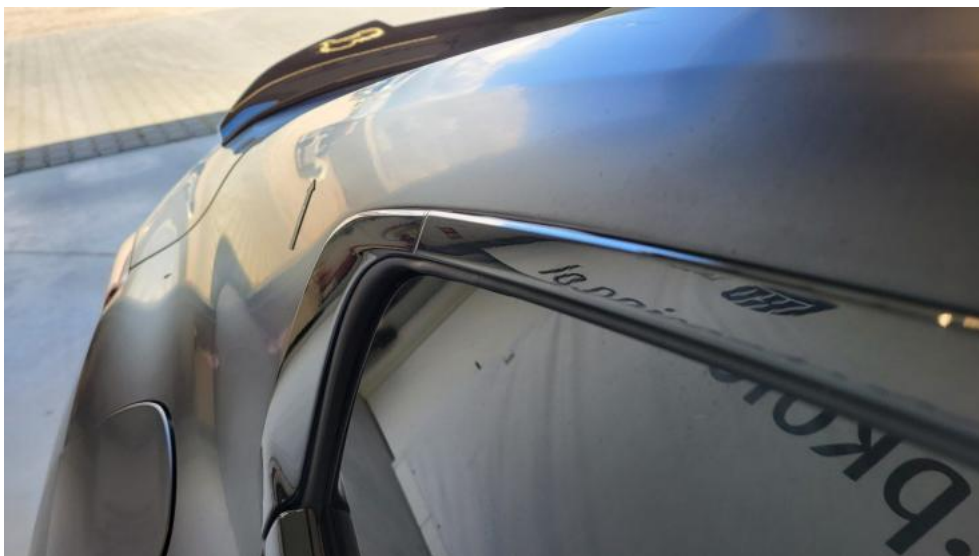
**Photo 62.**

Błotnik tylny P / Ściana boczna P - Wgniecenie/odkształcenie 1

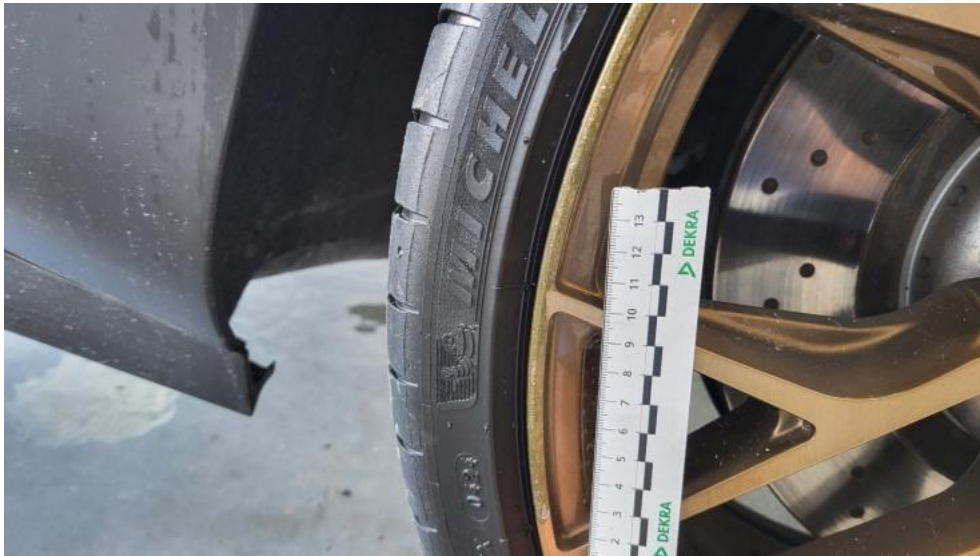
**Photo 63.**

Felga aluminiowa tylna P - Rysa/odprysk 1

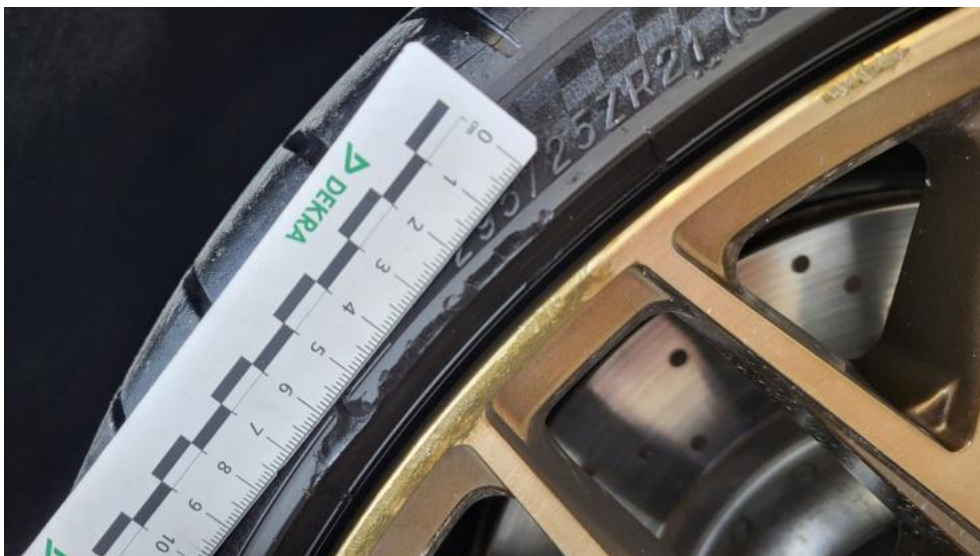
**Photo 64.**

Opona tylna P - Pęknięcie/rozerwanie 1

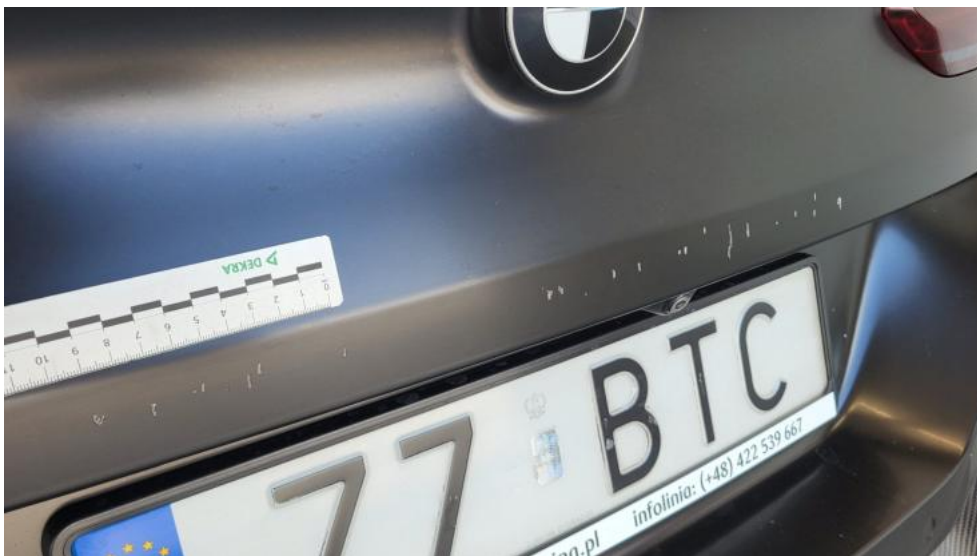
**Photo 65.**

Pokrywy bagażnika - Inne 1

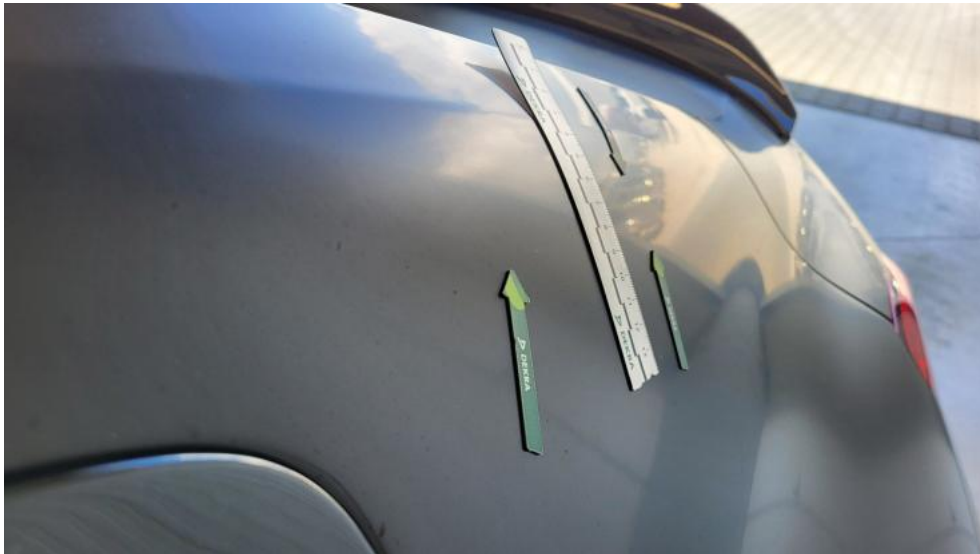
**Photo 67.**

Błotnik tylny L / Ściana boczna L - Wgniecenie/odkształcenie 1

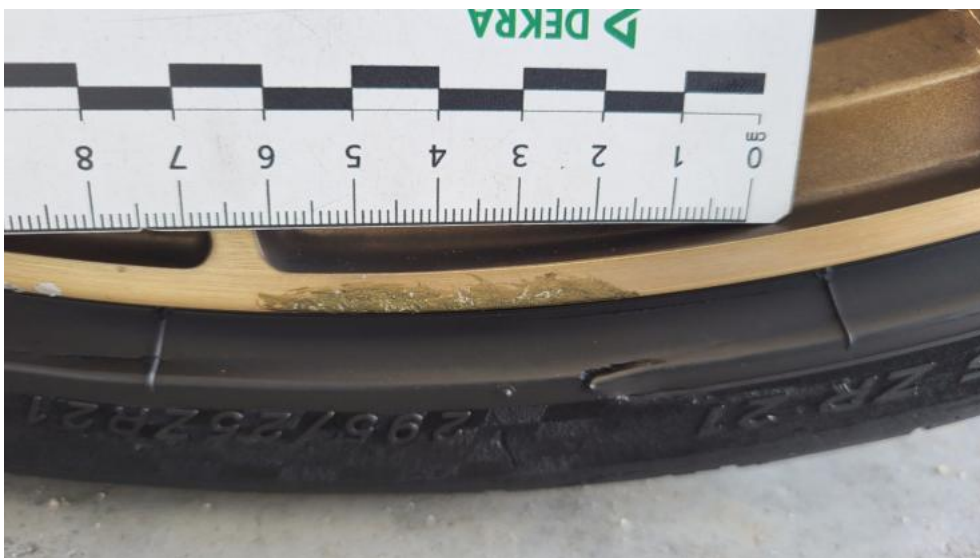
**Photo 68.**

Felga aluminiowa tylna L - Rysa/odprysk 1

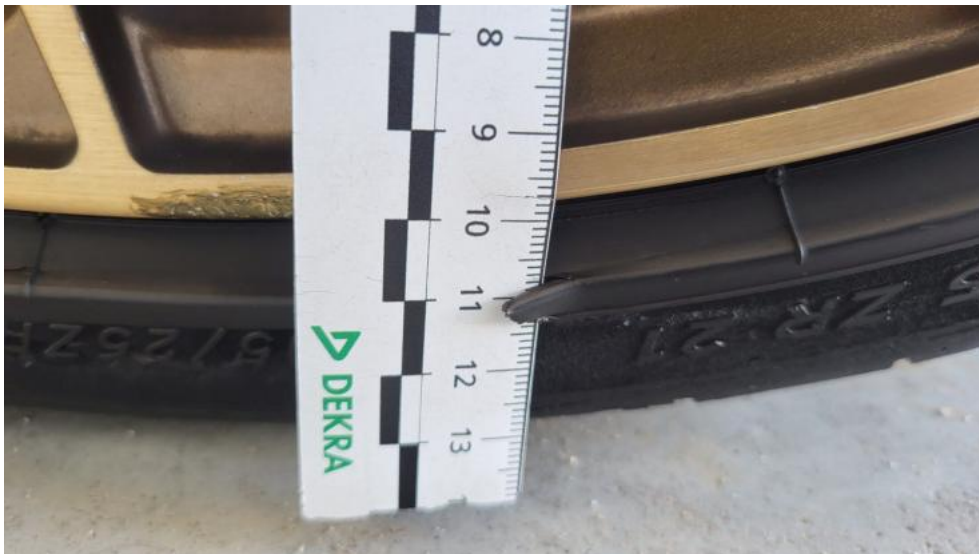
**Photo 69.**

Opona tylna L - Pęknięcie/rozerwanie 1

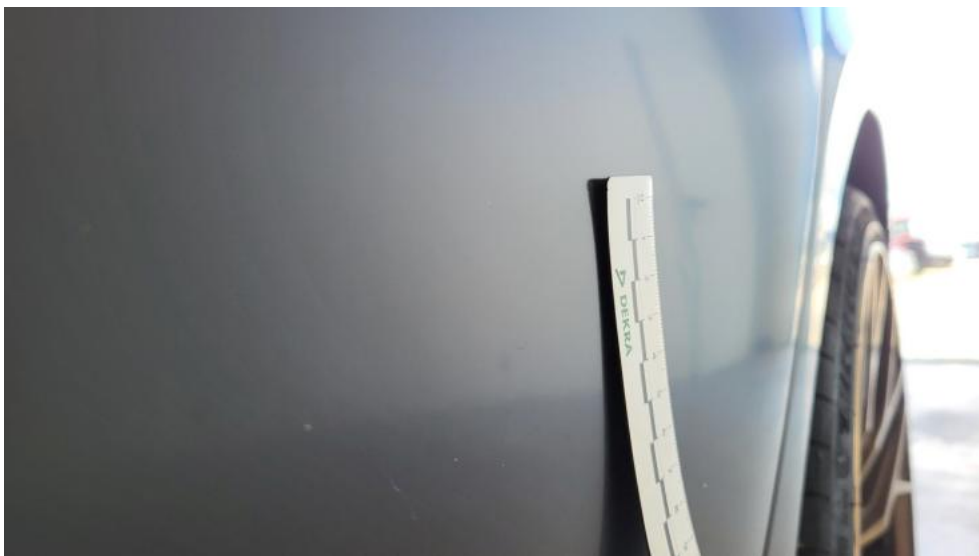
**Photo 70.**

Drzwi tylne L - Wgniecenie/odkształcenie 1

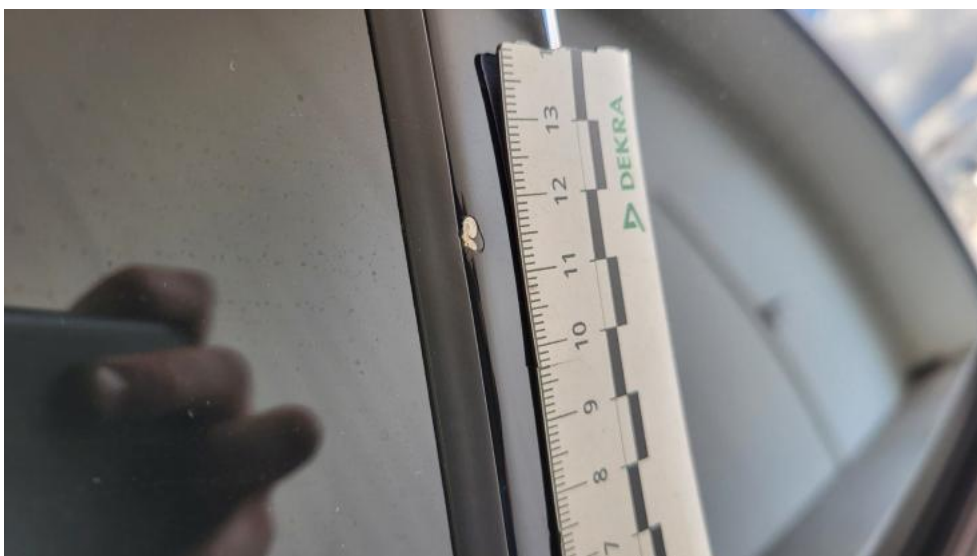
**Photo 72.**

Listwa drzwi tylnych L - Rysa/odprysk 1

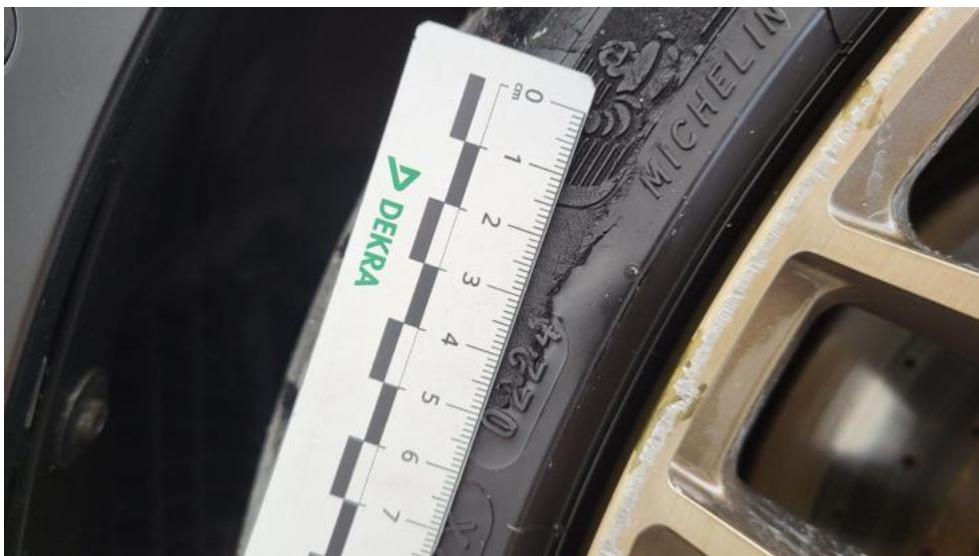
**Photo 74.**

Opona przednia L - Pęknięcie/rozerwanie 1

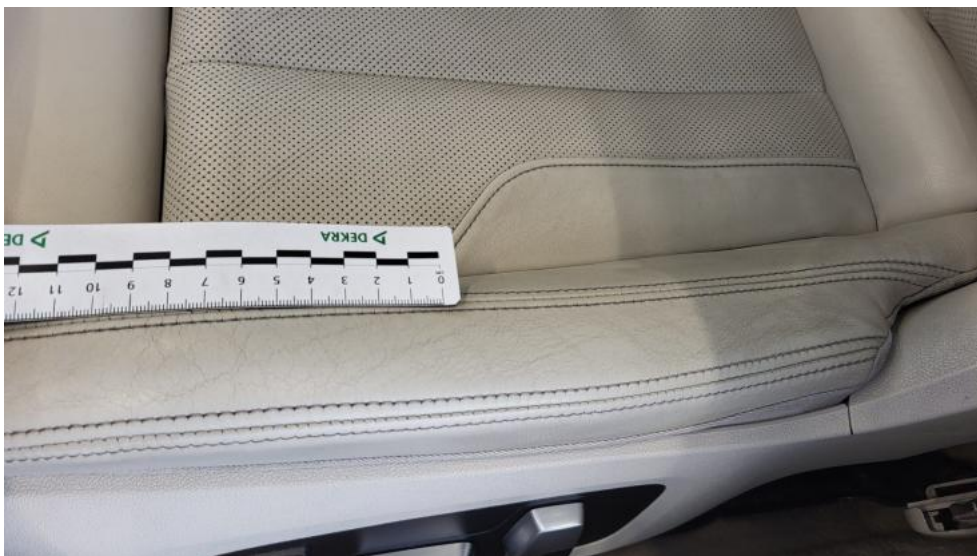
**Photo 75.**

Fotel prz. lew. - Rysa/odprysk 1

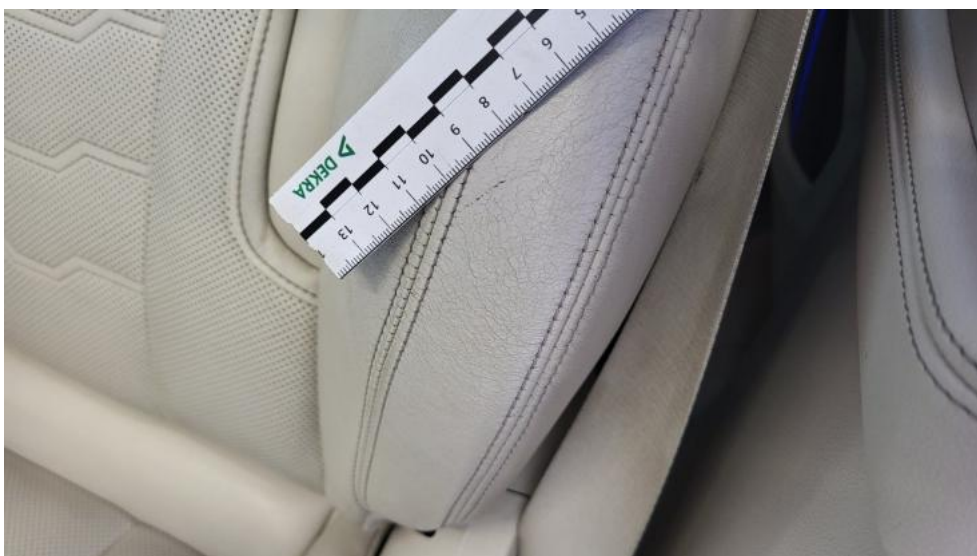
**Photo 76.**

Fotel prz. lew. - Rysa/odprysk 2

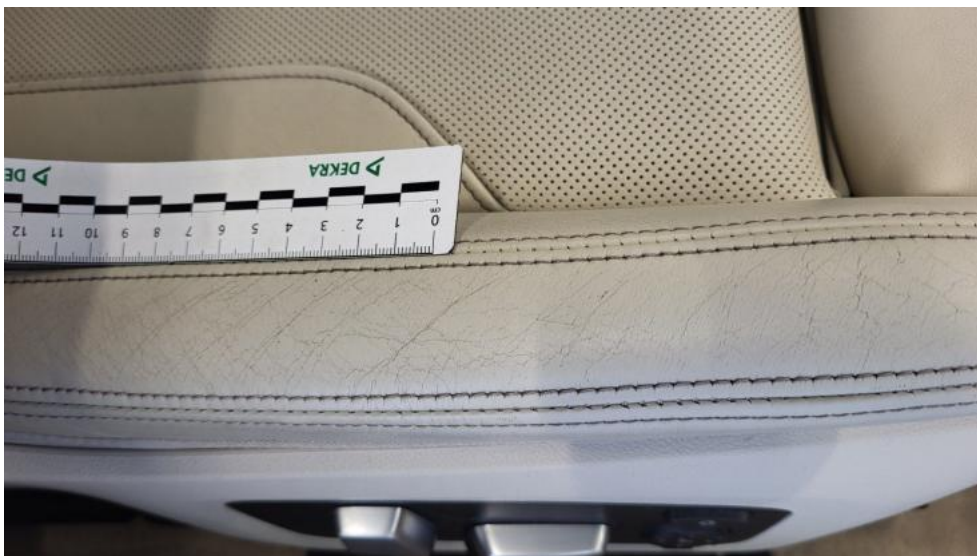
**Photo 77.**

Fotel prz. praw. - Rysa/odprysk 1

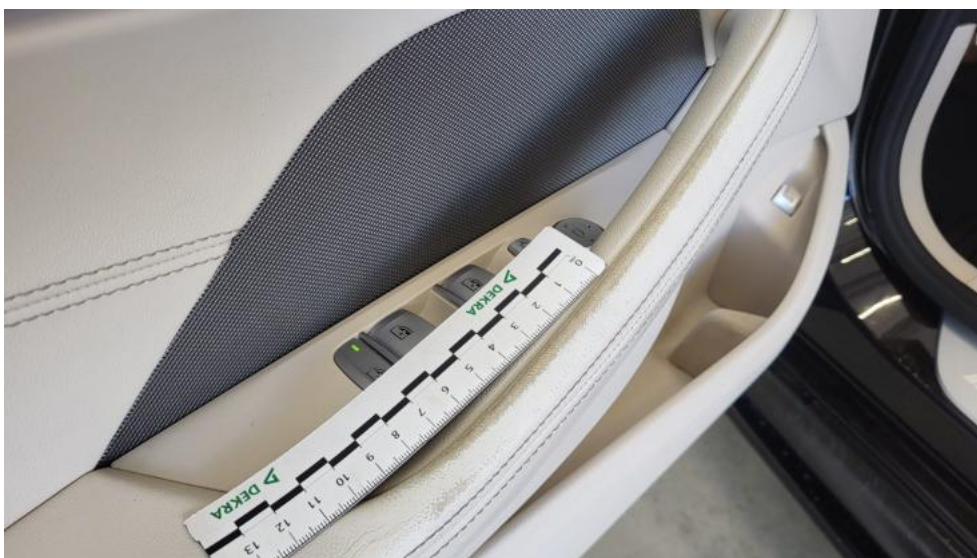
**Photo 78.**

Uchwyt drzwi prze L - Inne 1

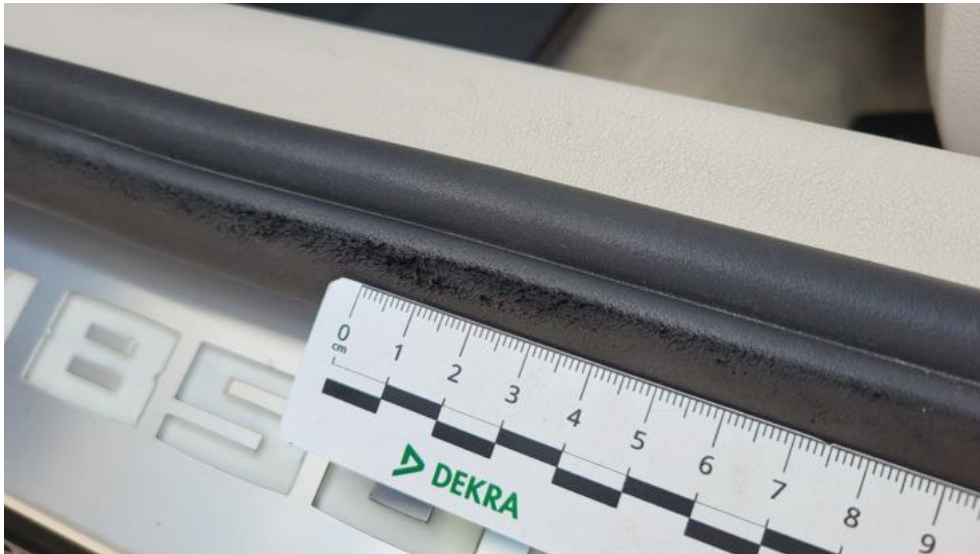
**Photo 79.**

Uszczelka drzwi przednich L - Rysa/odprysk 1

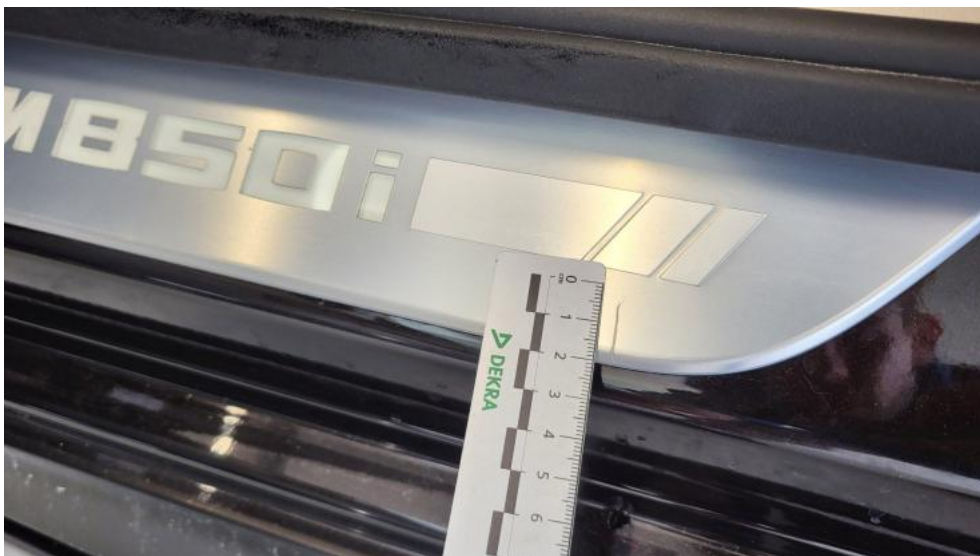
**Photo 80.**

Listwy progowe lew. - Rysa/odprysk 1
