DEKRA's commission No. : PKOL(W)/LODZ/27819/26/03/30  
 commission/ damage No. : 24/001010  
 Date of commission: 30-03-2026

**Vehicle data**

Group of objects (Eurotax)	cars
EC code (Eurotax)	0135835
Manufacturer	AUDI
Model	A6 Avant [C8] 18-23
Type / version	A6 40 TDI mHEV Quattro Sport S tronic
Body type	KOM
Number of doors / seats	5/5
Curb weight [kg]	1985
Gross vehicle weight [kg]	2425
Wheelbase 1/2	2924
Engine type	Automatic ignition
Pollution reduction system	KSC
Engine capacity [ccm]	1968
Engine Power [hp/kW]	204/150
Gearbox	automatic
Registration /record No.	DW3XW43
VIN / serial number	WAUZZZF29KN107397
Date of first registration	13-08-2019
Date of next. tech. test	15-01-2027
Year of manufacture	2019
Readout [km]	107 213 (read)
Body color / type of coating	white/double-layered, metallized

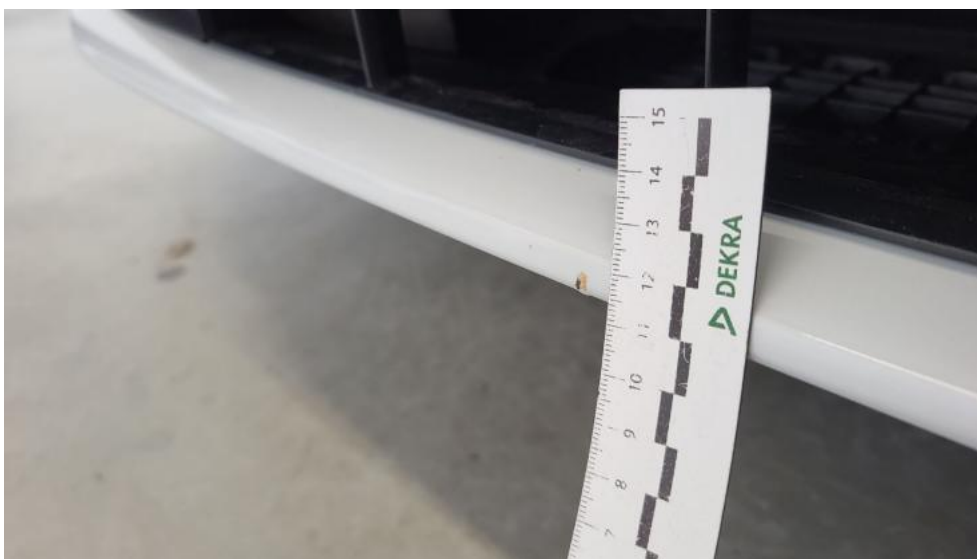
**Photo 41.**  
Zderzak - Rysa/odprysk 1

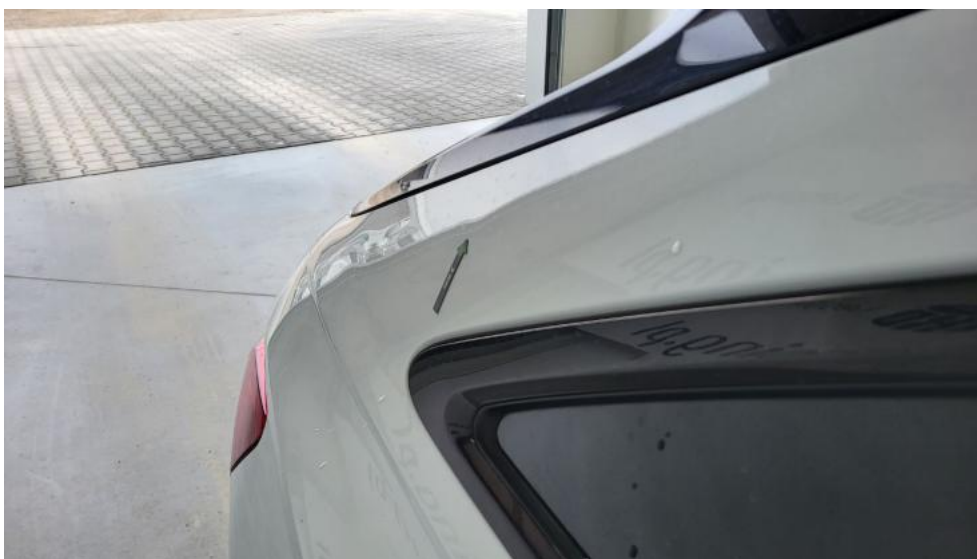
**Photo 45.**  
Błotnik tylny P / Ściana boczna P - Wgniecenie/odkształcenie 1

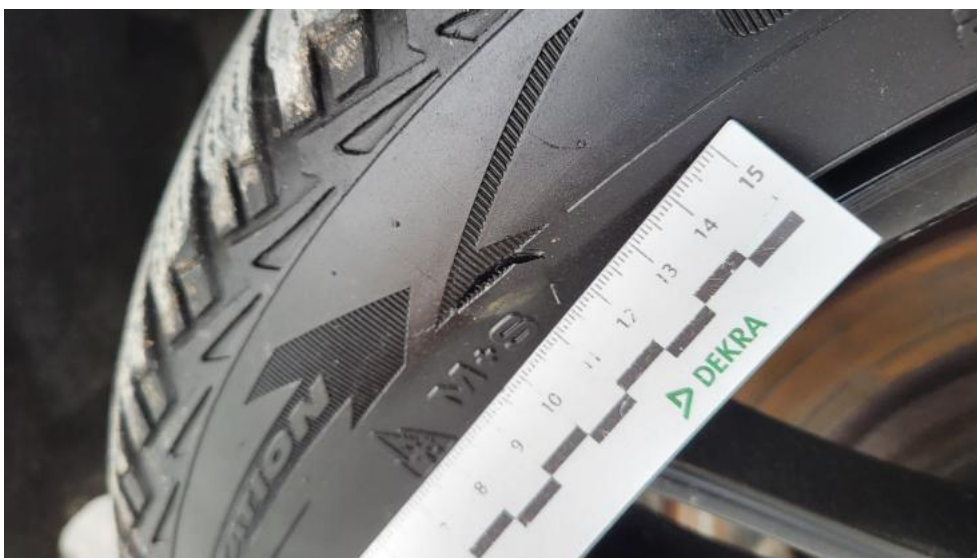
**Photo 46.**  
Opona tylna P - Pęknięcie/rozerwanie 1

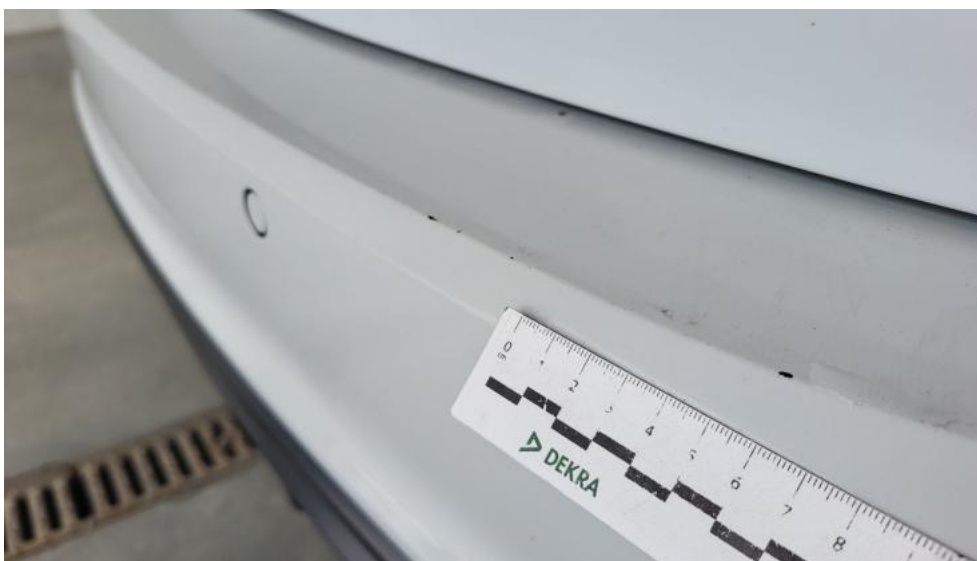
**Photo 47.**  
Zderzak tylny - Rysa/odprysk 1

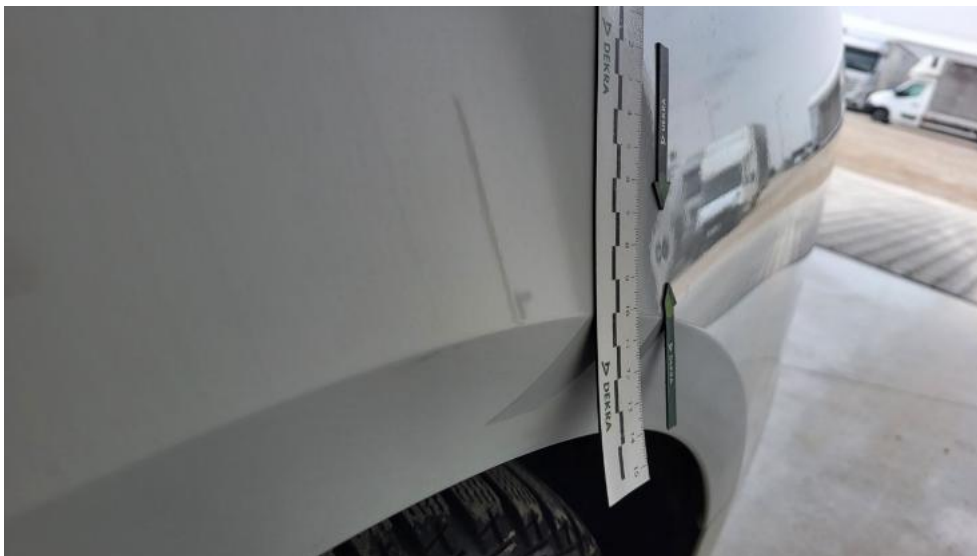
**Photo 51.**  
Błotnik tylny L / Ściana boczna L - Wgniecenie/odkształcenie 1

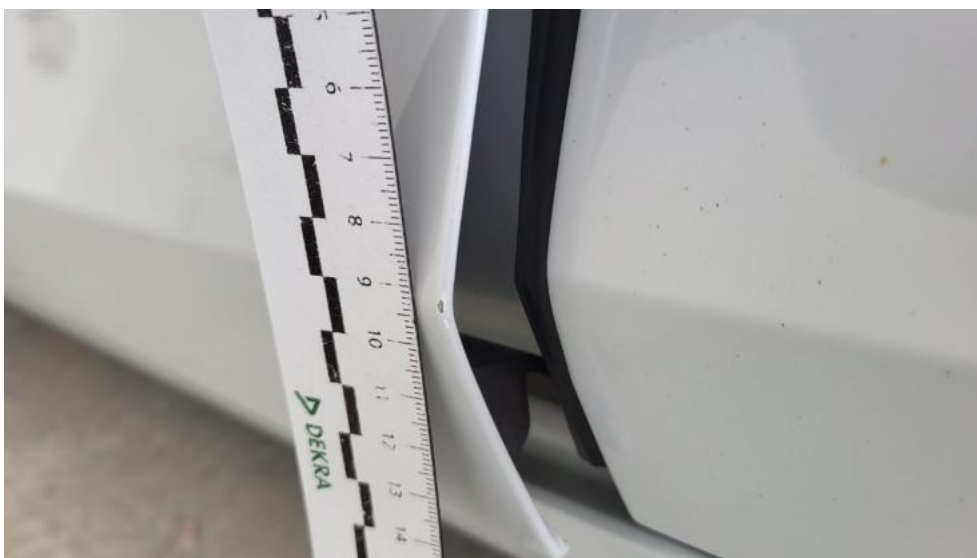
**Photo 52.**  
Drzwi przed L - Rysa/odprysk 1

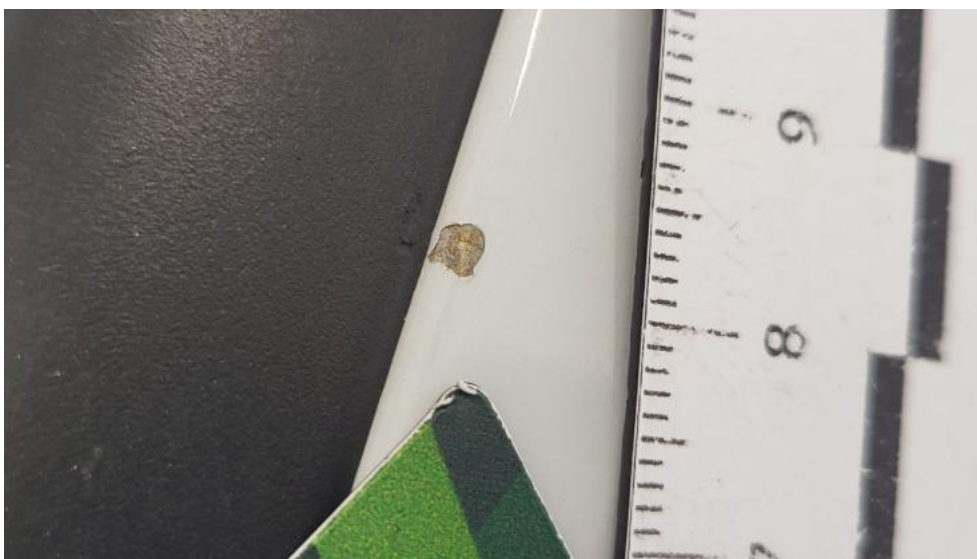
**Photo 55.**  
Stupek przedni L - Inne 1

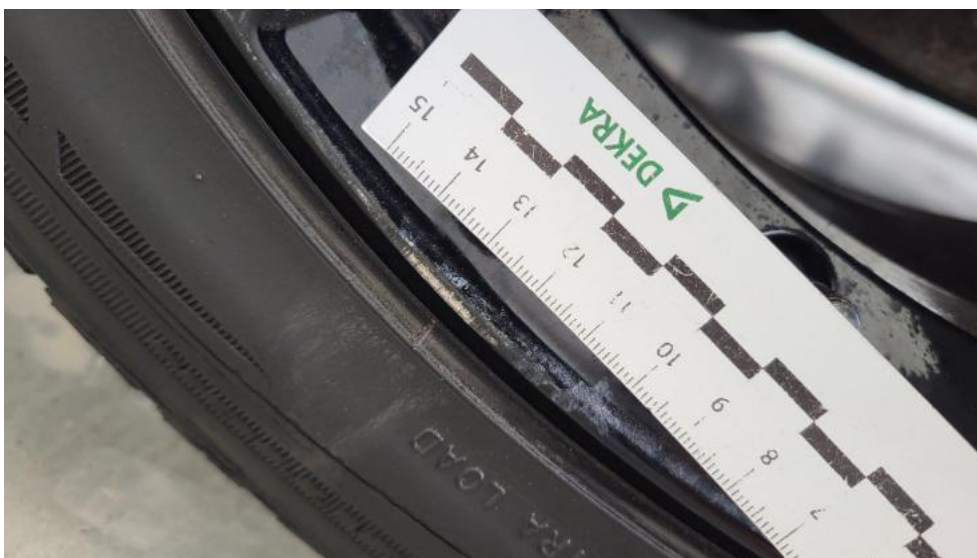
**Photo 56.**  
Felga Aluminiowa przednia L - Rysa/odprysk 1

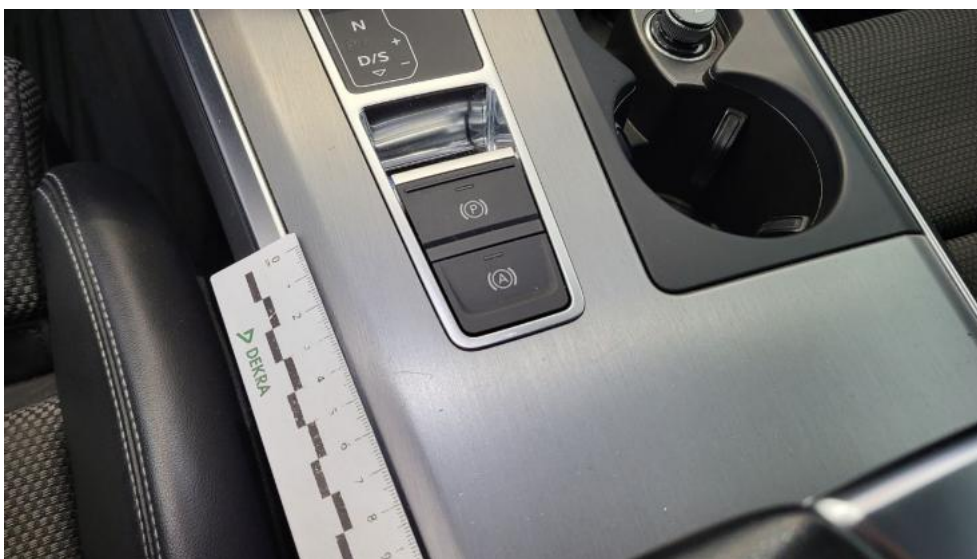
**Photo 57.**  
Konsola tunelu śr. - Rysa/odprysk 1

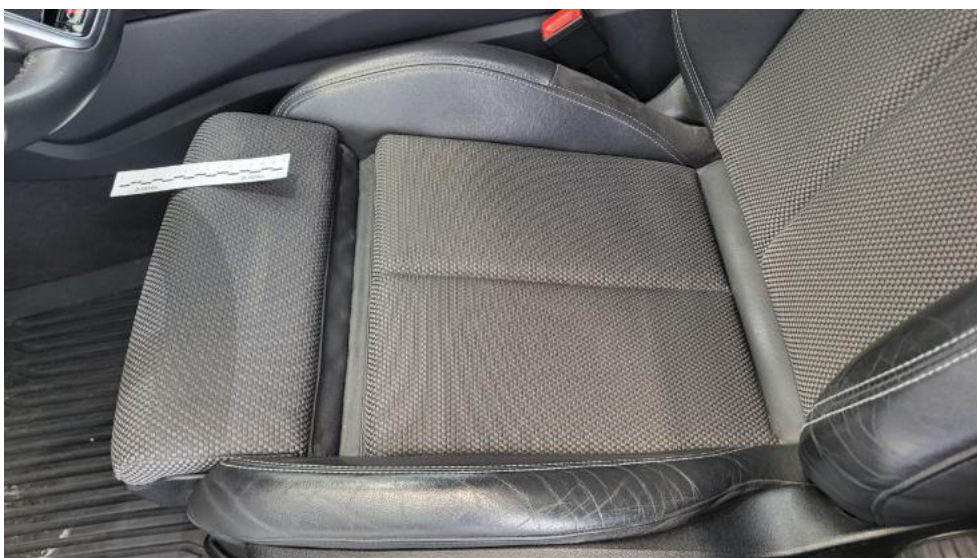
**Photo 58.**  
Fotel prz. lew. - Inne 1
