DEKRA's commission No. : PKOL(W)/LODZ/17045/25/03/07  
 commission/ damage No. : 24/025834  
 Date of commission: 07-03-2025

**Vehicle data**

PHOTOGRAPHIC DOCUMENTATION

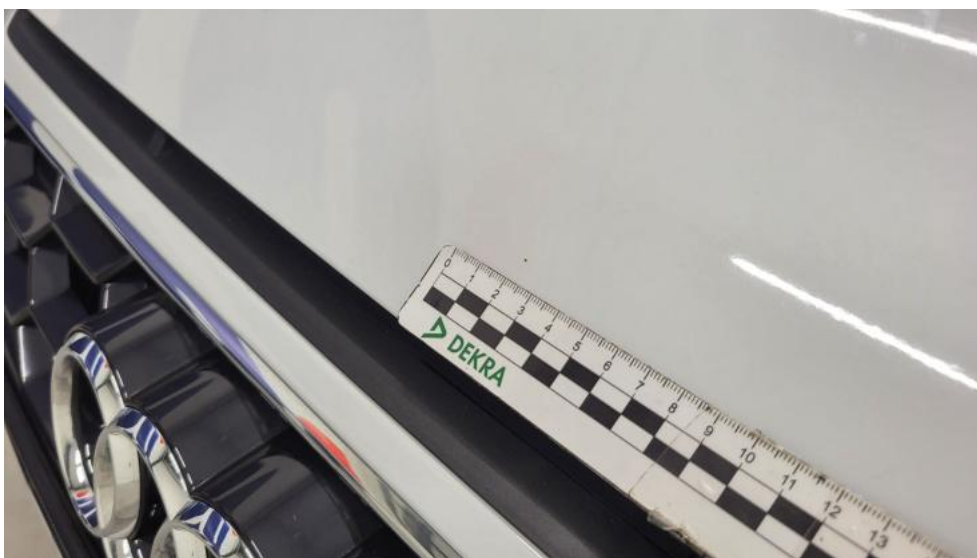
**Photo 40.**  
Pokrywa komory silnika - Rysa/odprysk 1

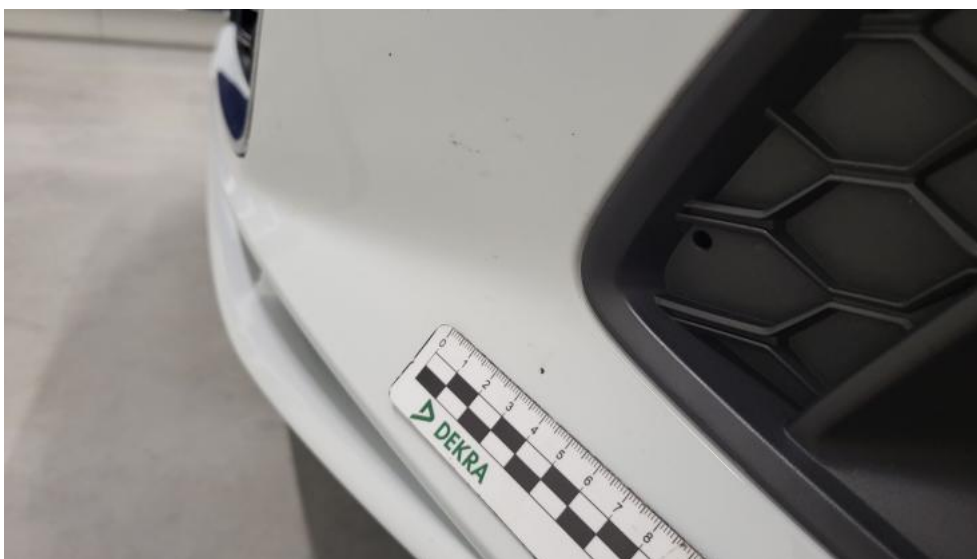
**Photo 41.**  
Zderzak - Rysa/odprysk 1

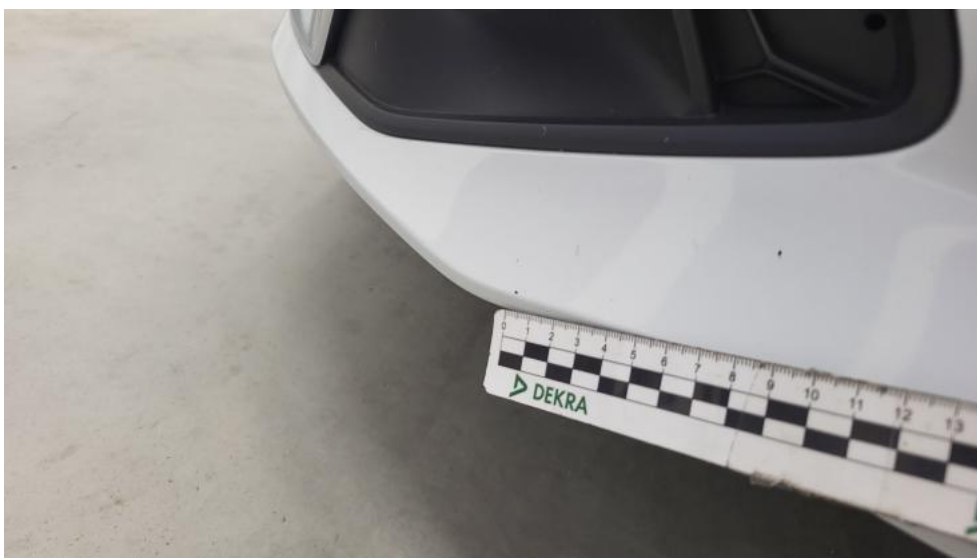
**Photo 42.**  
Zderzak - Rysa/odprysk 2

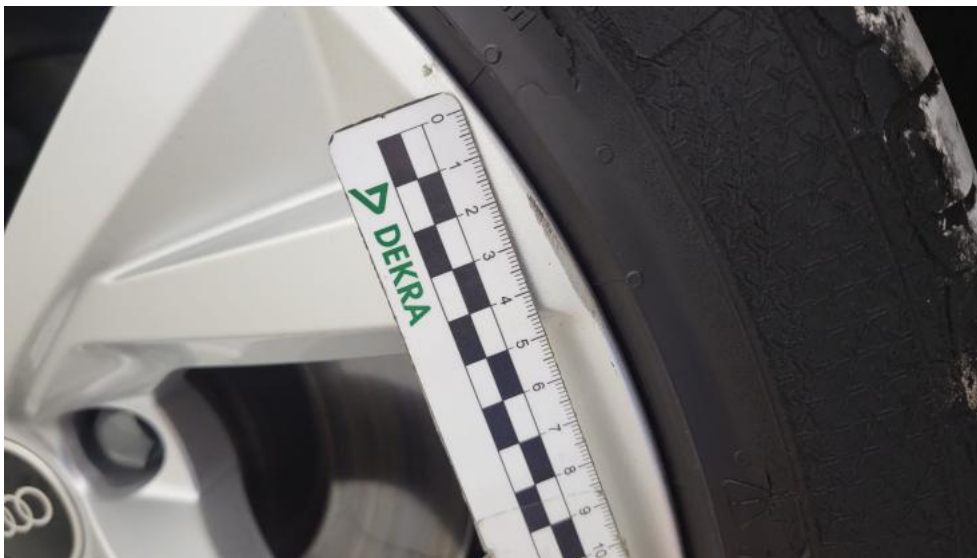
**Photo 43.**  
Felga aluminiowa przednia P - Rysa/odprysk 1

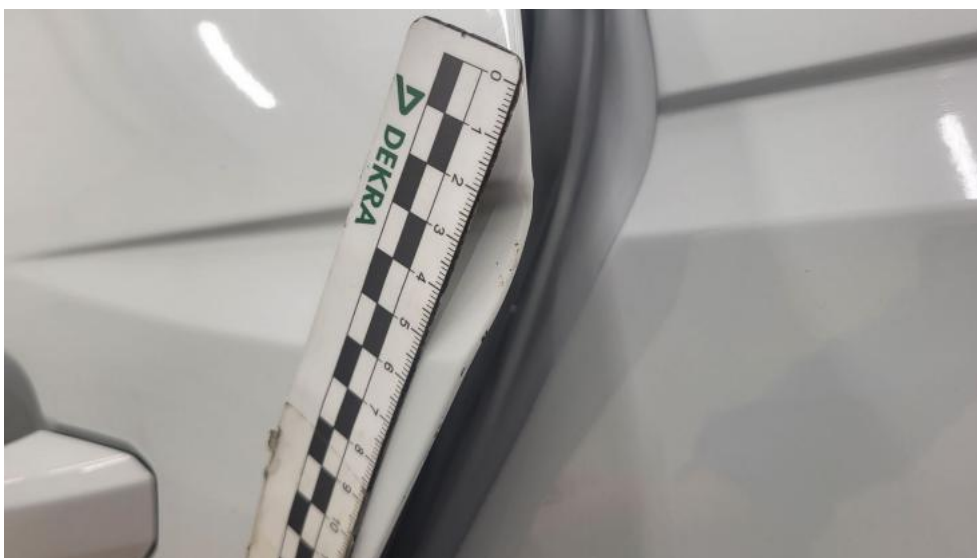
**Photo 44.**  
Drzwi tylne L - Rysa/odprysk 1

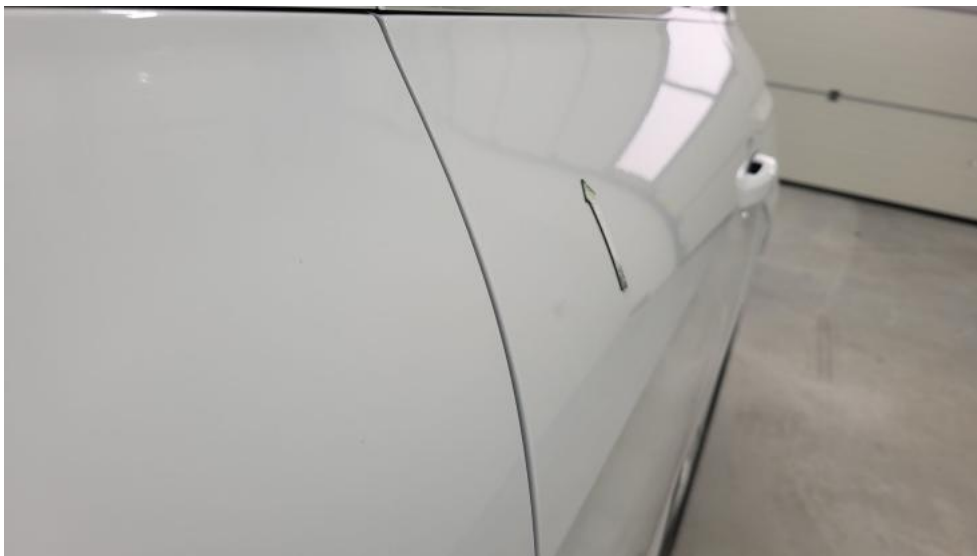
**Photo 45.**

Drzwi tylne L - Wgniecenie/odkształcenie 1

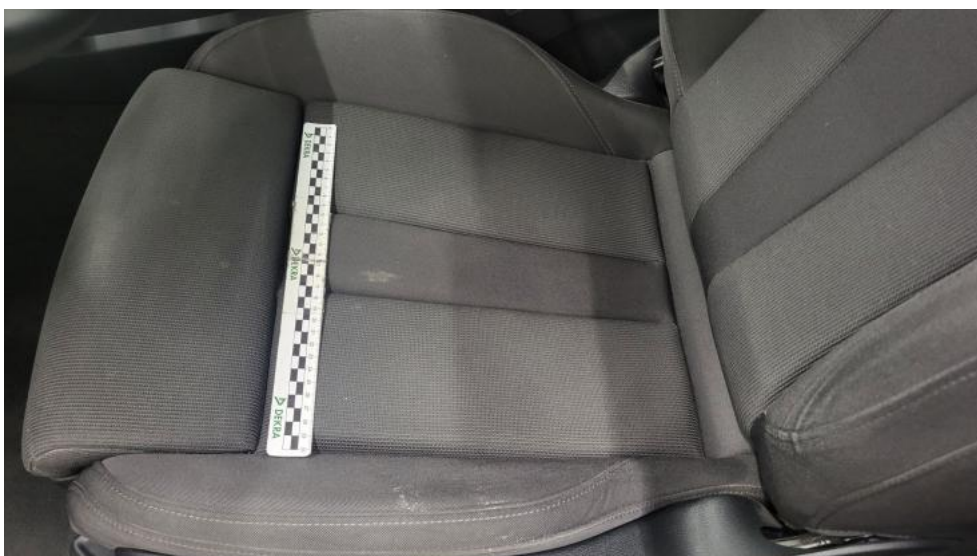
**Photo 46.**

Fotel prz. lew. - Inne 1
