DEKRA's commission No. : PKOL(W)/LODZ/79505/24/10/14  
commission/ damage No. : 20/042185  
Date of commission: 14-10-2024

**DEKRA Poland - Headquarters**  
02-673 Warszawa, ul. Konstruktorska 12A

PKO Leasing SA  
Świętokrzyska 36  
00-116 Warszawa

| Model | Cayenne III 17-23 |

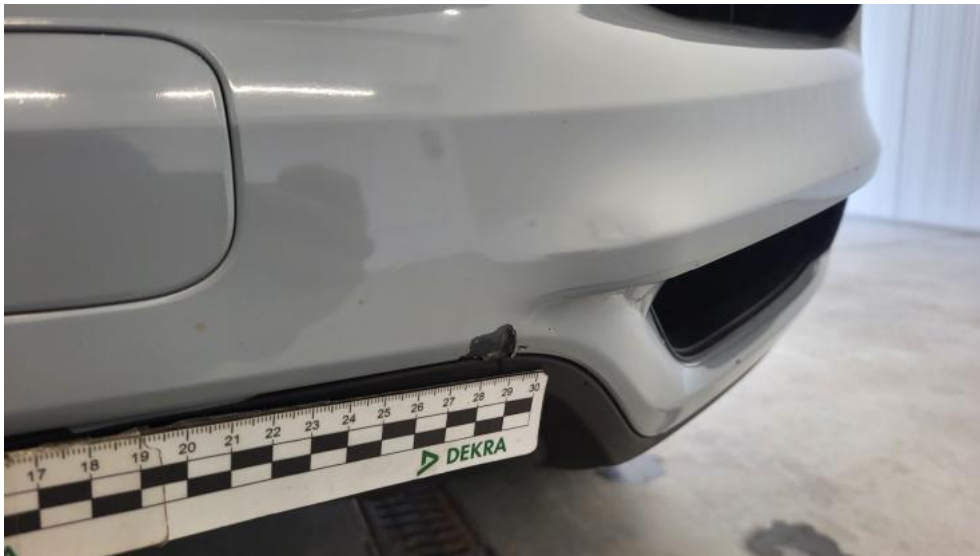
**Photo 45.**  
Zderzak() - Rysa/odprysk 3

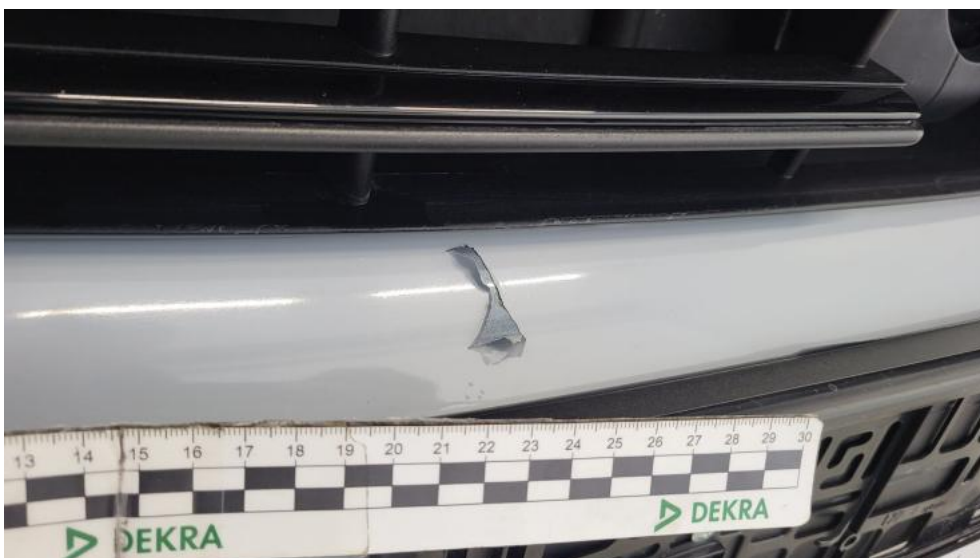
**Photo 46.**  
Zderzak - Inne 1

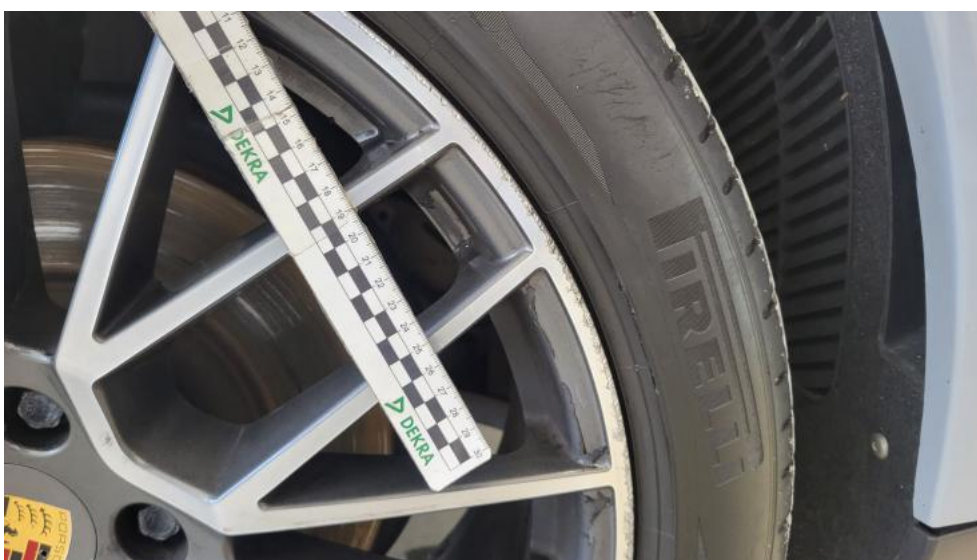
**Photo 50.**

Felga aluminiowa przednia P - Rysa/odprysk 1

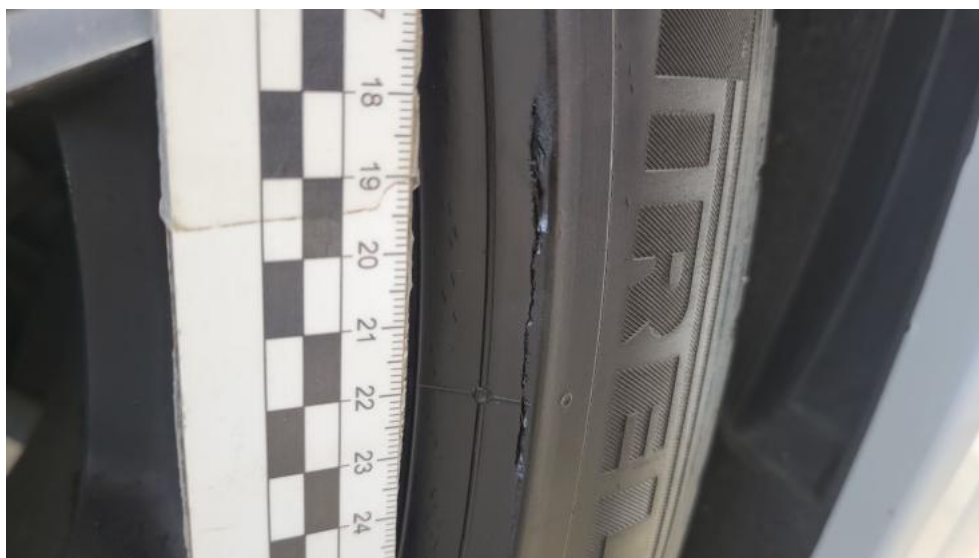
**Photo 52.**  
Opona przednia P - Pęknięcie/rozerwanie 1

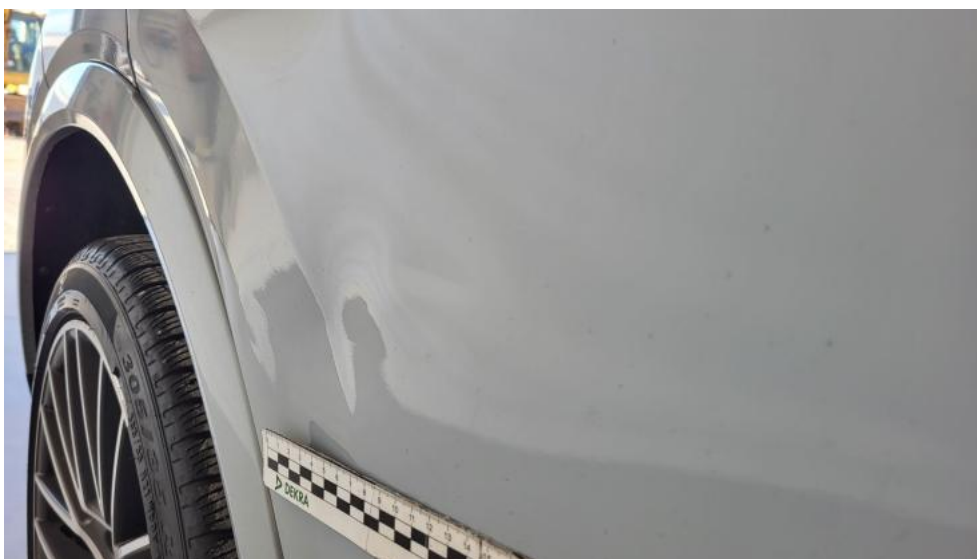
**Photo 57.**  
Drzwi tylne P - Wgniecenie/odkształcenie 2

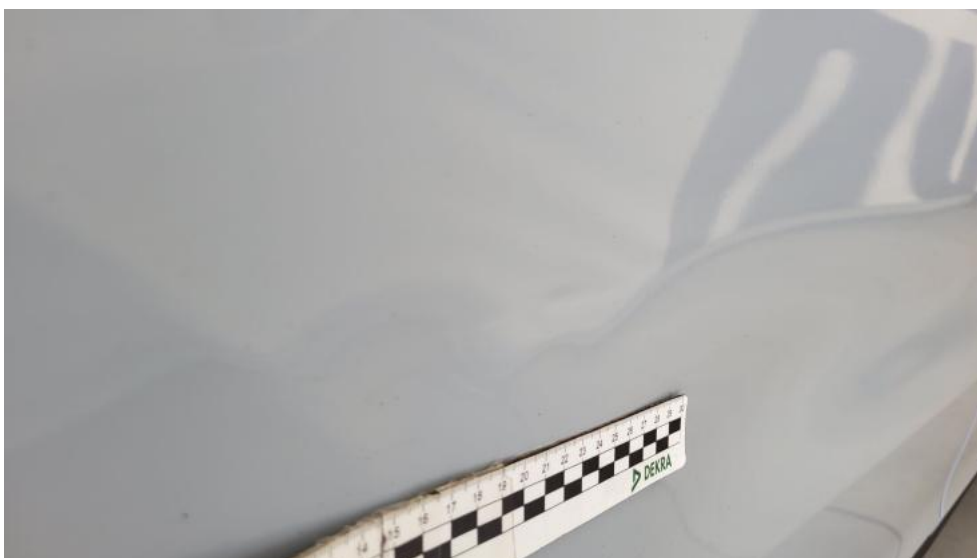
**Photo 58.**  
Drzwi tylne P() - Wgniecenie/odkształcenie 3

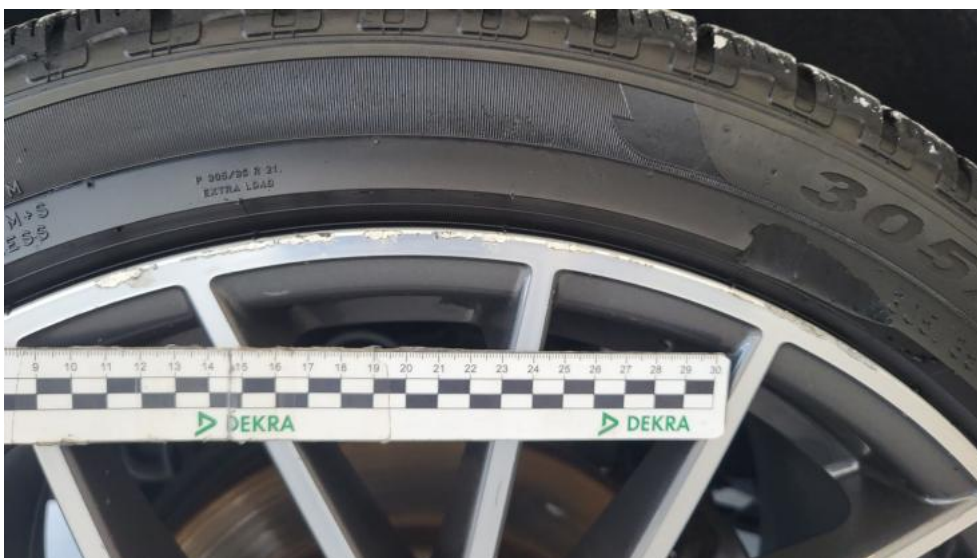
**Photo 60.**  
Felga aluminiowa tylna P - Rysa/odprysk 1

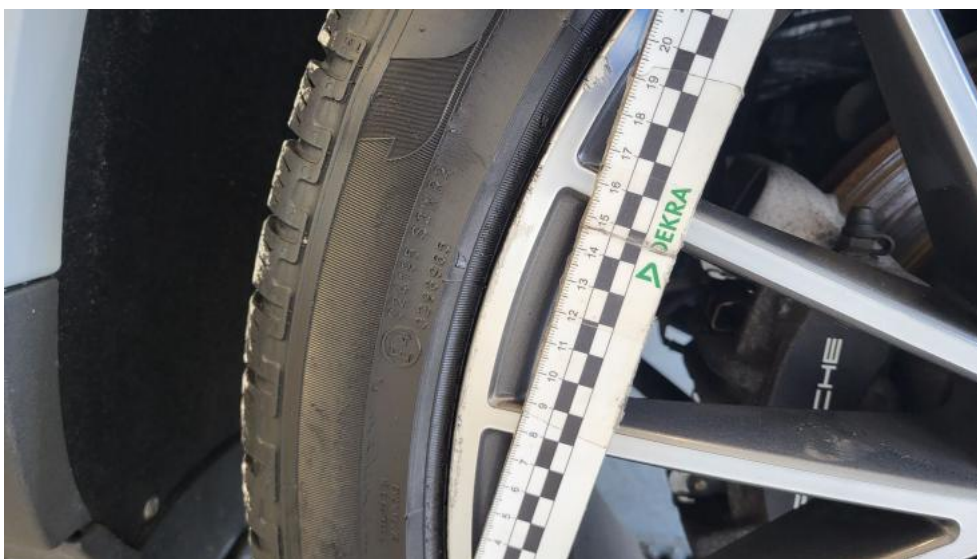
**Photo 65.**  
Felga aluminiowa tylna L - Rysa/odprysk 1

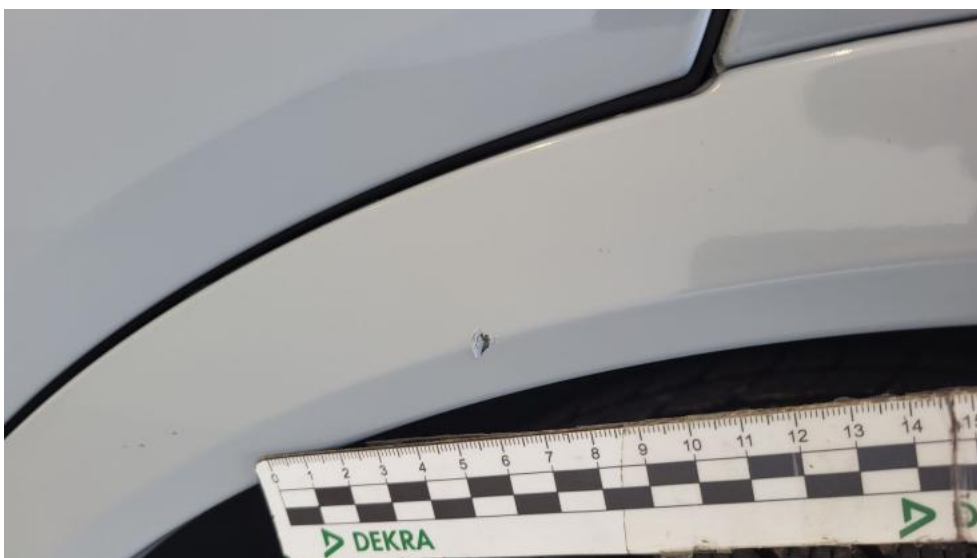
**Photo 66.**  
Listwa krawędzi błotnika tył L - Rysa/odprysk 1

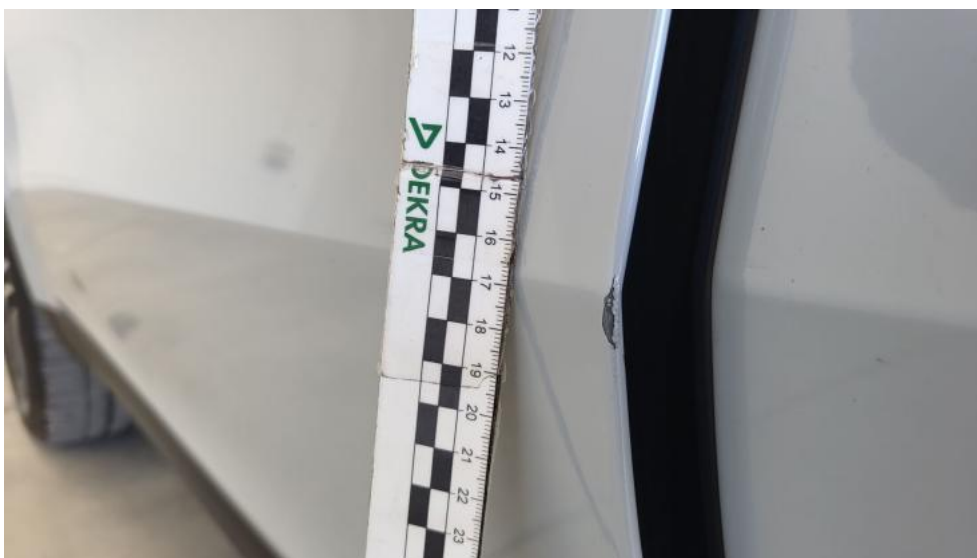
**Photo 70.**

Drzwi przed L - Rysa/odprysk 2

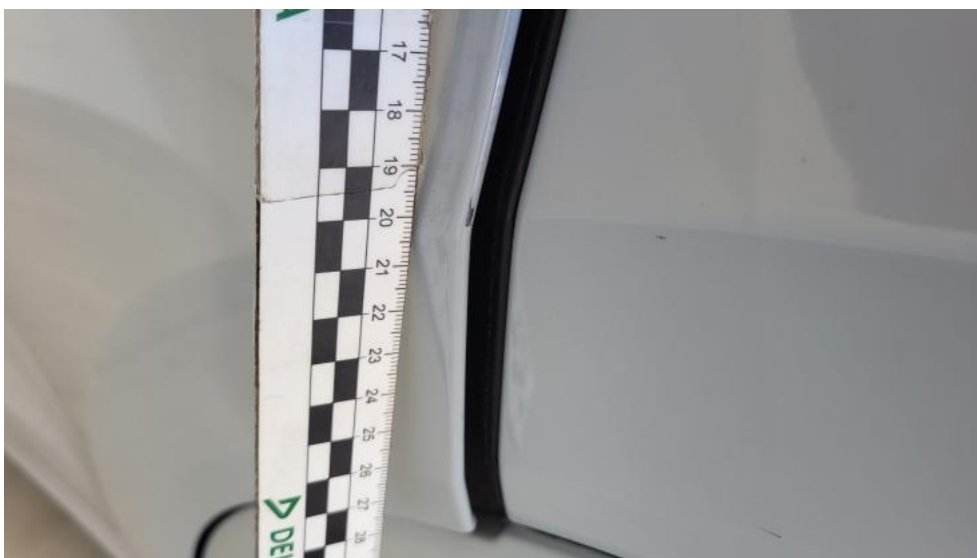
**Photo 72.**

Drzwi tylne L - Rysa/odprysk 1

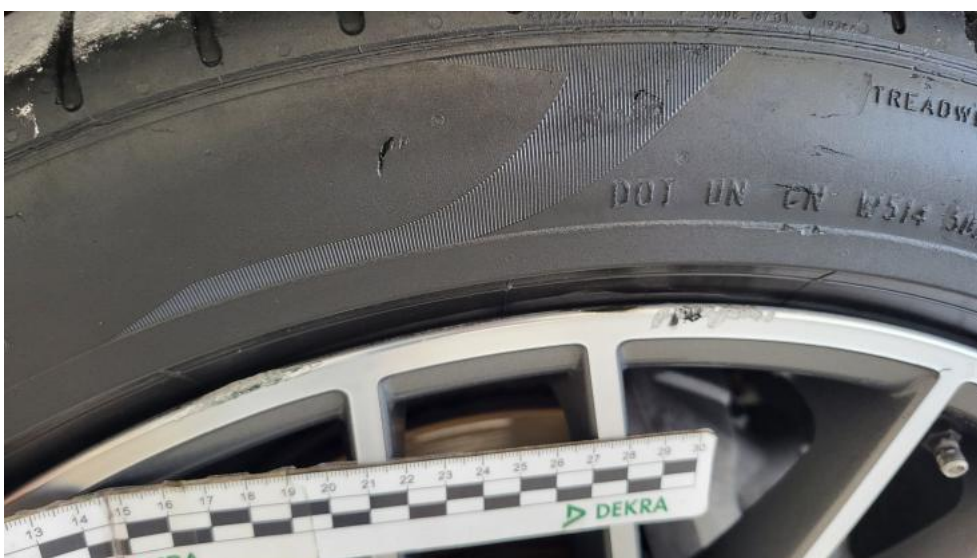
**Photo 74.**  
Felga Aluminiowa przednia L - Rysa/odprysk 1
