DEKRA's commission No. : PKOL(W)/LODZ/32114/25/05/05  
commission/ damage No. : 22/024624  
Date of commission: 05-05-2025

| Manufacturer | BMW |
| Type / version | 530d mHEV M Sport sport-aut |
| Registration /record No. | TK955CC |

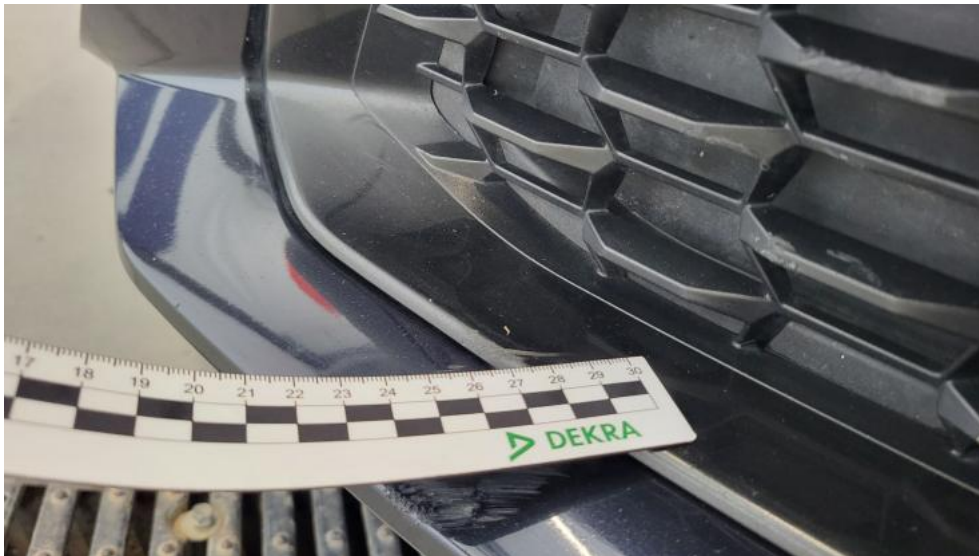
**Photo 41.**

Kratka/zaślepka halogenu L - Rysa/odprysk 1

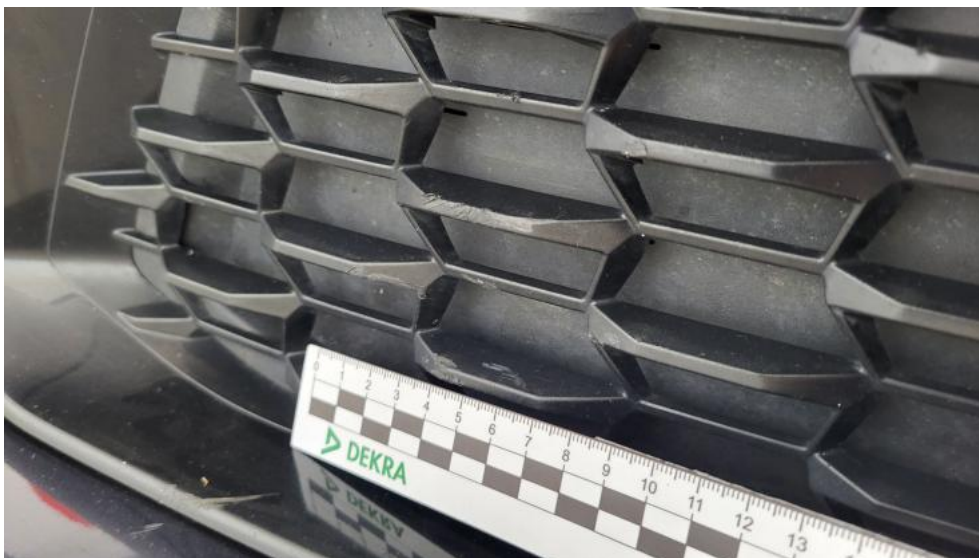
**Photo 42.**

Kratka/zaślepka halogenu L - Rysa/odprysk 2

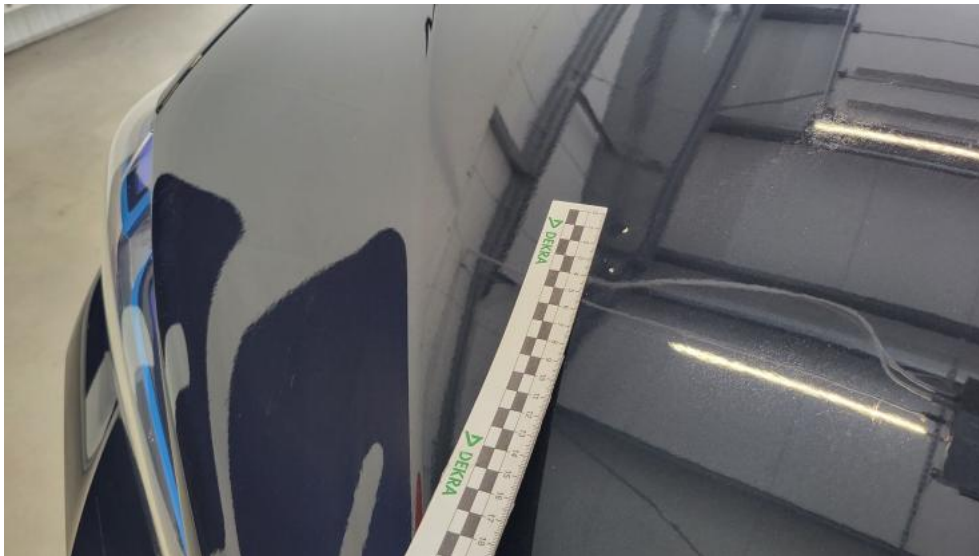
**Photo 43.**

Pokrywa komory silnika - Rysa/odprysk 1

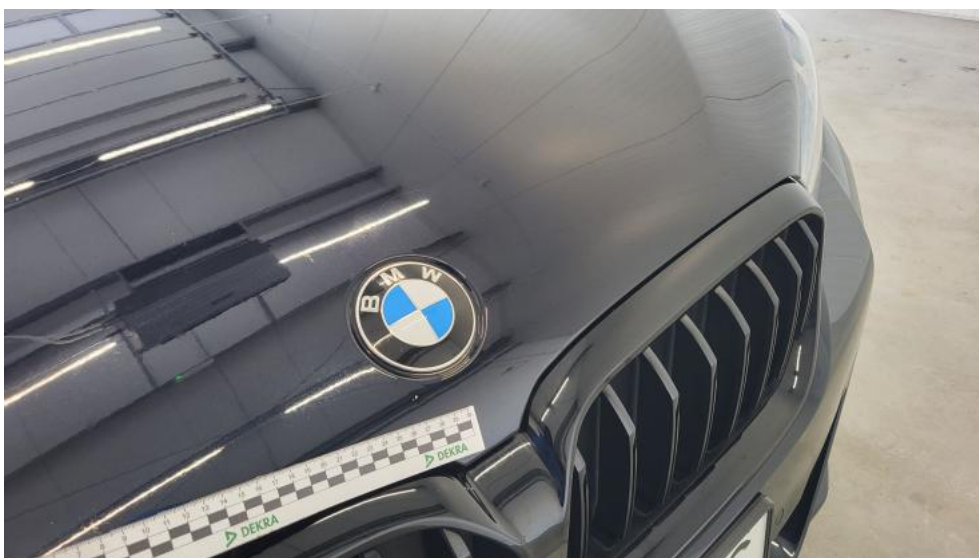
**Photo 44.**

Pokrywa komory silnika - Rysa/odprysk 2

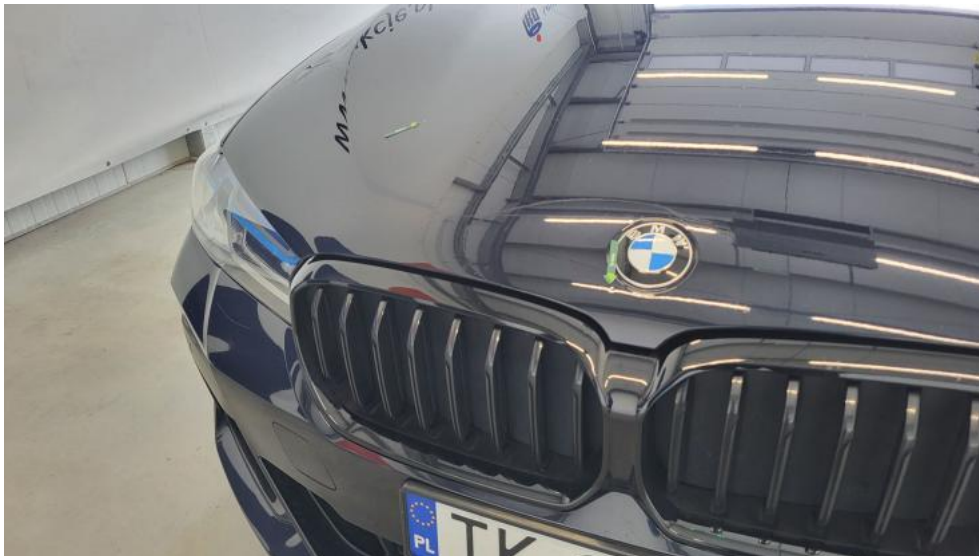
**Photo 45.**

Pokrywa komory silnika - Wgniecenie/odkształcenie 1

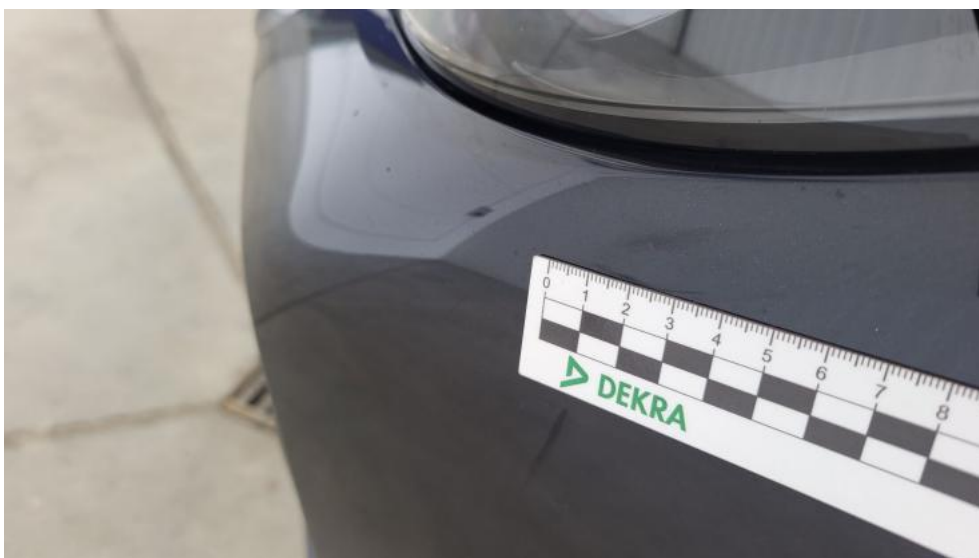
**Photo 46.**

Zderzak - Rysa/odprysk 1

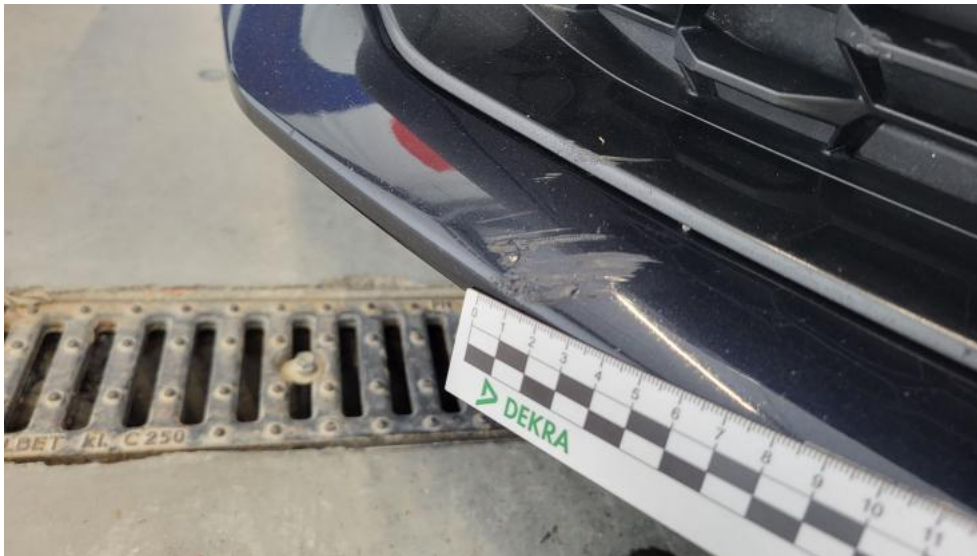
**Photo 47.**

Zderzak - Rysa/odprysk 2

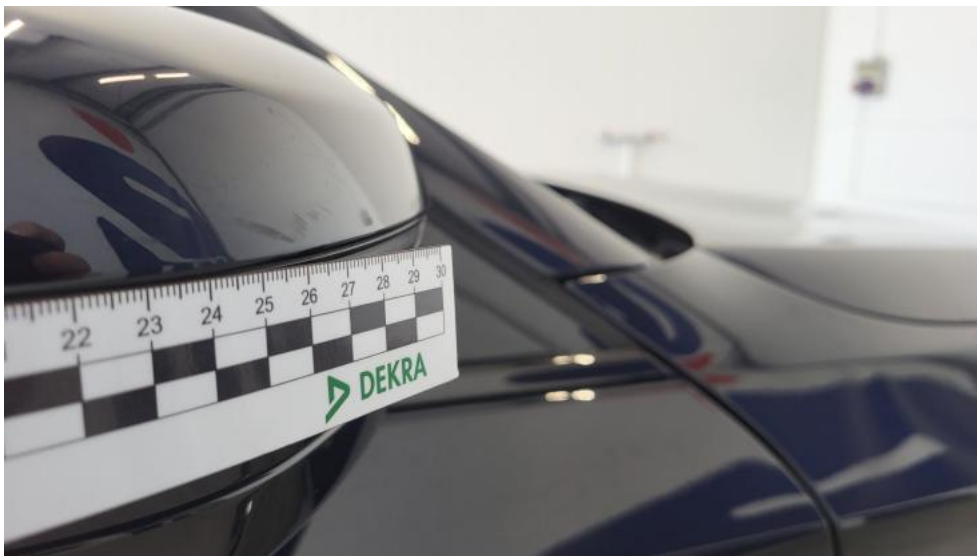
**Photo 51.**

Lusterko zew P - Rysa/odprysk 1

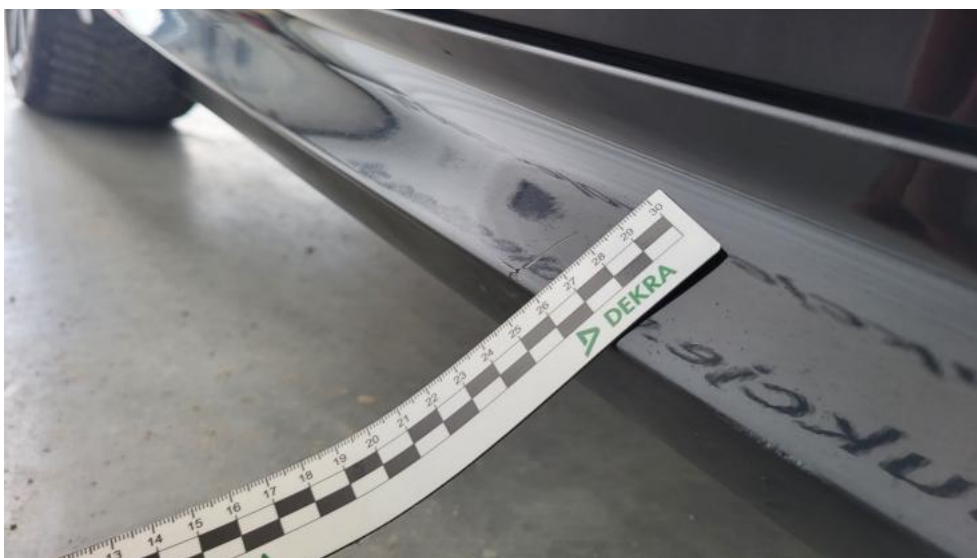
**Photo 52.**

Próg P - Rysa/odprysk 1

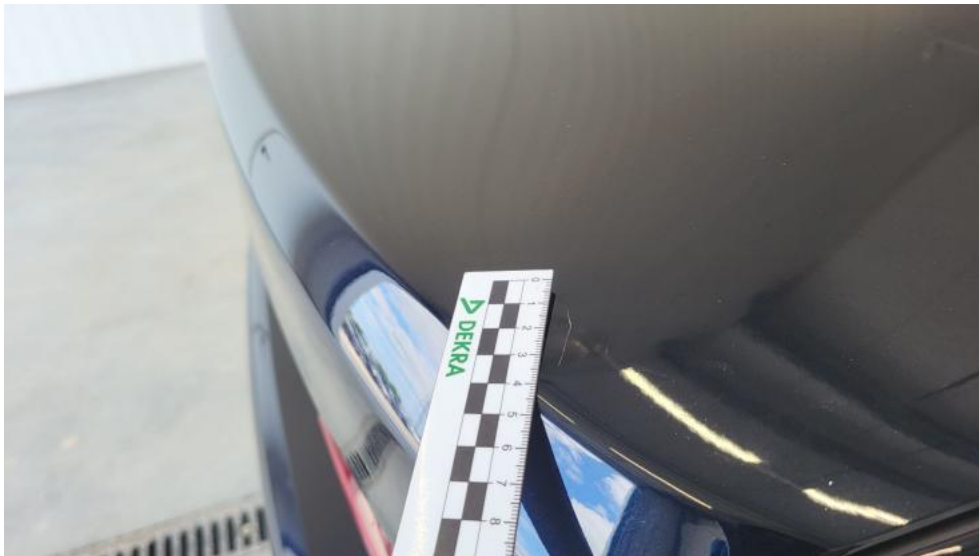
**Photo 55.**

Pokrywy bagażnika - Rysa/odprysk 1

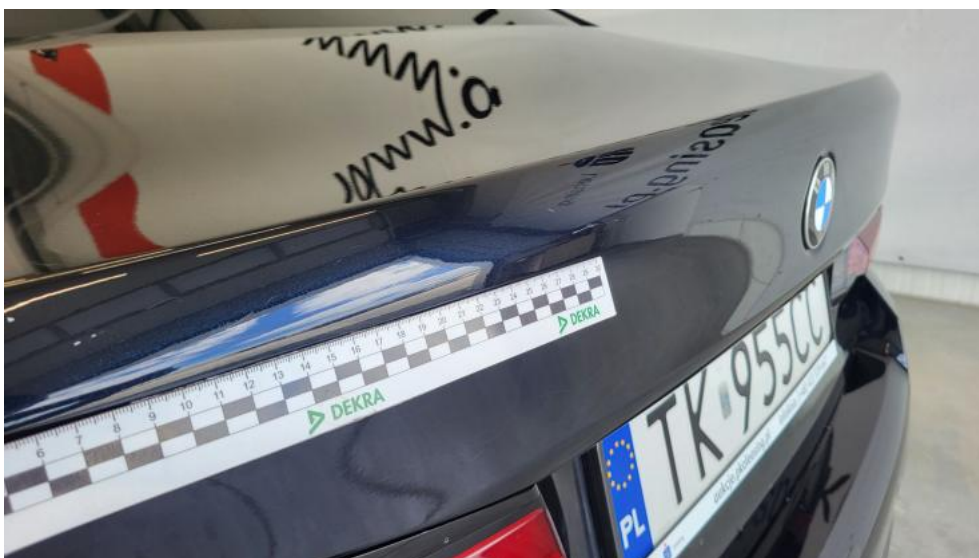
**Photo 56.**

Pokrywy bagażnika - Rysa/odprysk 2

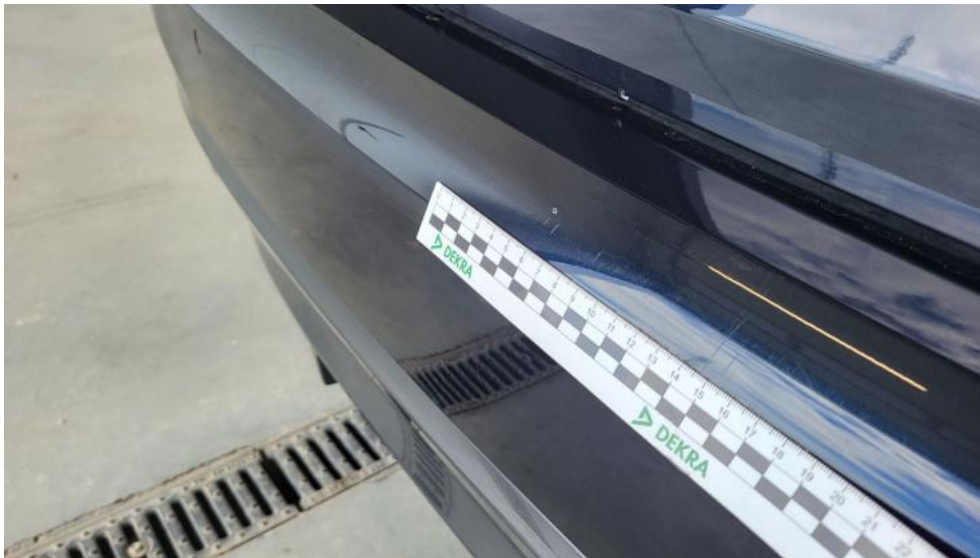
**Photo 59.**

Zderzak tylny - Rysa/odprysk 2

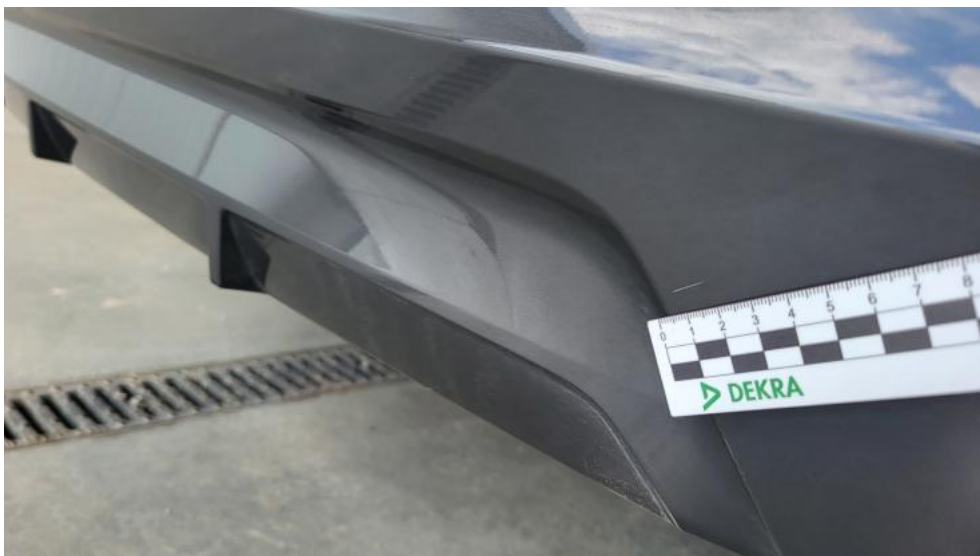
**Photo 60.**

Zderzak tylny cz dolna - Rysa/odprysk 1

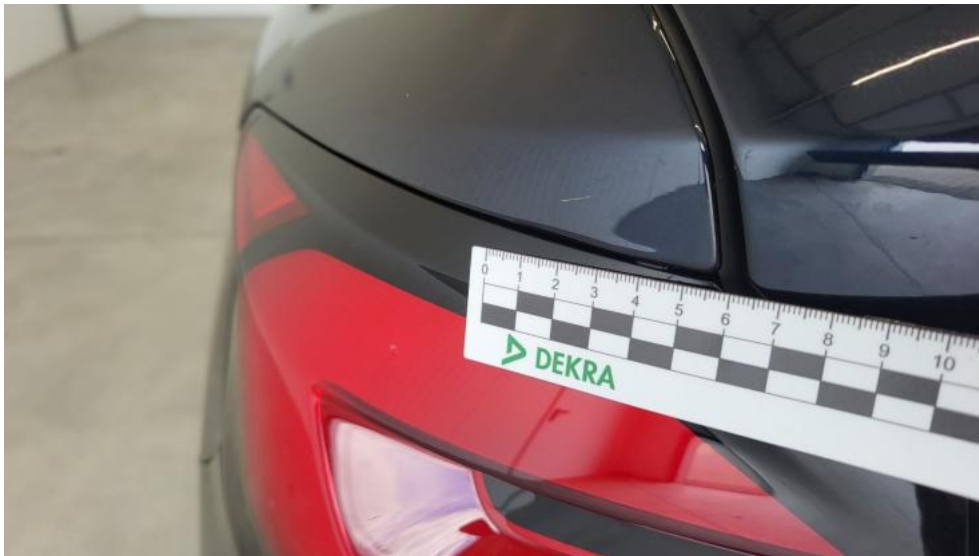
**Photo 61.**

Błotnik tylny L / Ściana boczna L - Rysa/odprysk 1

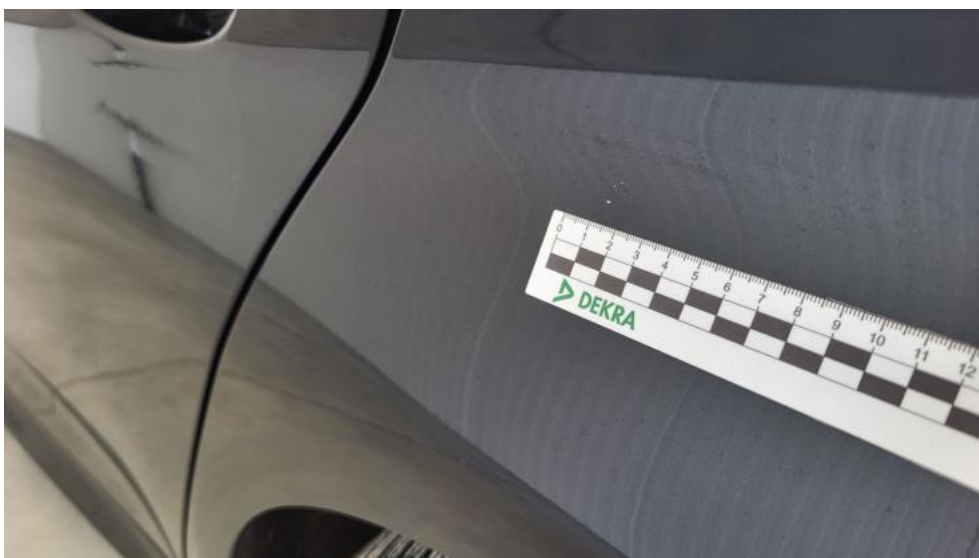
**Photo 62.**

Błotnik tylny L / Ściana boczna L - Rysa/odprysk 2

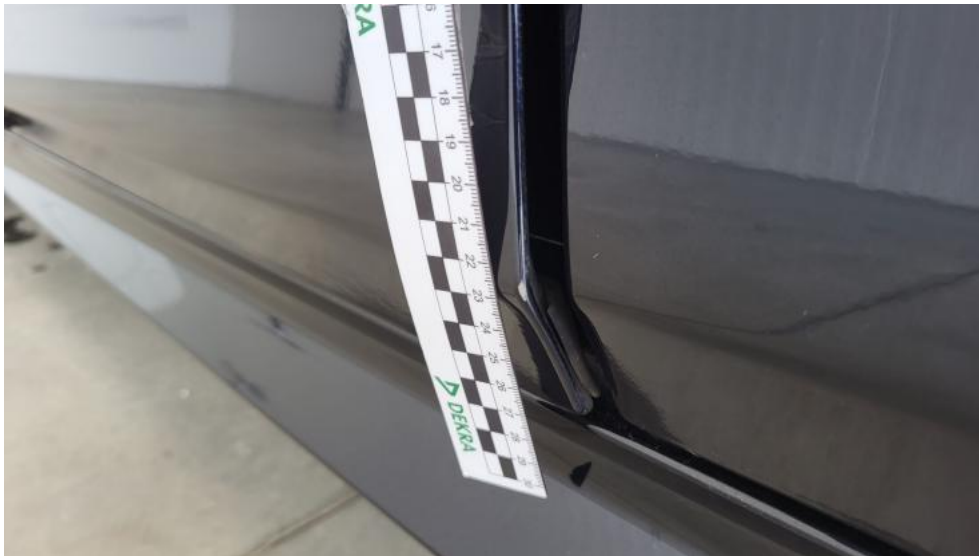
**Photo 63.**

Drzwi przed L - Rysa/odprysk 1

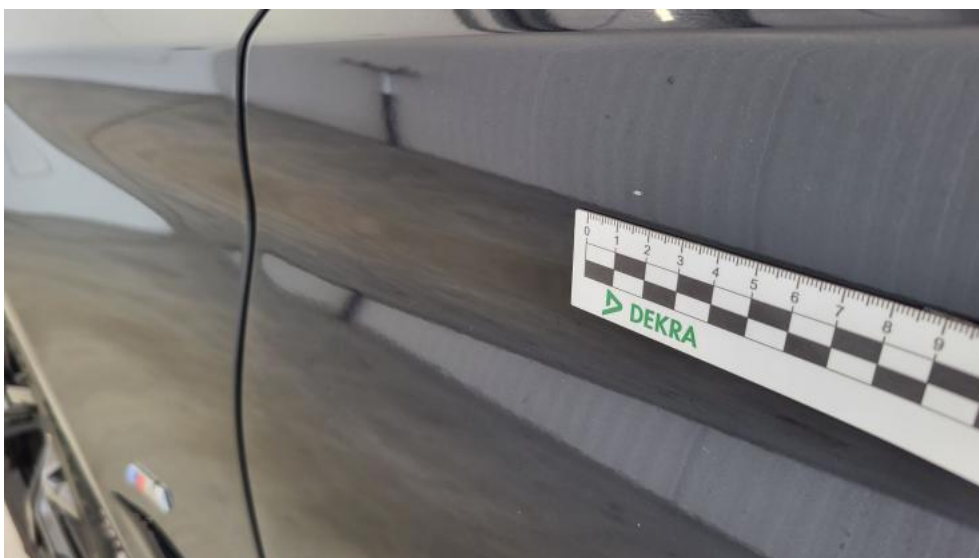
**Photo 64.**

Drzwi przed L - Rysa/odprysk 2

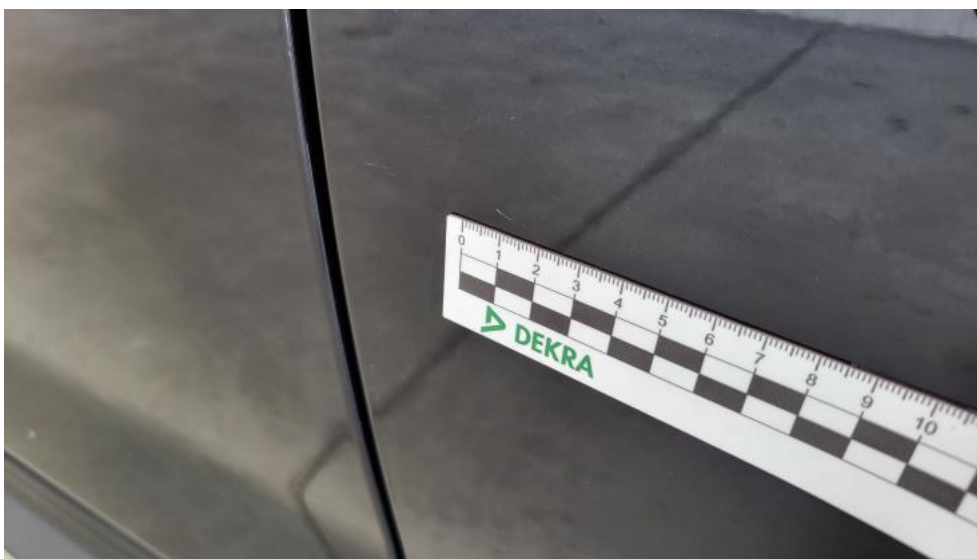
**Photo 65.**

Drzwi tylne L - Rysa/odprysk 1

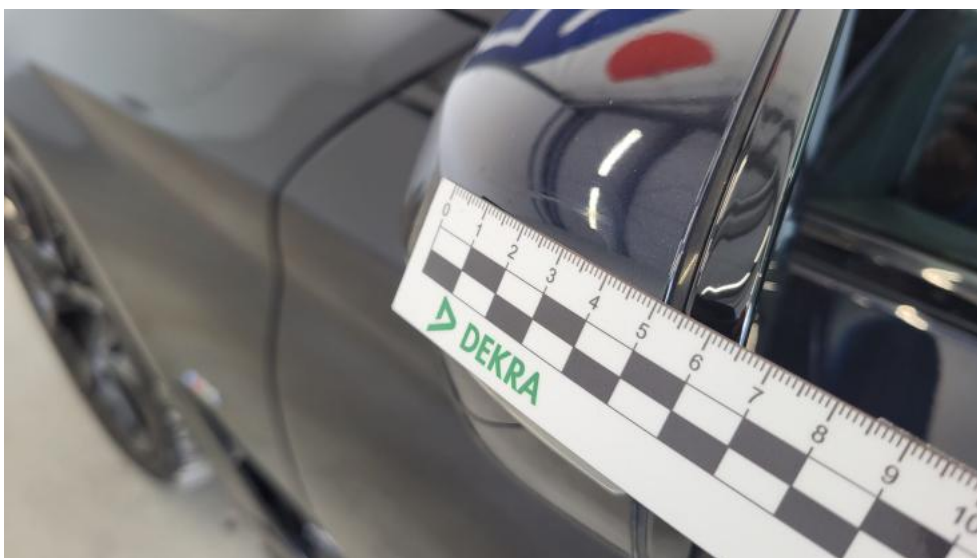
**Photo 66.**

Lusterko zew L - Rysa/odprysk 1

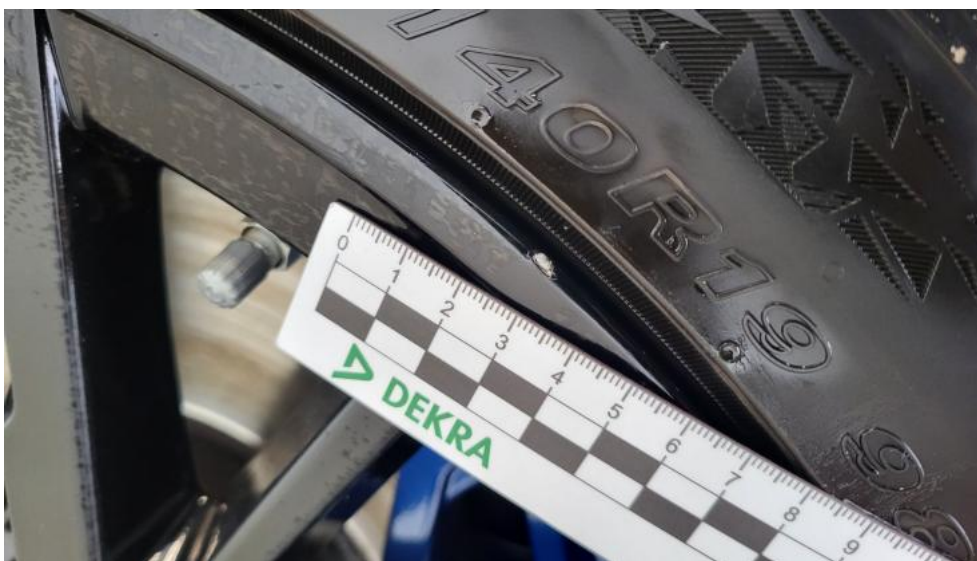
**Photo 67.**

Felga Aluminiowa przednia L - Rysa/odprysk 1

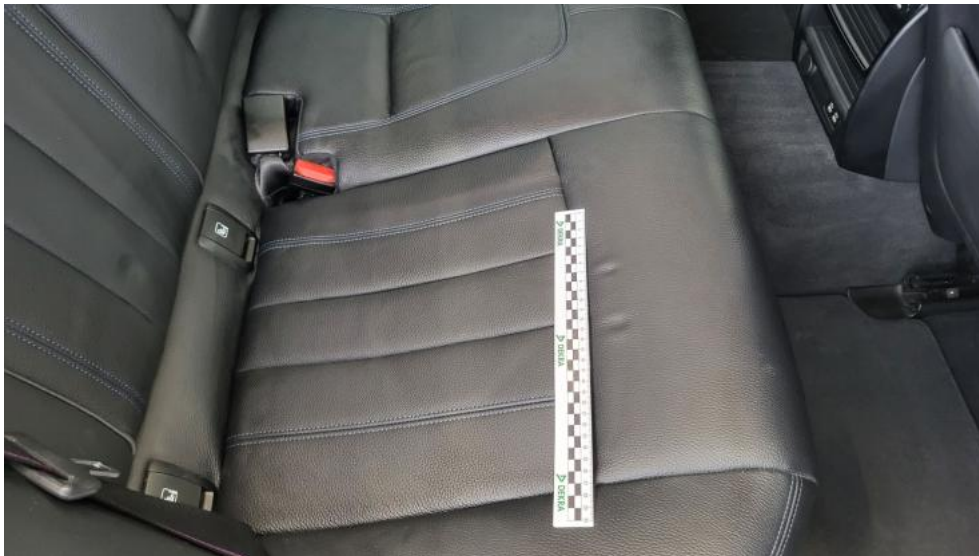
**Photo 69.**  
Kanapa tyl. - Inne 1

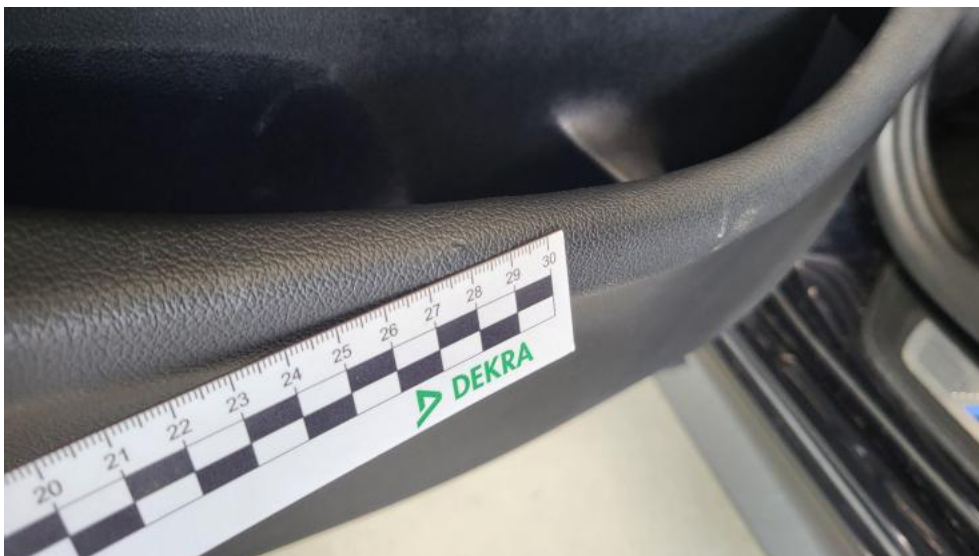
**Photo 70.**  
Tapicerka drzwi tylnych L - Rysa/odprysk 1
