DEKRA's commission No. : PKOL(W)/LODZ/37030/25/05/22  
commission/ damage No. : 23/014456  
Date of commission: 22-05-2025

**Vehicle data**

| Model | Range Rover 21- |
| Type / version | Range Rover 3.0 P510e PHEV SV |

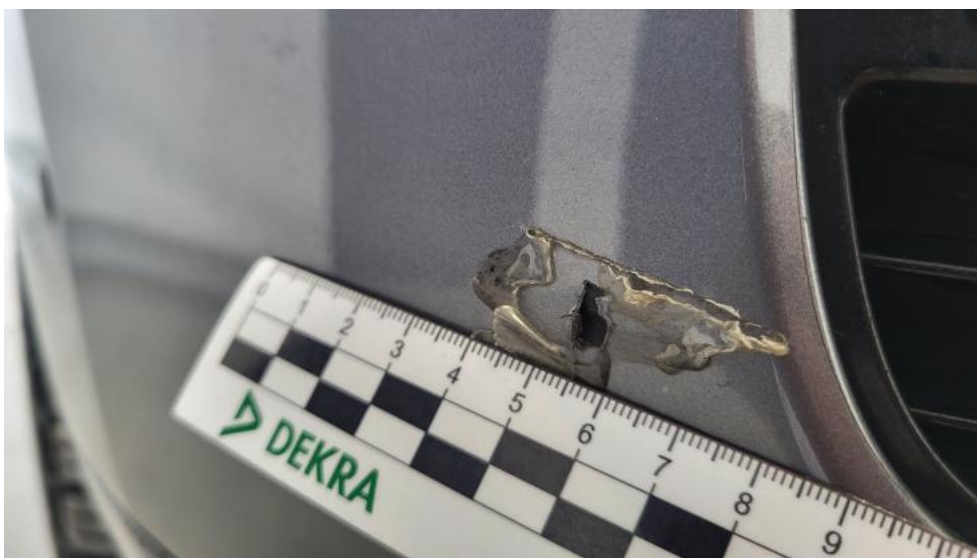
**Photo 60.**

Zderzak - Rysa/odprysk 1

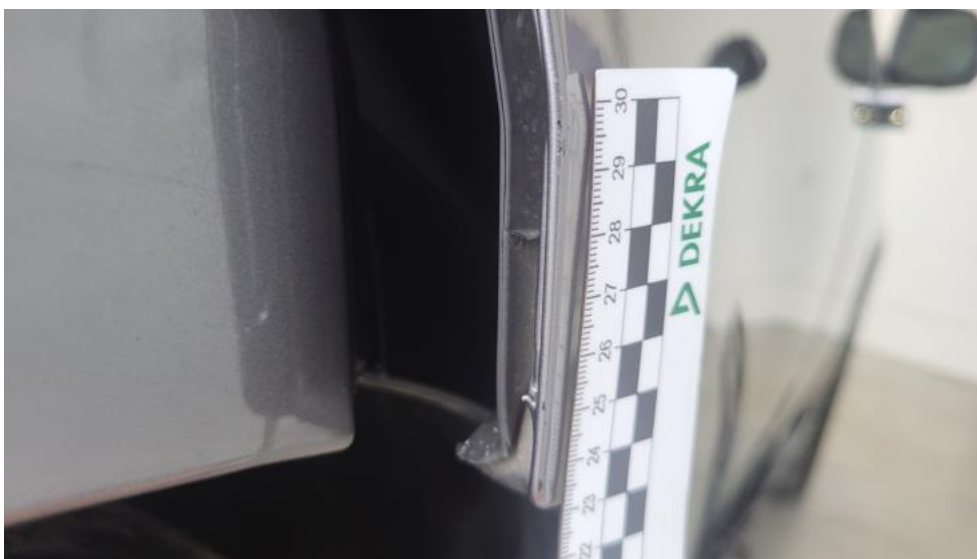
**Photo 63.**

Drzwi tylne P - Rysa/odprysk 1

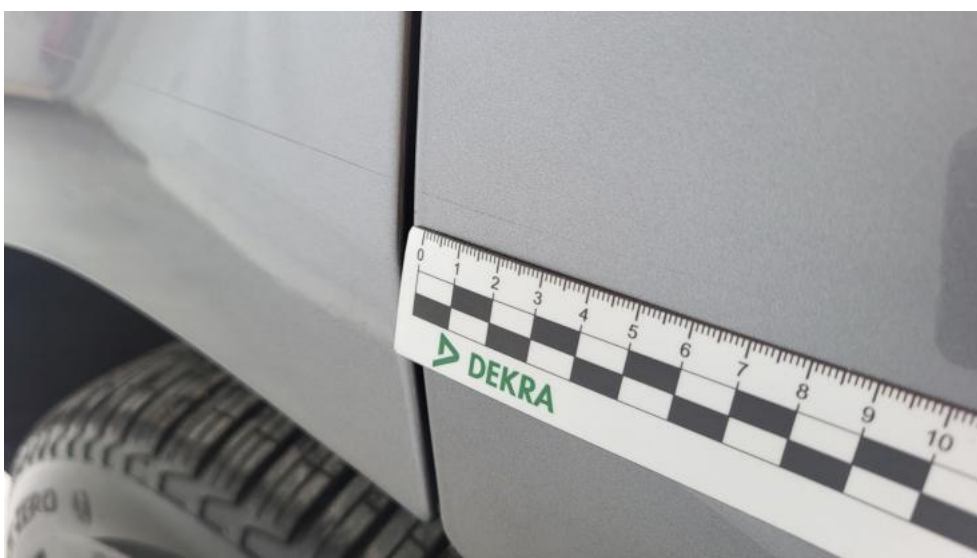
**Photo 64.**

Drzwi tylne P - Rysa/odprysk 2

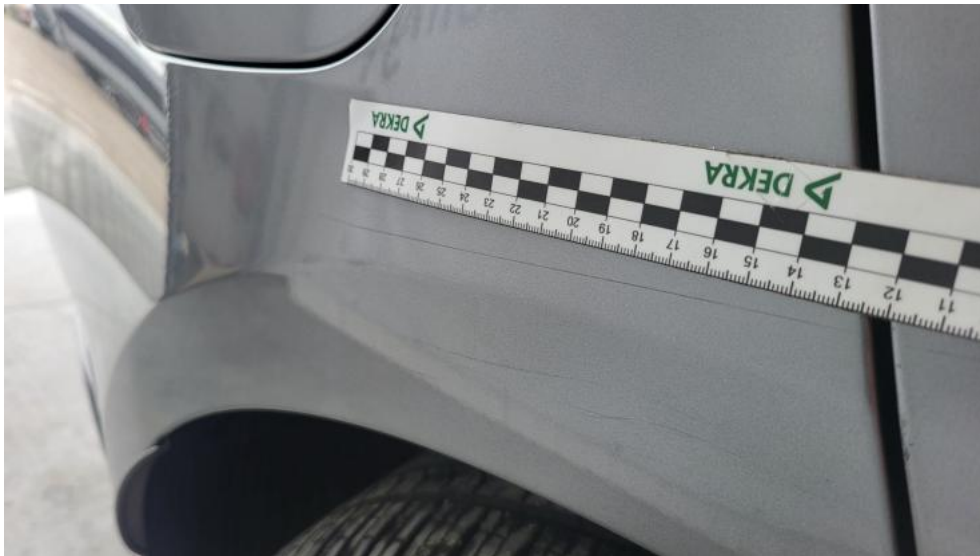
**Photo 67.**

Błotnik tylny P / Ściana boczna P - Rysa/odprysk 2

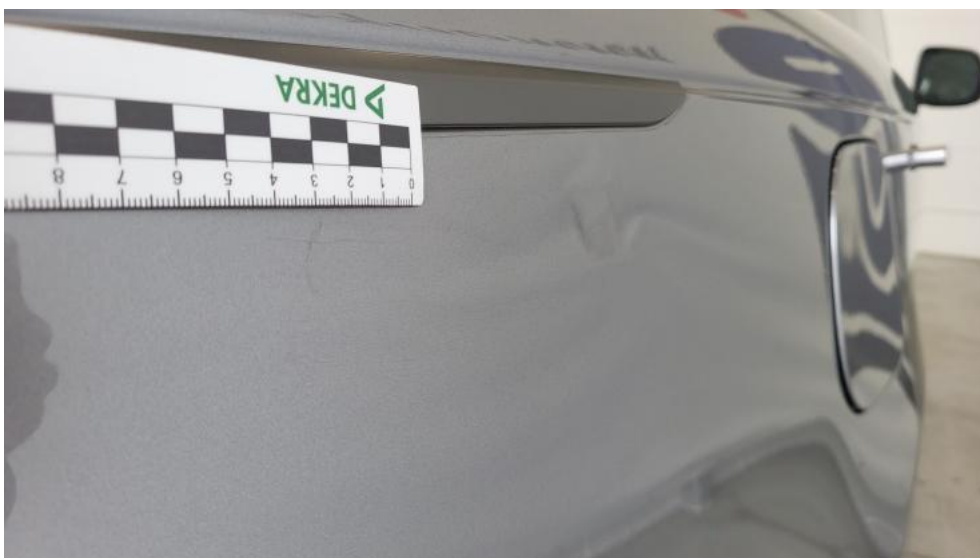
**Photo 68.**

Błotnik tylny P / Ściana boczna P() - Rysa/odprysk 3

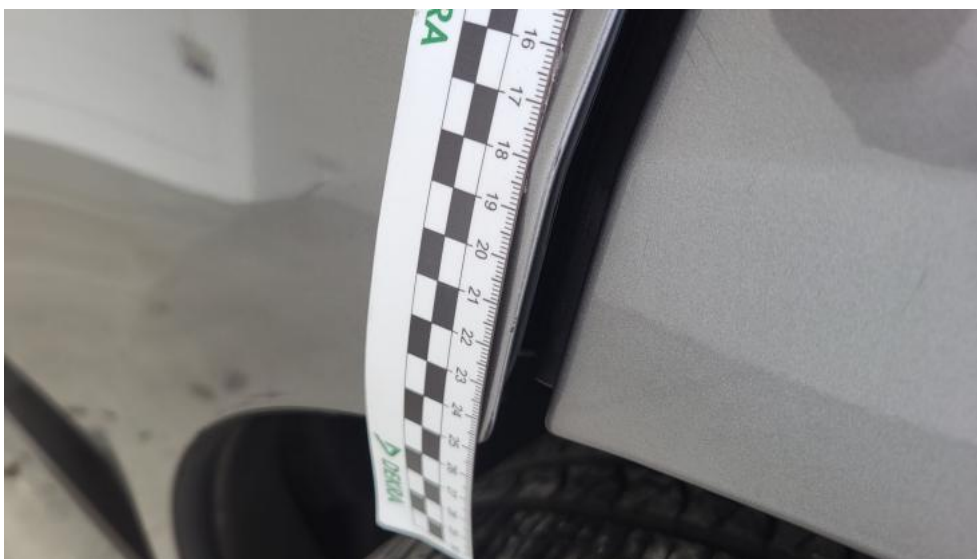
**Photo 73.**

Drzwi tylne L - Rysa/odprysk 1

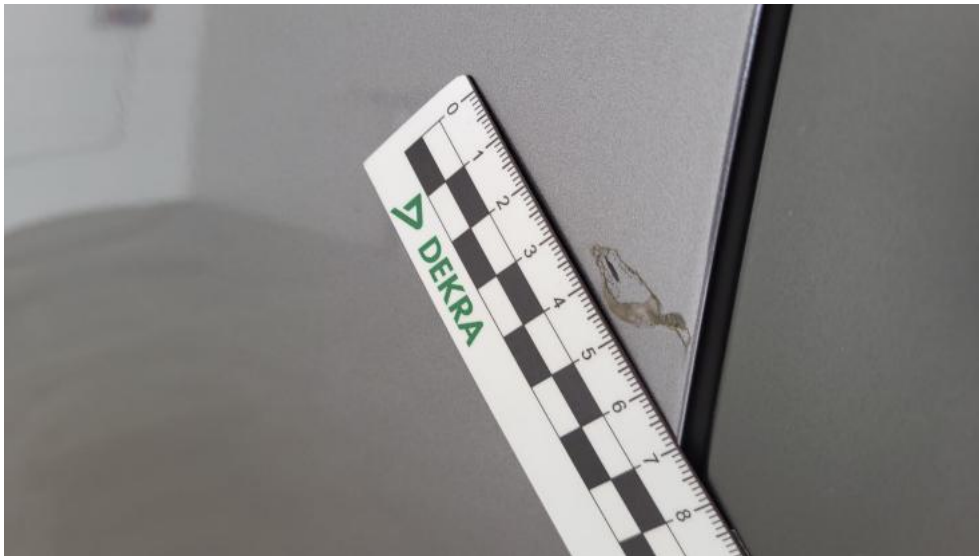
**Photo 75.**

Błotnik przedni L - Rysa/odprysk 1

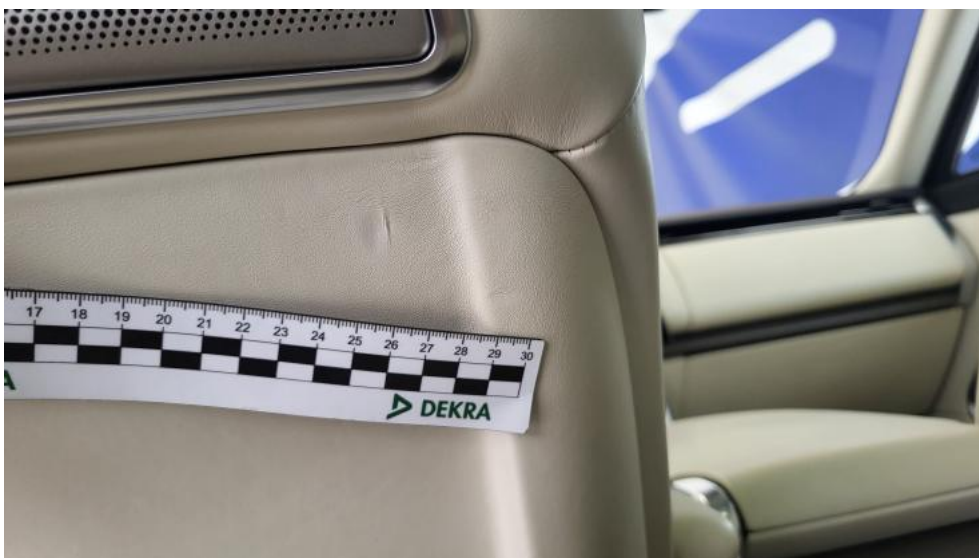
**Photo 76.**

Fotel prz. lew. - Wgniecenie/odkształcenie 1

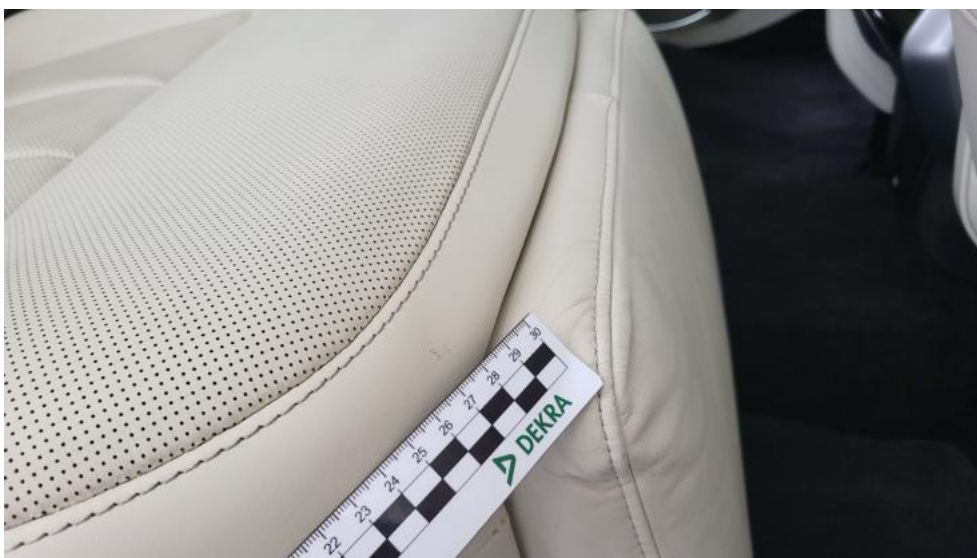
**Photo 78.**

Kanapa tyl. - Rysa/odprysk 1

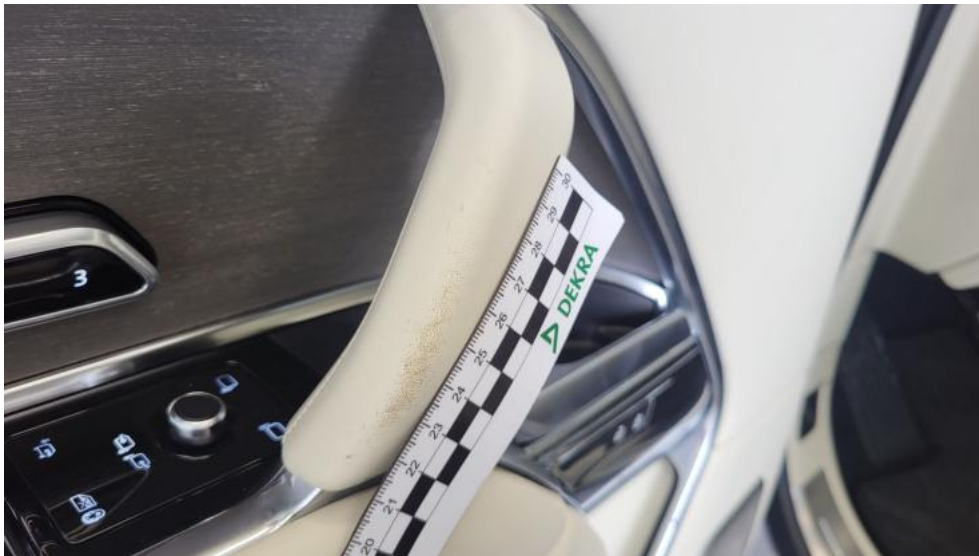
**Photo 79.**

Tapicerka drzwi przednich L - Inne 1

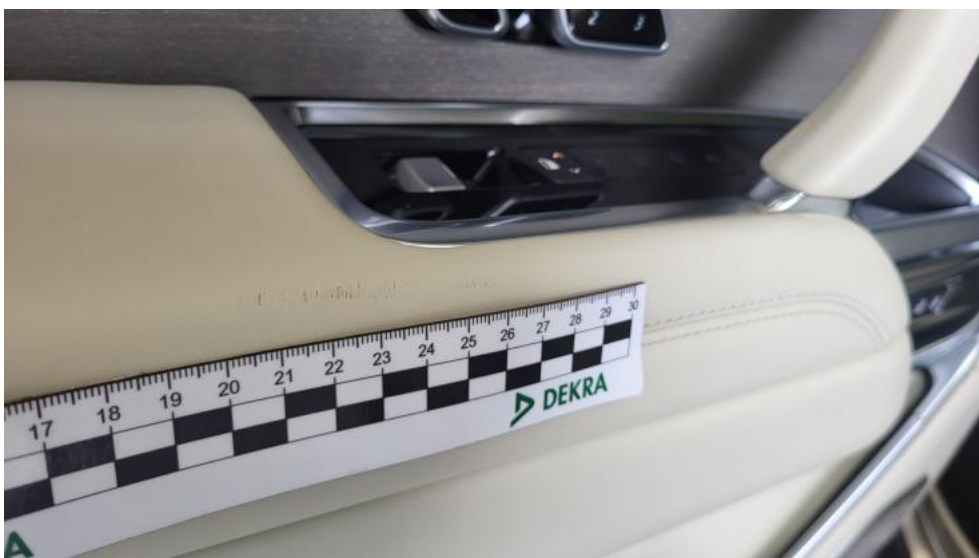
**Photo 80.**

Tapicerka drzwi tylnych L - Rysa/odprysk 1

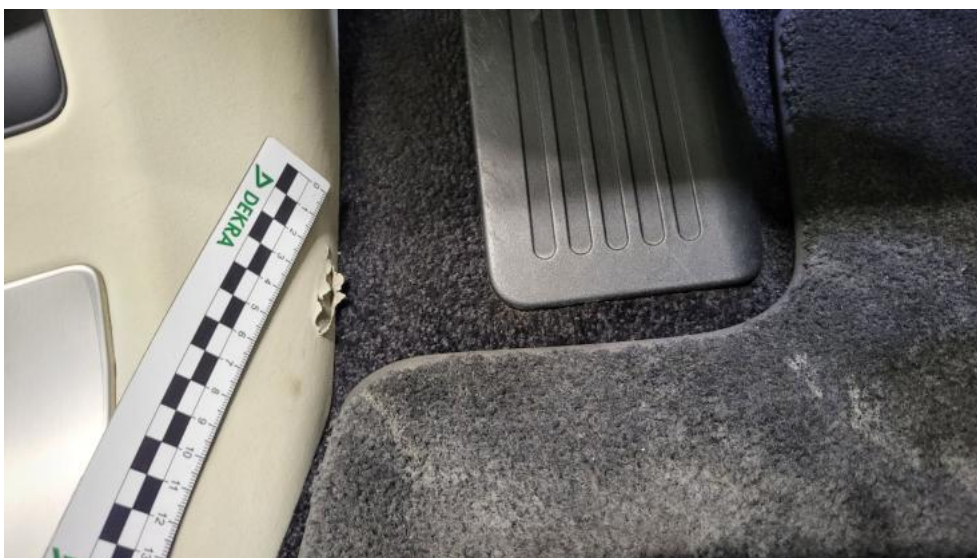
**Photo 82.**

Listwy progowe lew. - Pęknięcie/rozerwanie 1

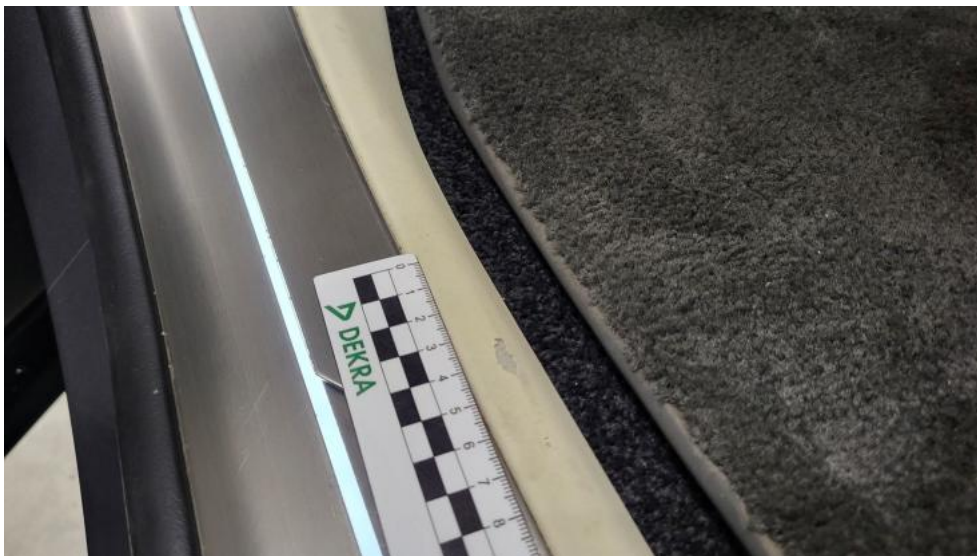
**Photo 83.**

Listwy progowe lew. - Pęknięcie/rozerwanie 2
