DEKRA's commission No. : PKOL(W)/LODZ/72520/24/09/19
commission/ damage No. : 00477/LF/23
Date of commission: 19-09-2024

Vehicle data

Group of objects (Eurotax)	cars
EC code (Eurotax)	0145926
Manufacturer	TOYOTA
Model	Corolla Sedan 18-22
Type / version	Corolla 1.5 Comfort
Body type	sedan
Number of doors / seats	4/5
Curb weight [kg]	1295
Gross vehicle weight [kg]	1795
Wheelbase 1/2	2700
Engine type	spark ignition
Pollution reduction system	GPF
Engine capacity [ccm]	1490
Engine Power [hp/kW]	125/92
Gearbox	manual 6- gear
Registration /record No.	WU6719P
VIN / serial number	NMTBA3BE00R048657
Date of first registration	03-04-2023
Date of next. tech. test	02-04-2026
Year of manufacture	2022 (year has been verified with the manufacturer's base)
Readout [km]	33 810 (read)
Body color / type of coating	beżowy/double-layered, metallized

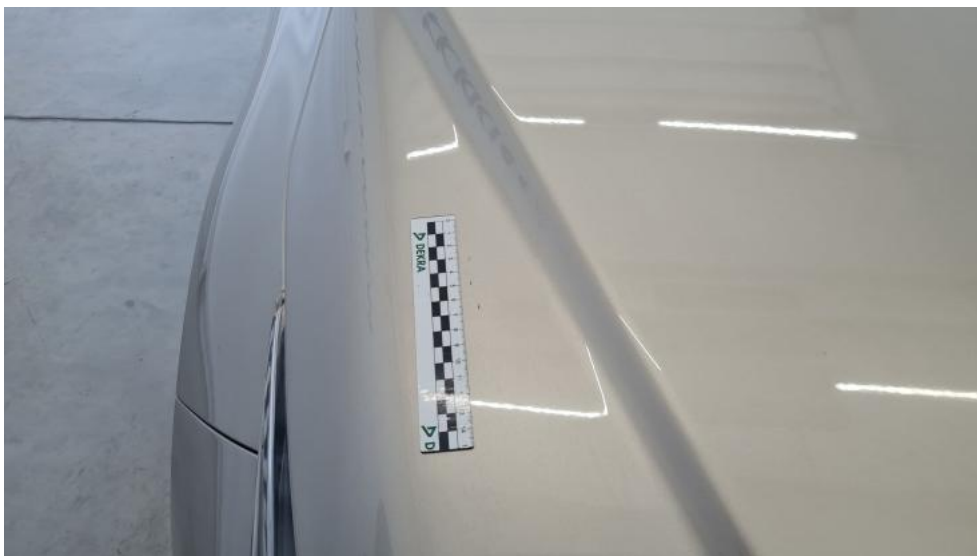
Photo 35.
Pokrywa komory silnika - Rysa/odprysk 1

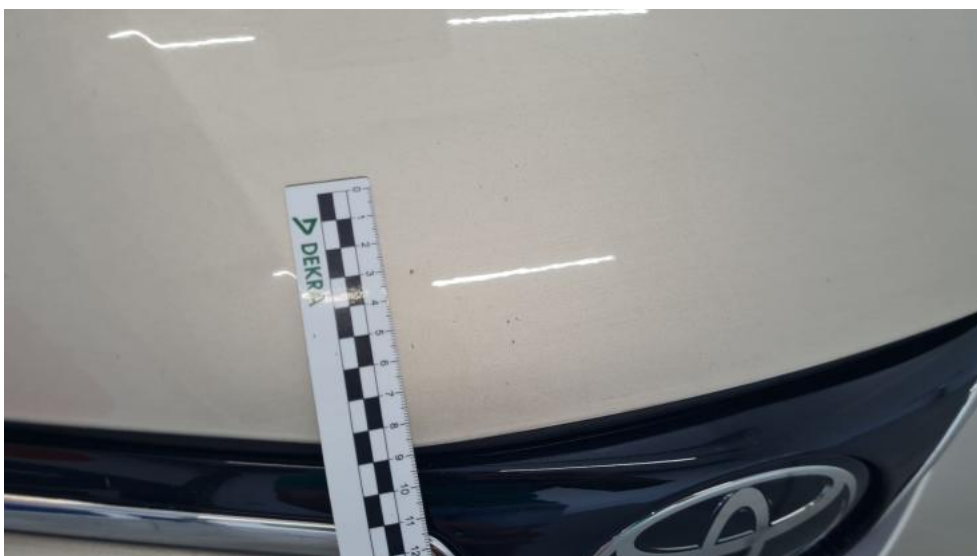
Photo 36.
Pokrywa komory silnika - Rysa/odprysk 2

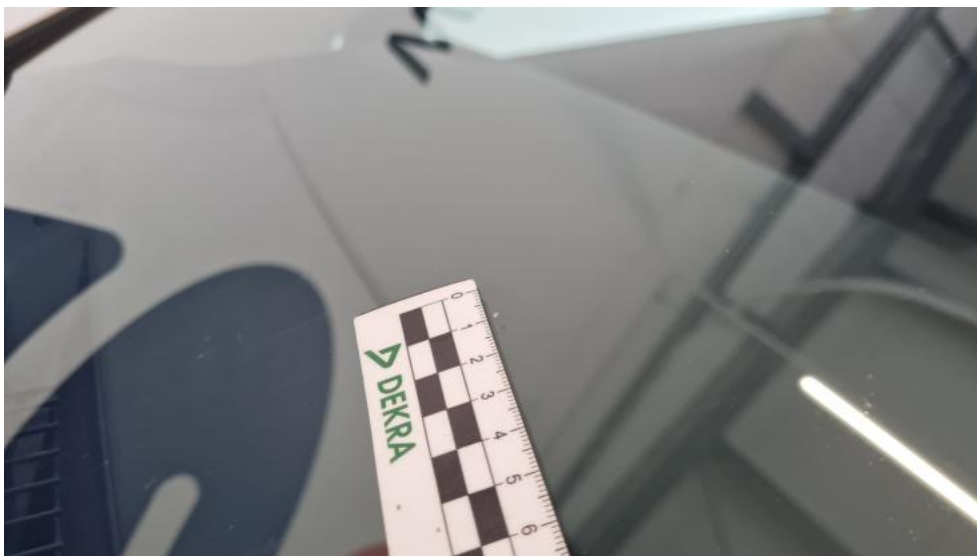
Photo 37.
Szyba czołowa - Rysa/odprysk 1

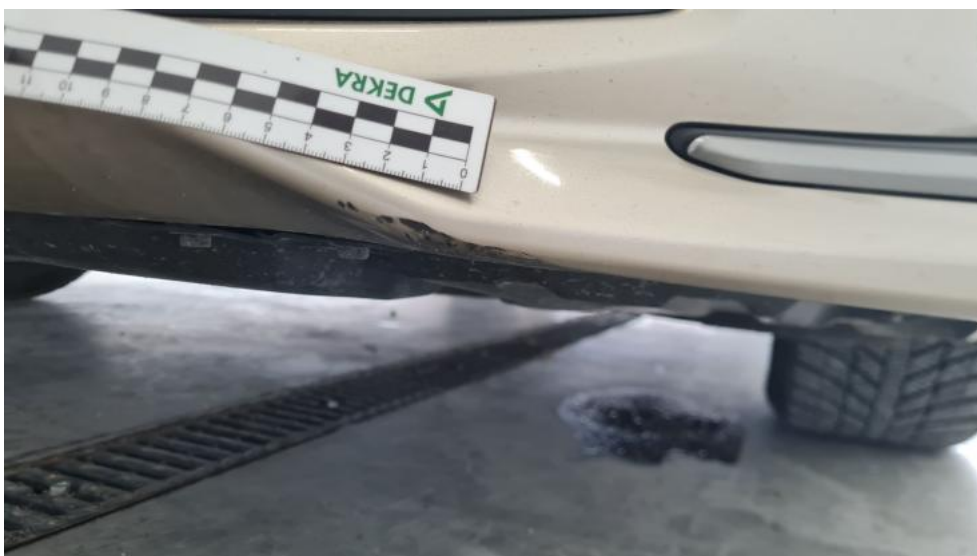
Photo 38.
Zderzak - Rysa/odprysk 1

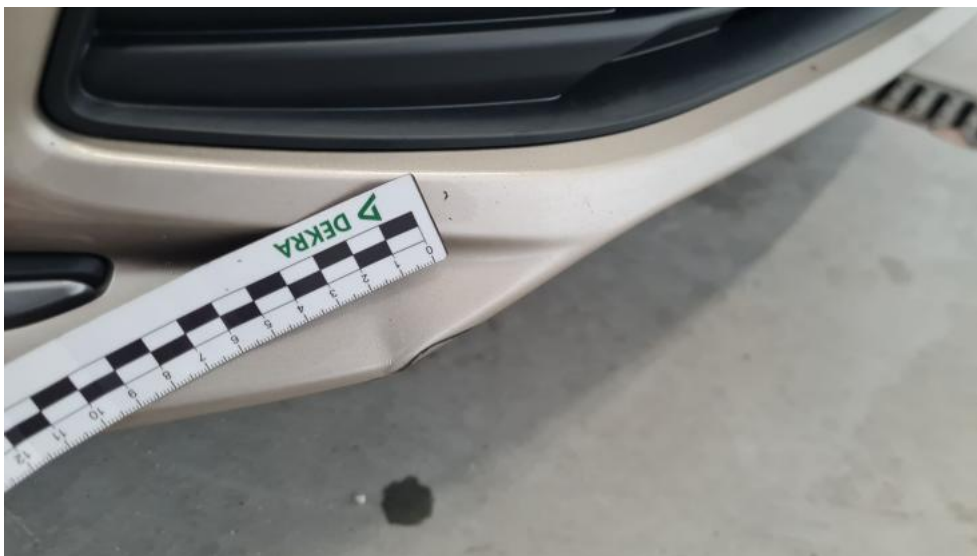
Photo 39.
Zderzak - Wgniecenie/odkształcenie 1

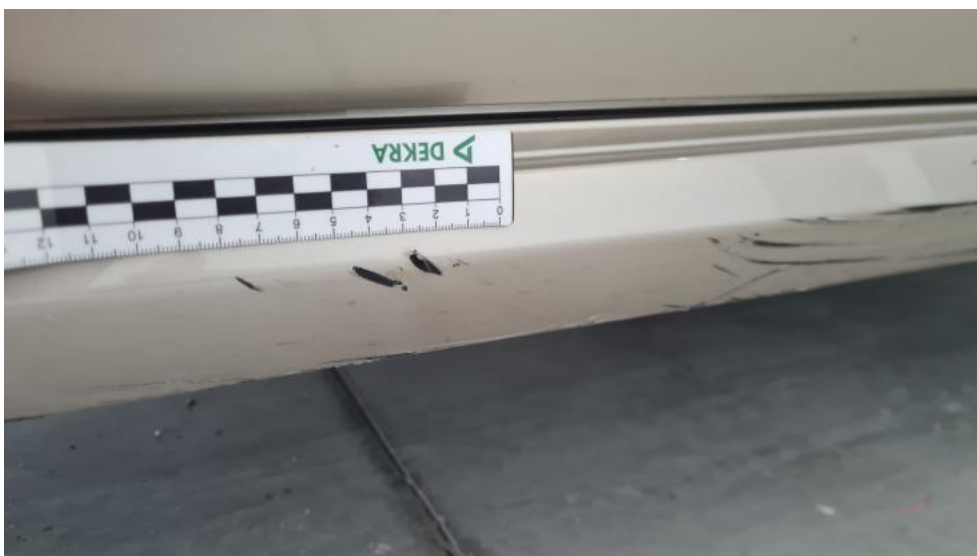
Photo 40.
Próg P - Rysa/odprysk 1

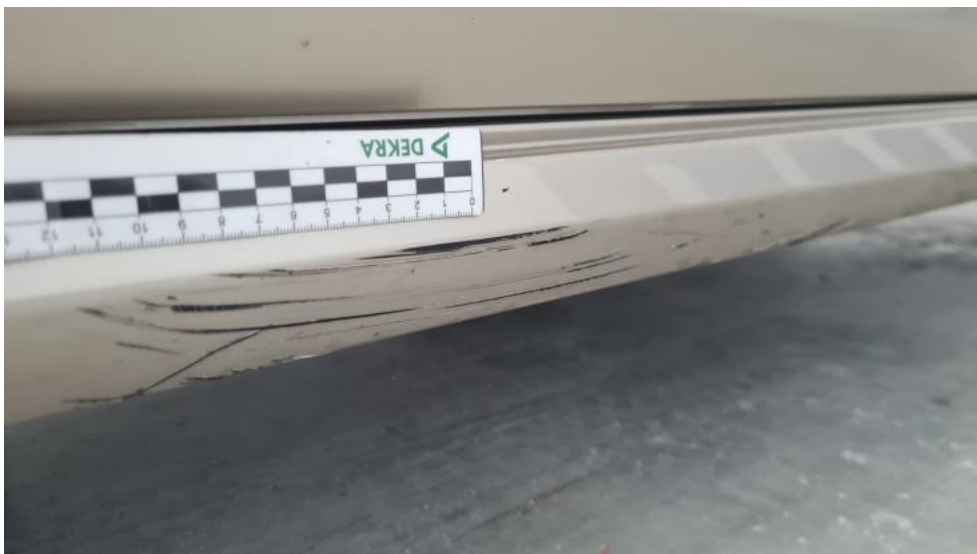
Photo 41.
Próg P - Rysa/odprysk 2

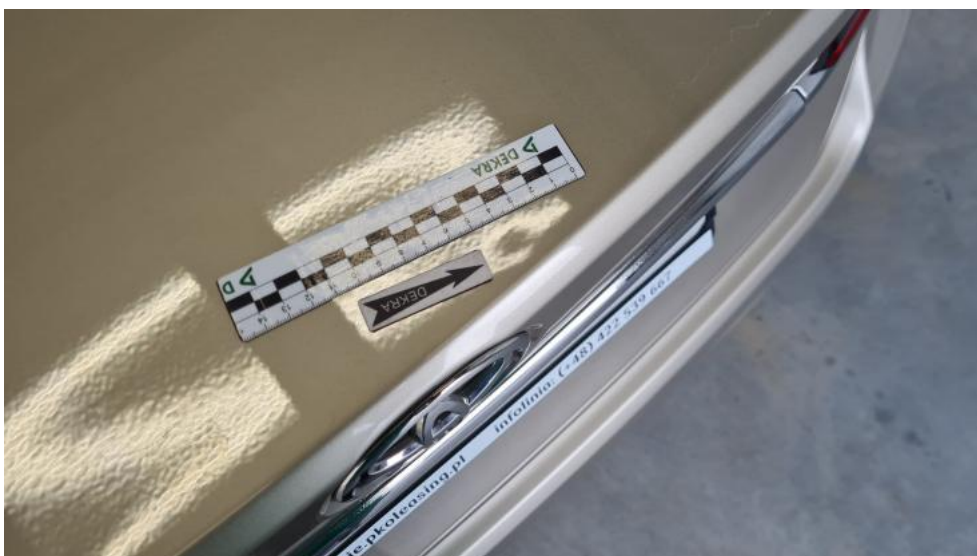
Photo 42.
Pokrywy bagażnika - Wgniecenie/odkształcenie 1

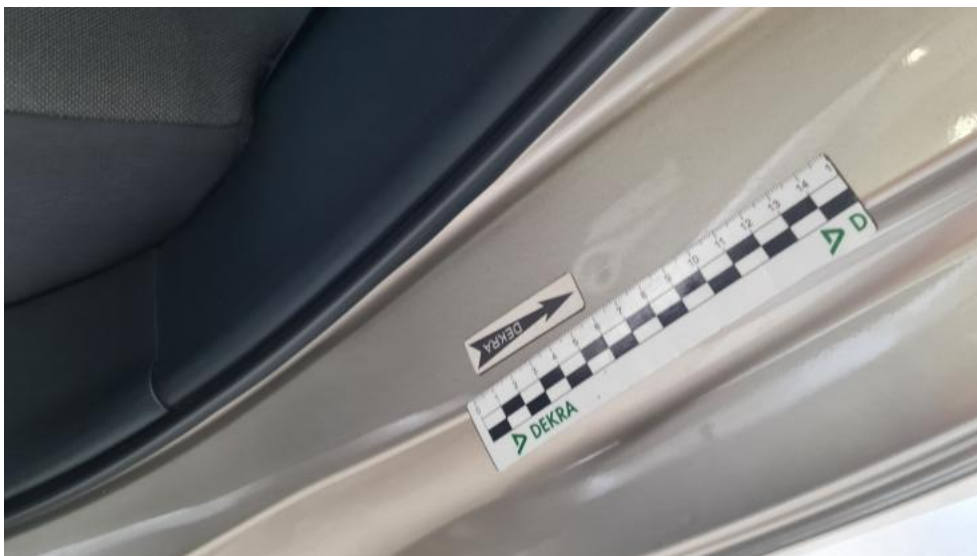
Photo 45.
Błotnik tylny L / Ściana boczna L - Wgniecenie/odkształcenie 1

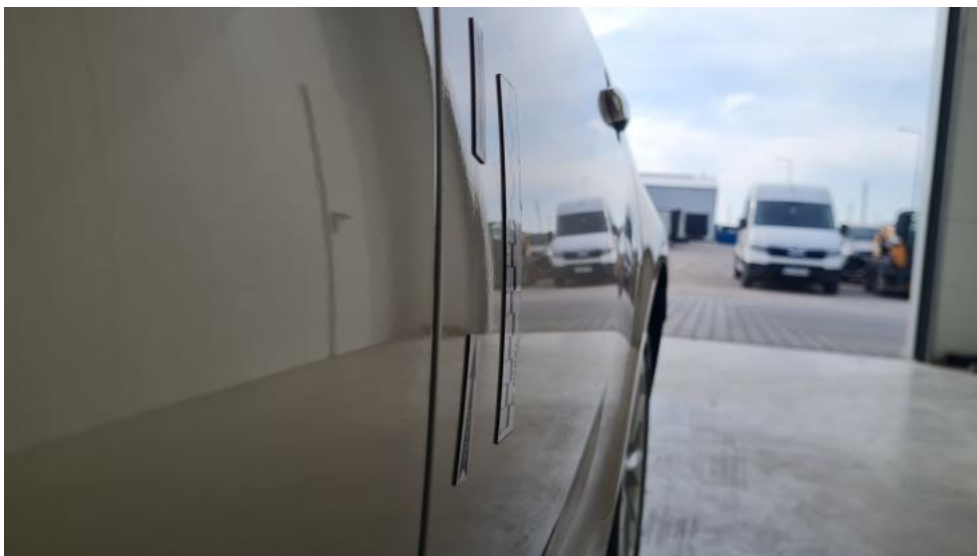
Photo 47.
Drzwi tylne L - Wgniecenie/odkształcenie 1

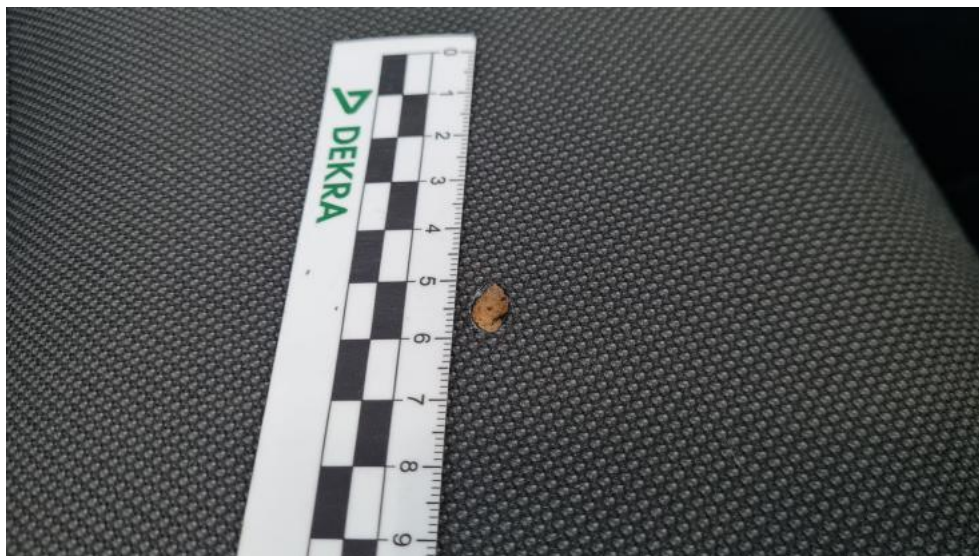
Photo 49.

Fotel prz. praw. - Inne 1
