DEKRA's commission No. : PKOL(W)/LODZ/64459/24/08/22  
commission/ damage No. : 22/001226  
Date of commission: 22-08-2024

| Manufacturer | PORSCHE |
| Model | Cayenne III Coupe 19-23 |
| VIN / serial number | WP1ZZZ9YZNDA41330 |

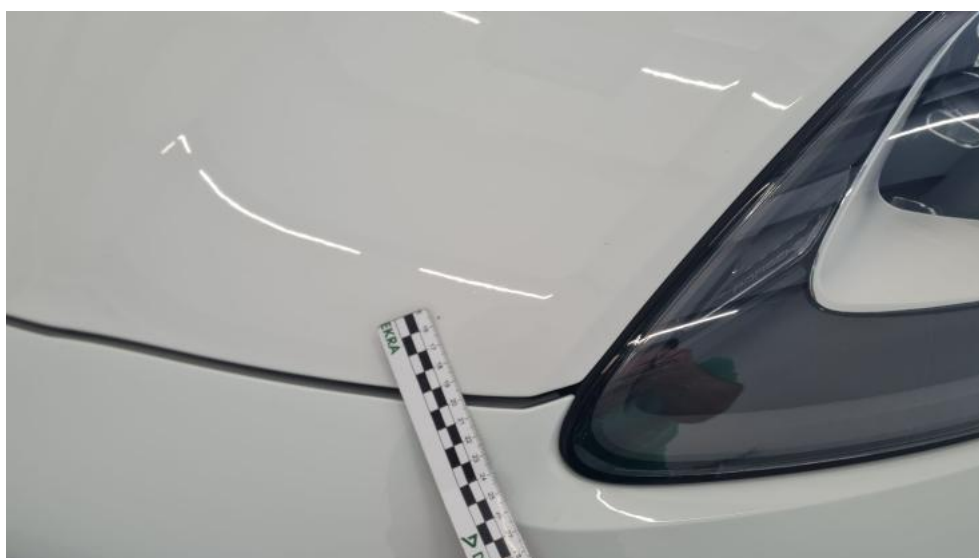
**Photo 36.**  
Pokrywa komory silnika - Rysa/odprysk 1

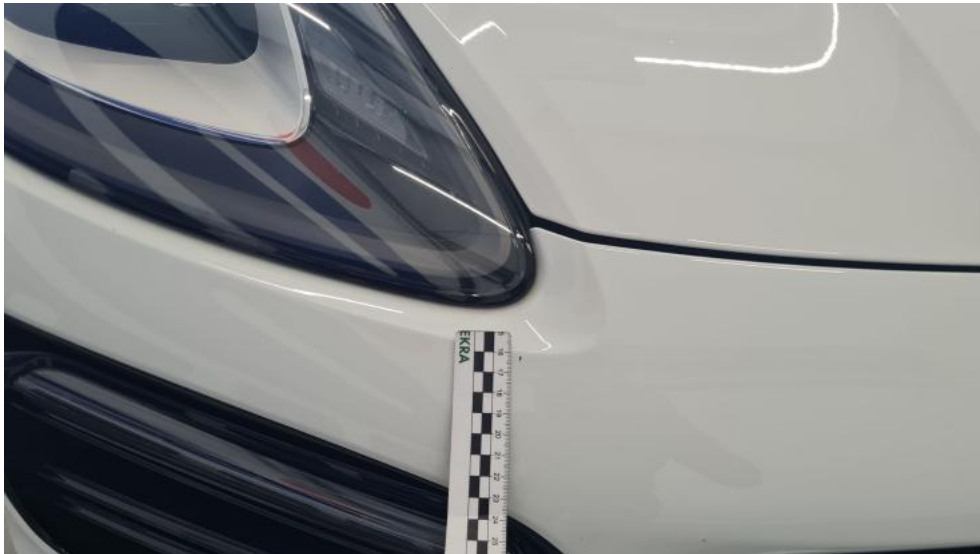
**Photo 37.**

Zderzak - Rysa/odprysk 1

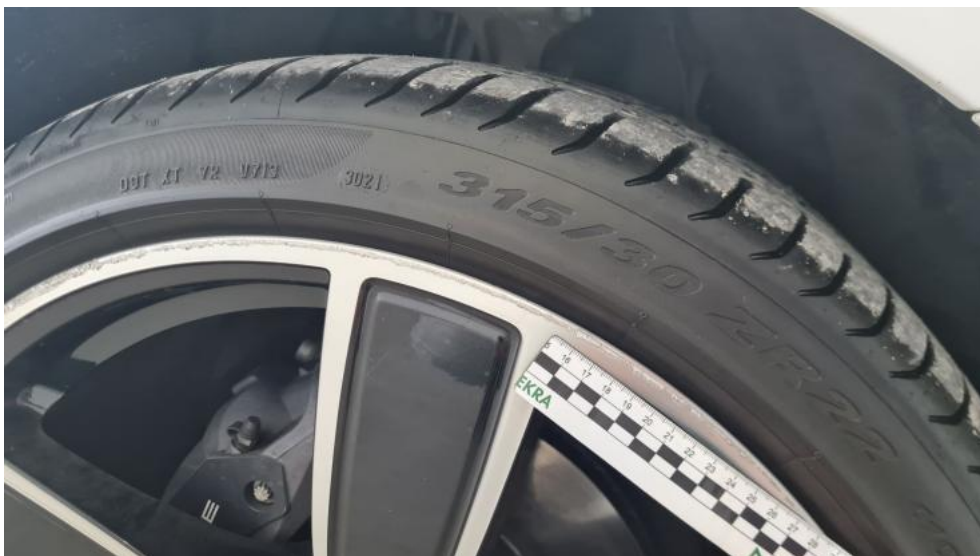
**Photo 38.**

Felga aluminiowa przednia P - Rysa/odprysk 1

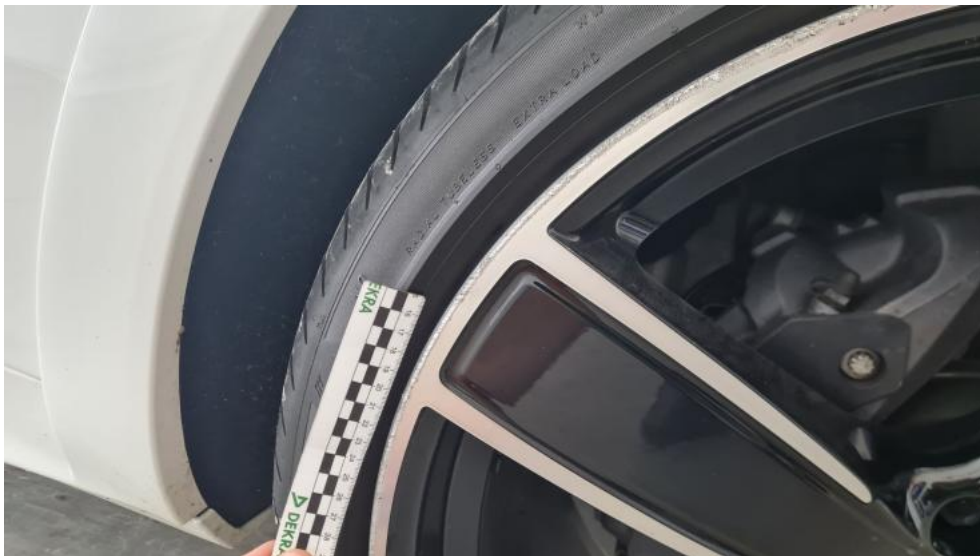
**Photo 39.**

Felga aluminiowa przednia P - Rysa/odprysk 2

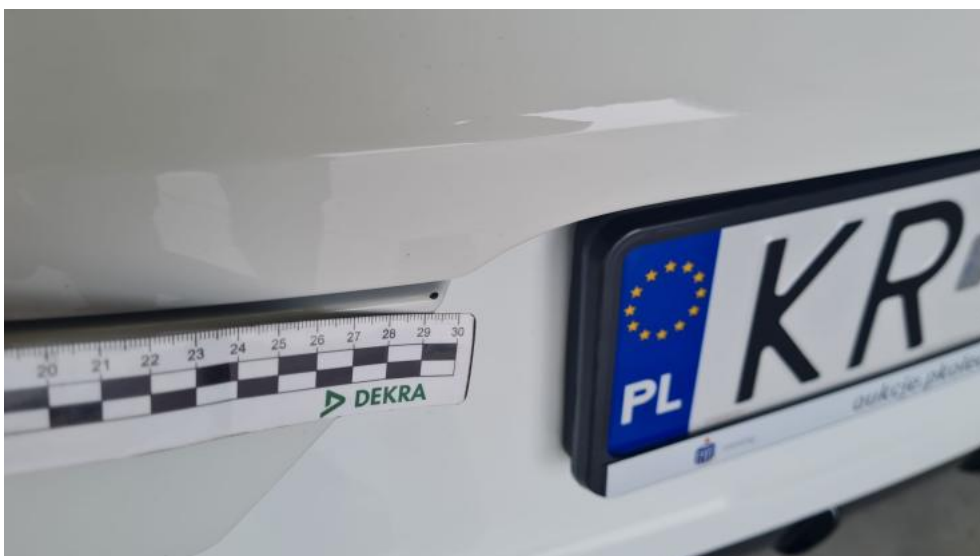
**Photo 40.**

Zderzak tylny - Rysa/odprysk 1

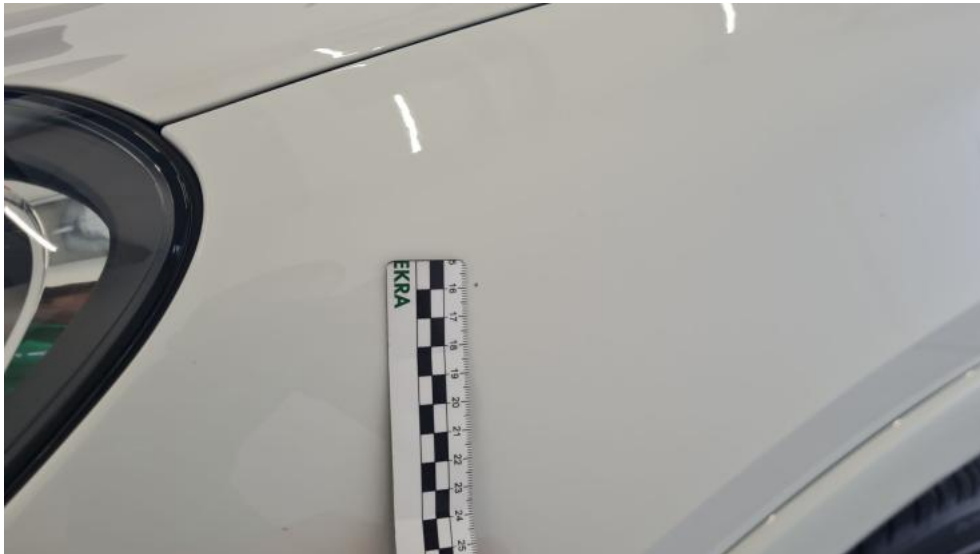
**Photo 41.**

Błotnik przedni L - Rysa/odprysk 1

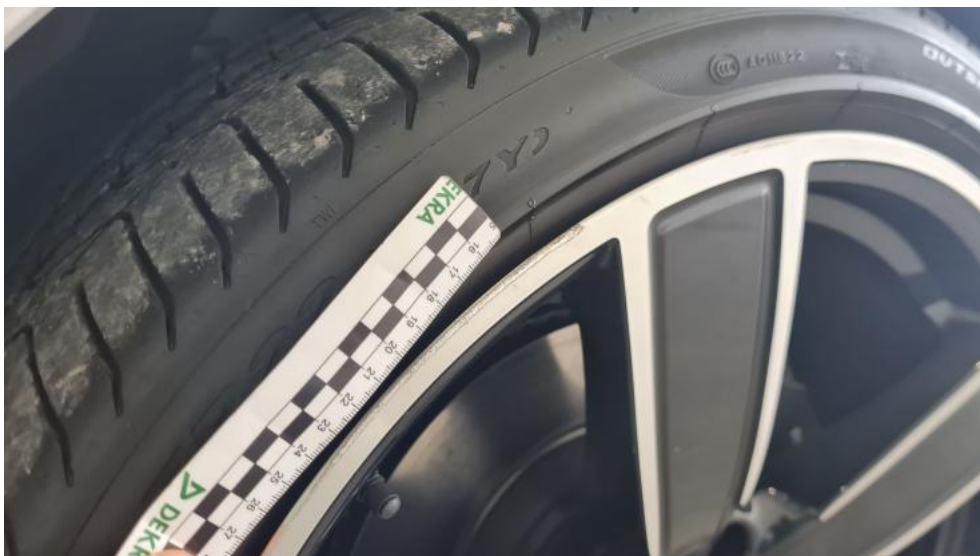
**Photo 42.**

Felga Aluminiowa przednia L - Rysa/odprysk 1
