DEKRA's commission No. : PKOL(W)/LODZ/73667/24/09/24  
commission/ damage No. : 00488/LF/23  
Date of commission: 24-09-2024

**Vehicle data**

Group of objects (Eurotax)	cars
EC code (Eurotax)	0145926
Manufacturer	TOYOTA
Model	Corolla Sedan 18-22
Type / version	Corolla 1.5 Comfort
Body type	sedan
Number of doors / seats	4/5
Curb weight [kg]	1295
Gross vehicle weight [kg]	1795
Wheelbase 1/2	2700
Engine type	spark ignition
Pollution reduction system	GPF
Engine capacity [ccm]	1490
Engine Power [hp/kW]	125/92
Gearbox	manual 6- gear
Registration /record No.	WU7371P
VIN / serial number	NMTBA3BE20R047817
Date of first registration	25-04-2023
Date of next. tech. test	10-03-2026
Year of manufacture	2022
Readout [km]	37 536 (read)
Body color / type of coating	green/double-layered, metallized

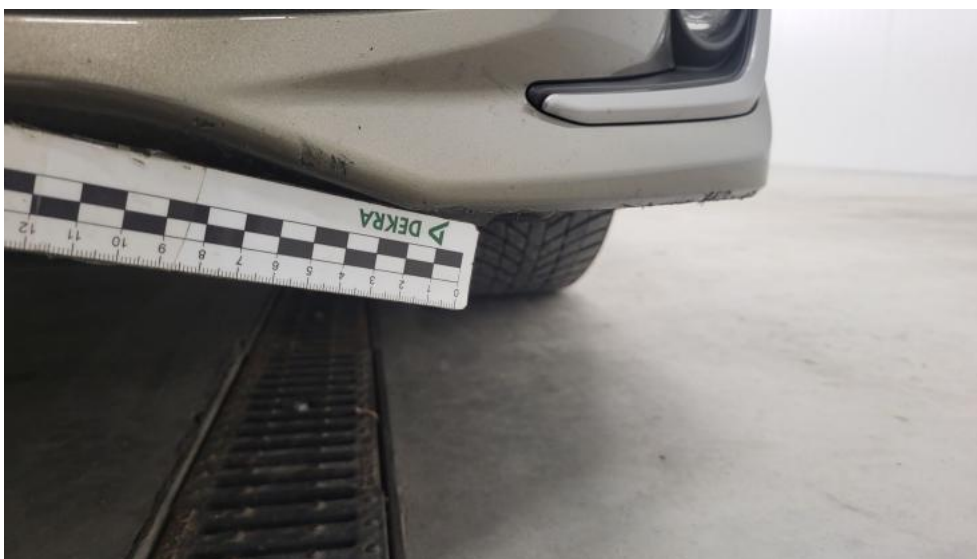
**Photo 39.**  
Zderzak - Rysa/odprysk 1

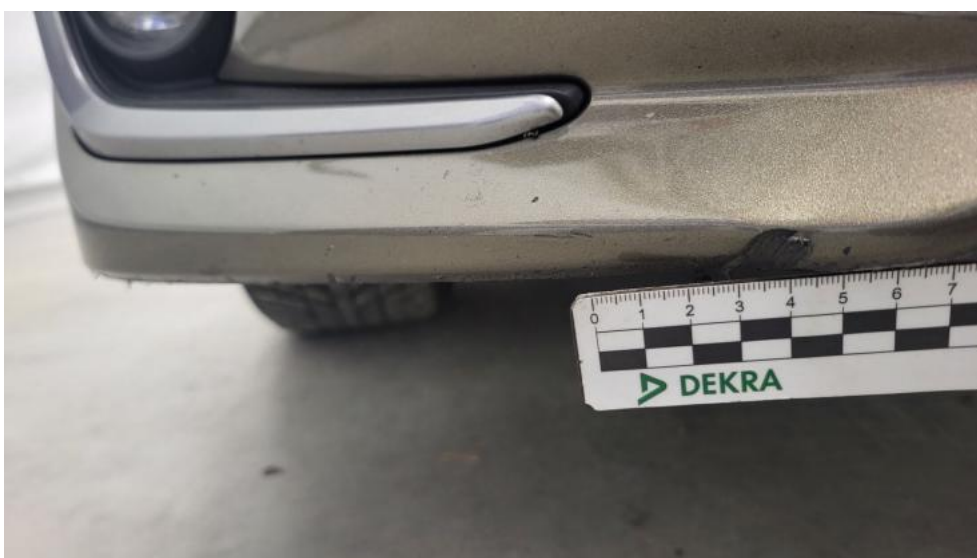
**Photo 40.**  
Zderzak - Rysa/odprysk 2

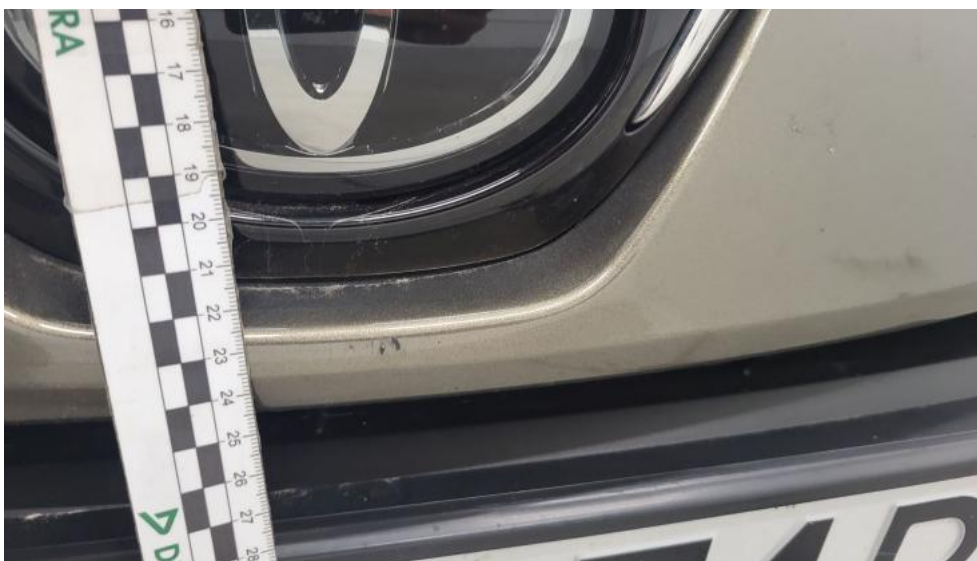
**Photo 41.**  
Zderzak() - Rysa/odprysk 3

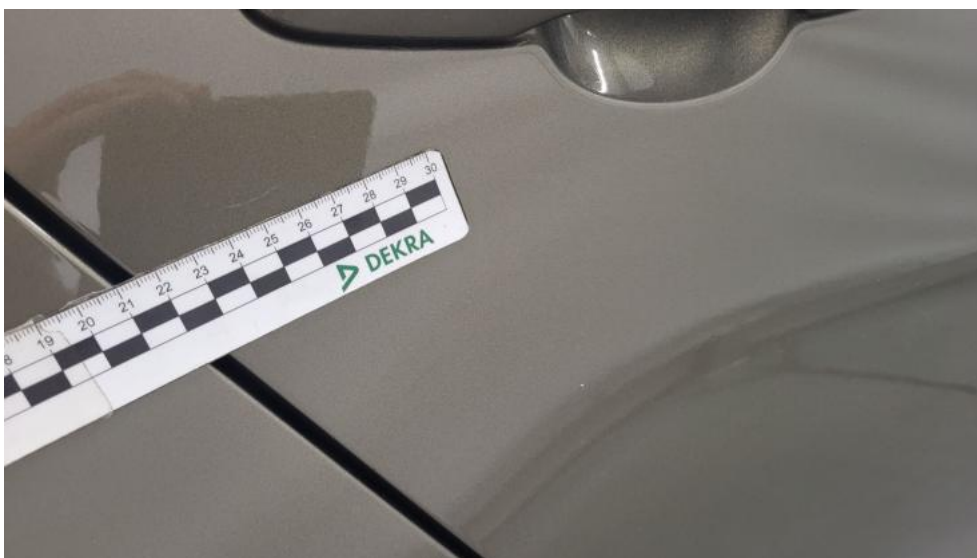
**Photo 42.**  
Drzwi tylne P - Rysa/odprysk 1

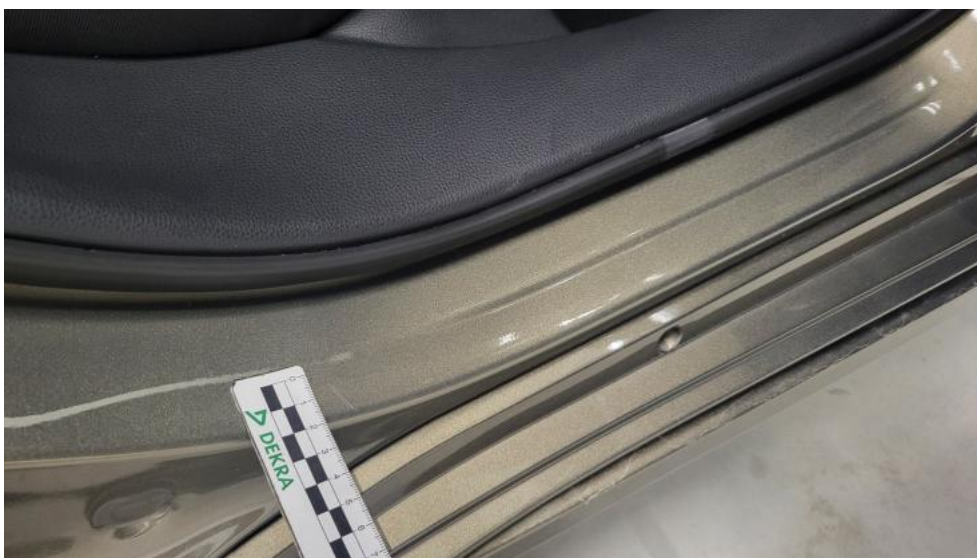
**Photo 44.**  
Próg P - Rysa/odprysk 1

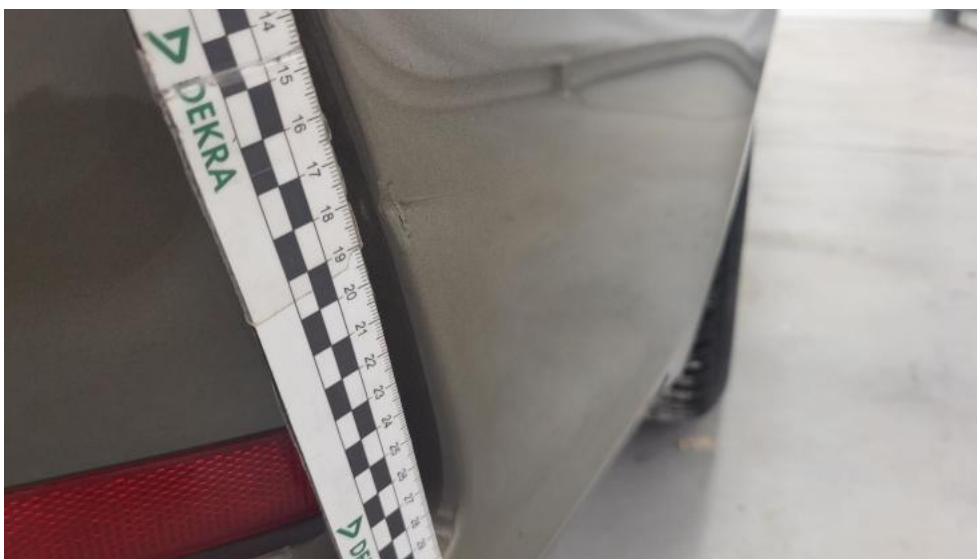
**Photo 45.**  
Zderzak tylny - Rysa/odprysk 1

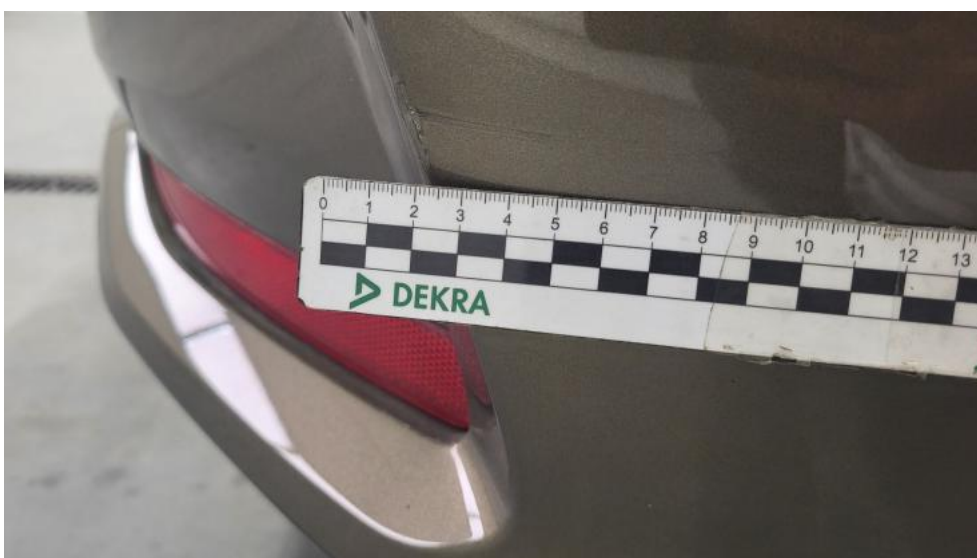
**Photo 46.**  
Zderzak tylny - Rysa/odprysk 2

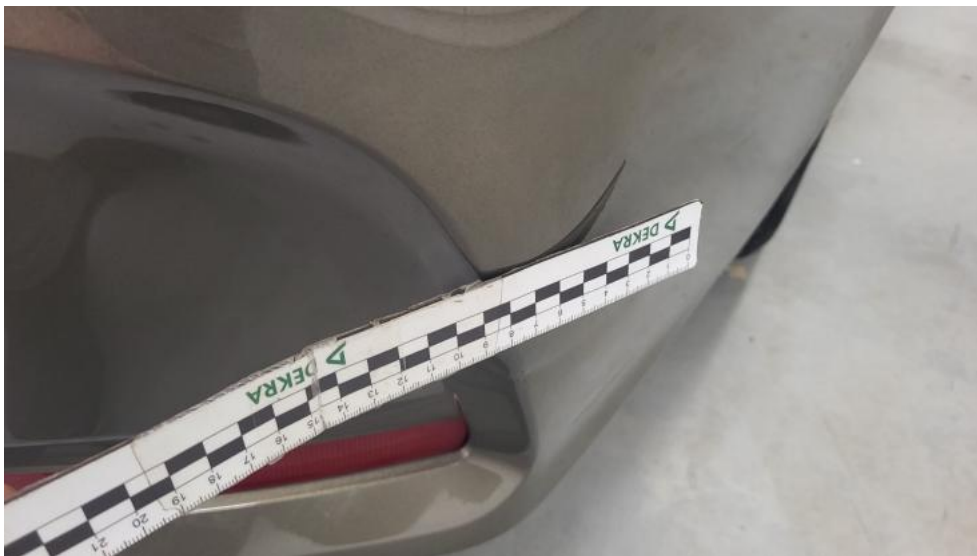
**Photo 47.**  
Zderzak tylny - Wgniecenie/odkształcenie 1

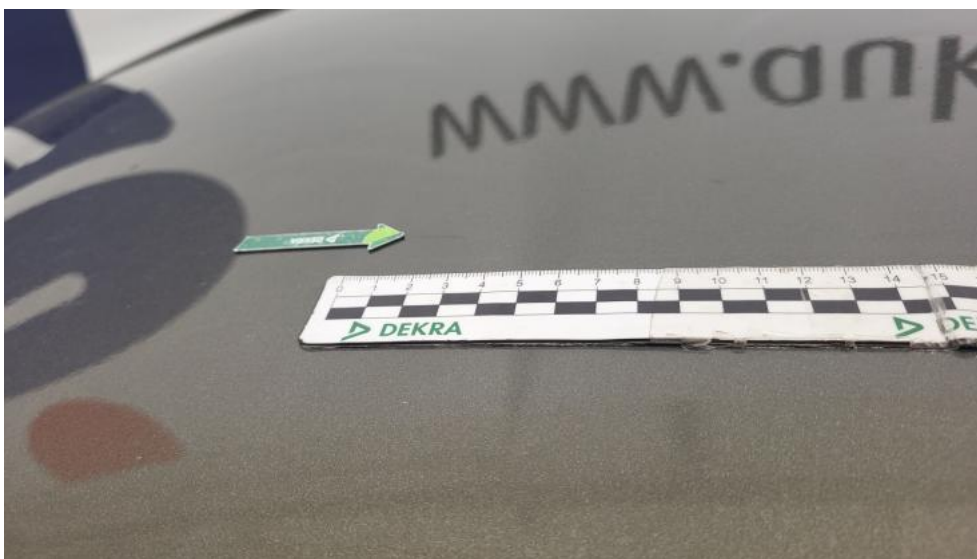
**Photo 49.**  
Dach - Rysa/odprysk 1

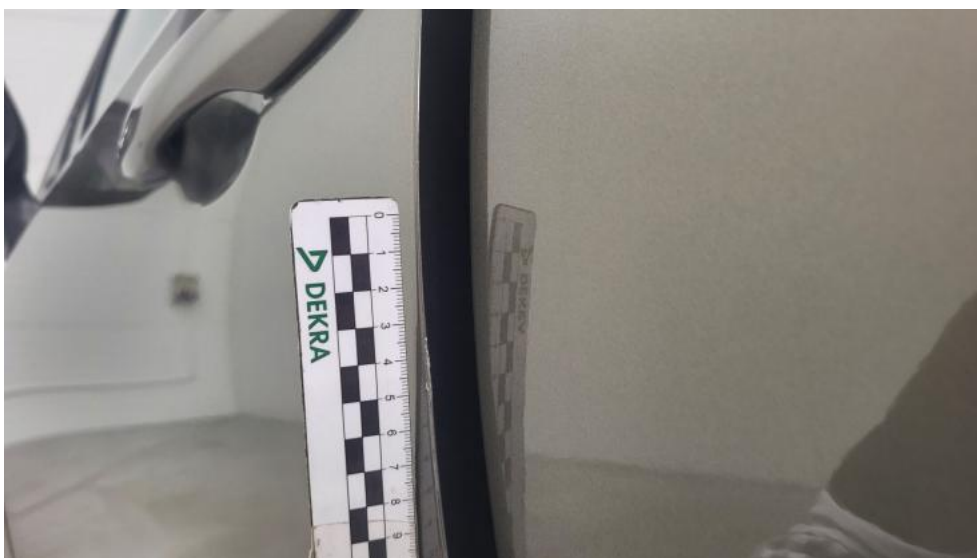
**Photo 50.**  
Drzwi przed L - Rysa/odprysk 1

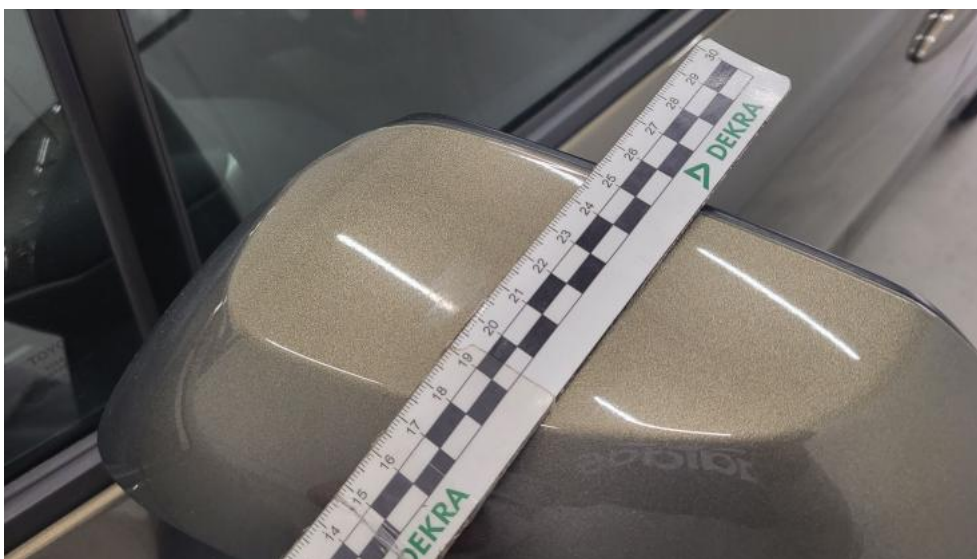
**Photo 51.**  
Lusterko zew L - Rysa/odprysk 1

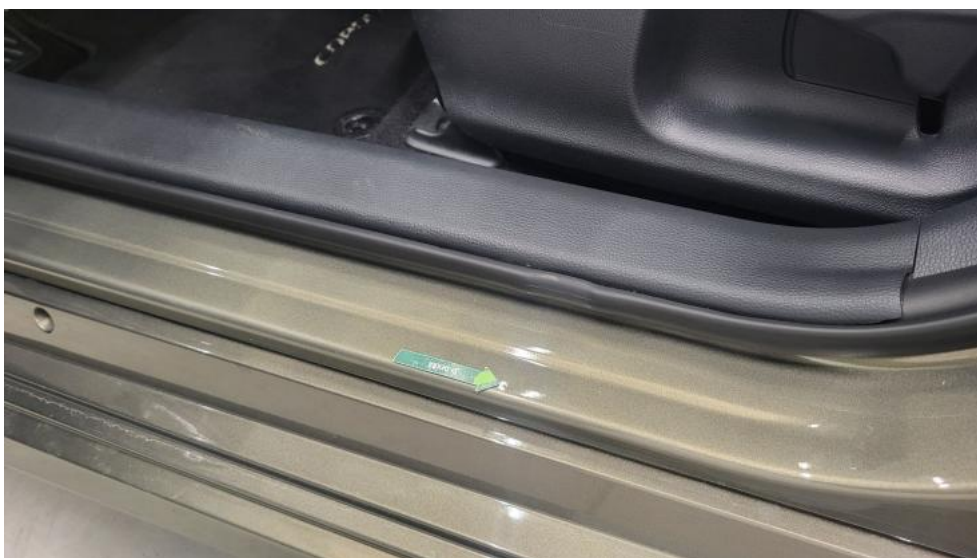
**Photo 52.**  
Próg L - Rysa/odprysk 1
