DEKRA's commission No. : PKOL(W)/LODZ/90125/26/09/25  
commission/ damage No. : 23/038830  
Date of commission: 25-09-2026

**DEKRA Poland - Headquarters**  
02-673 Warszawa, ul. Konstruktorska 12A

| Manufacturer | CITROEN |
| Type / version | SpaceTourer 2.0 BlueHDi XL Business Lounge Aut. |

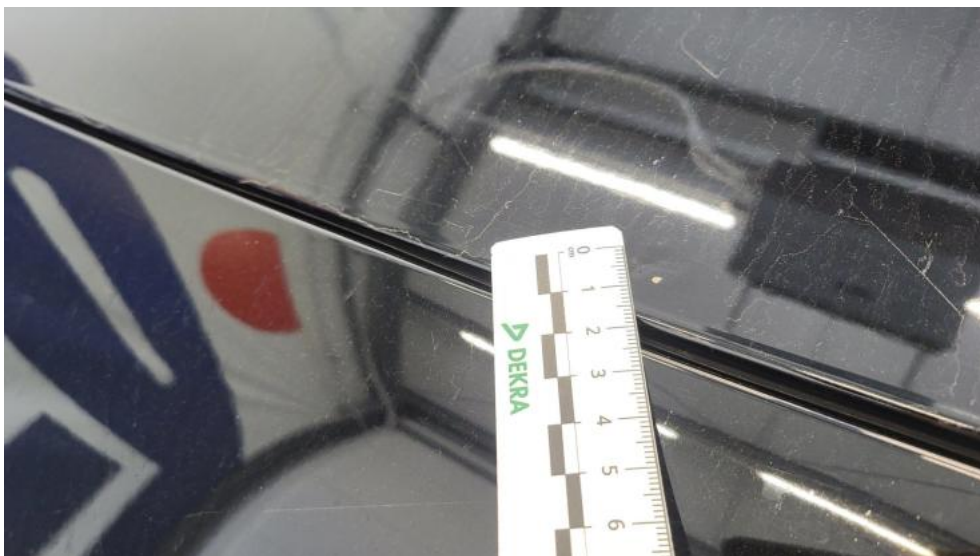
**Photo 42.**

Pokrywa komory silnika - Rysa/odprysk 1

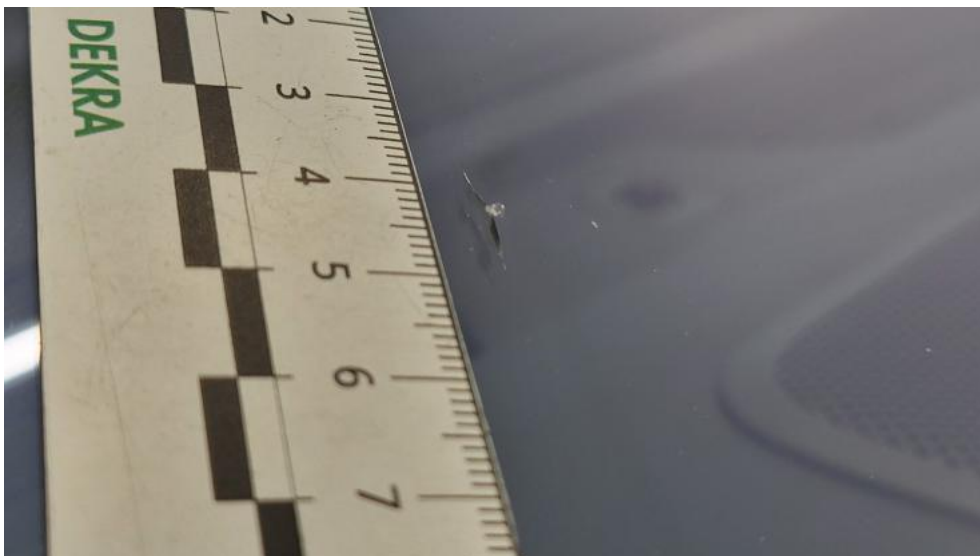
**Photo 44.**

Szyba czołowa - Pęknięcie/rozerwanie 1

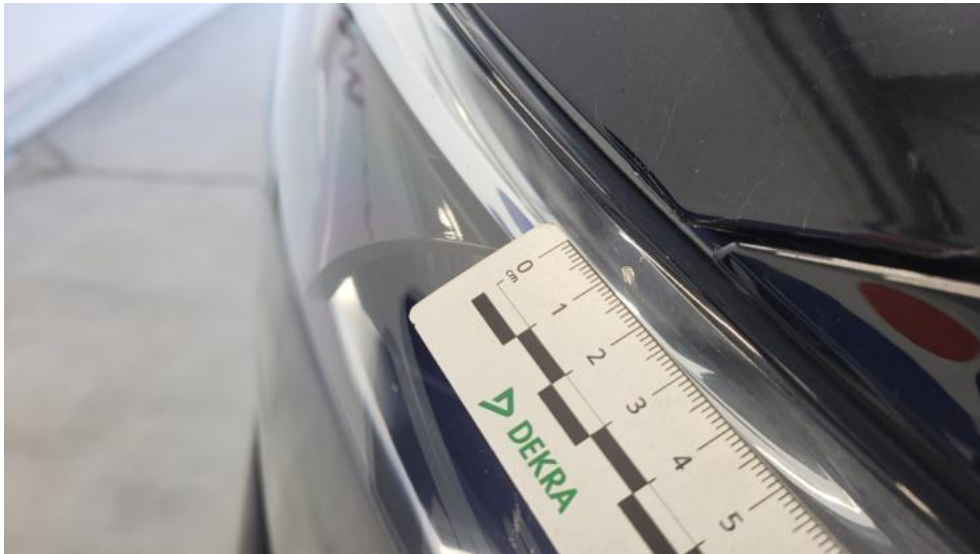
**Photo 49.**

Reflektor P - Rysa/odprysk 1

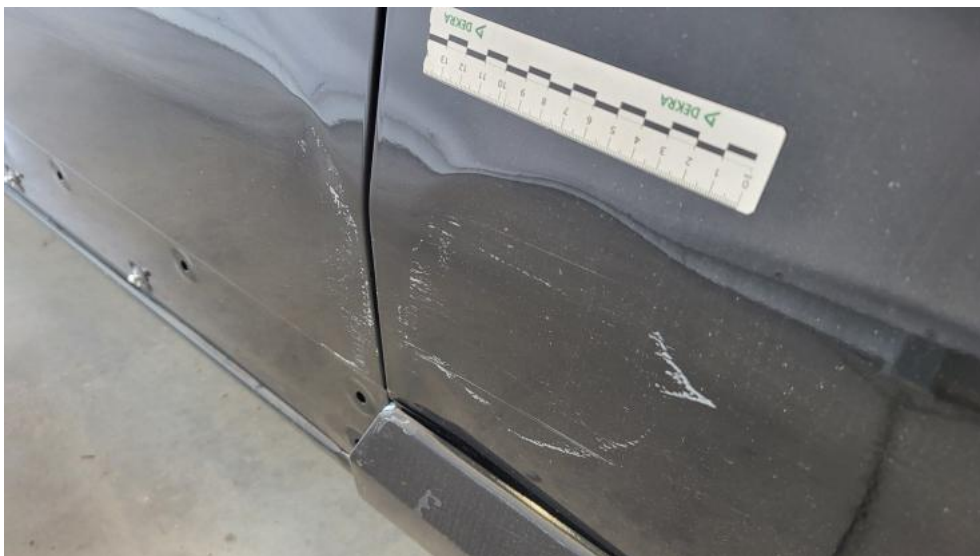
**Photo 50.**

Drzwi przednie P - Rysa/odprysk 1

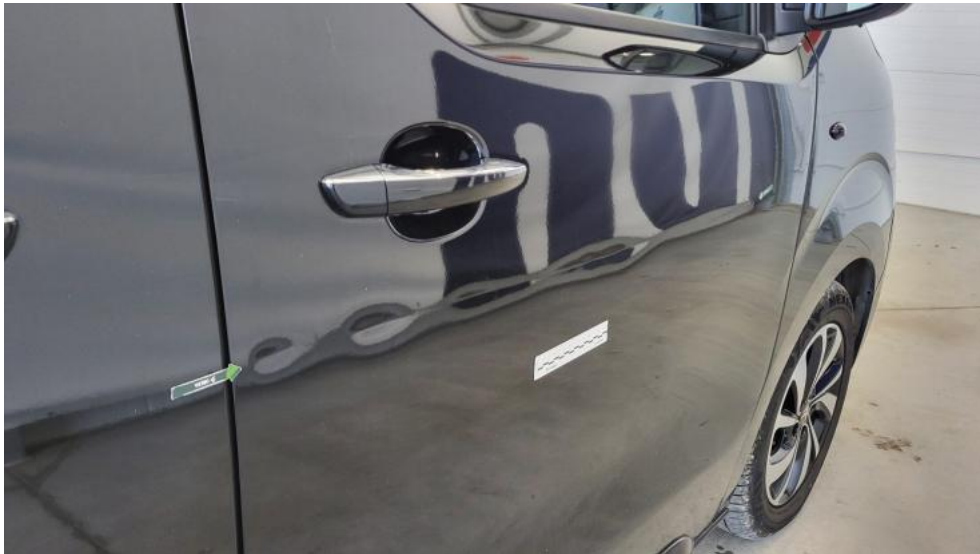
**Photo 51.**

Drzwi przednie P - Wgniecenie/odkształcenie 1

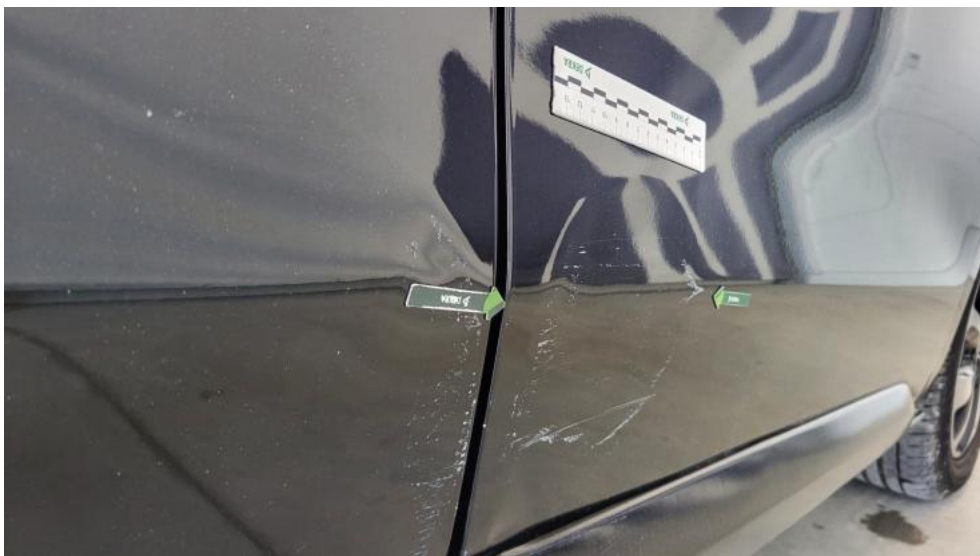
**Photo 52.**

Drzwi przednie P - Wgniecenie/odkształcenie 2

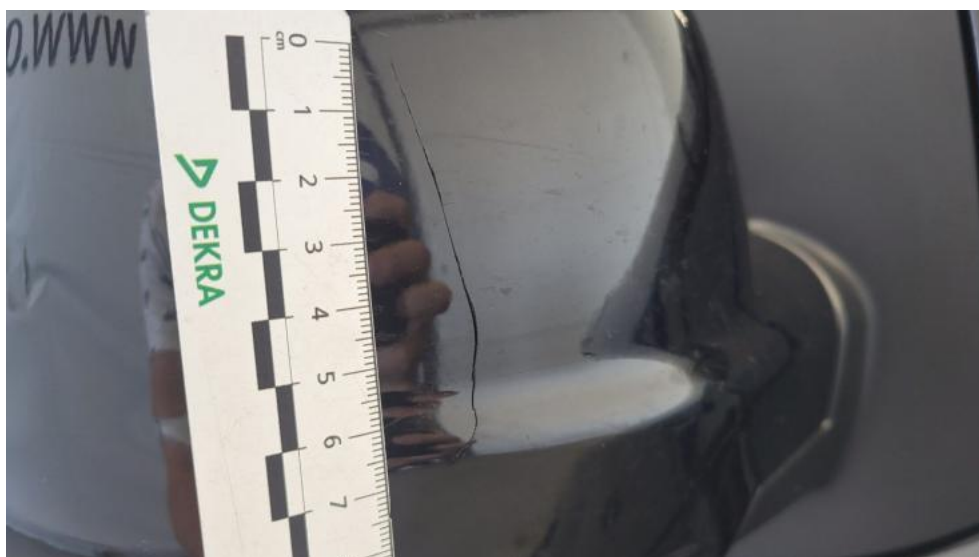
**Photo 59.**

Lusterko zew P - Pęknięcie/rozerwanie 1

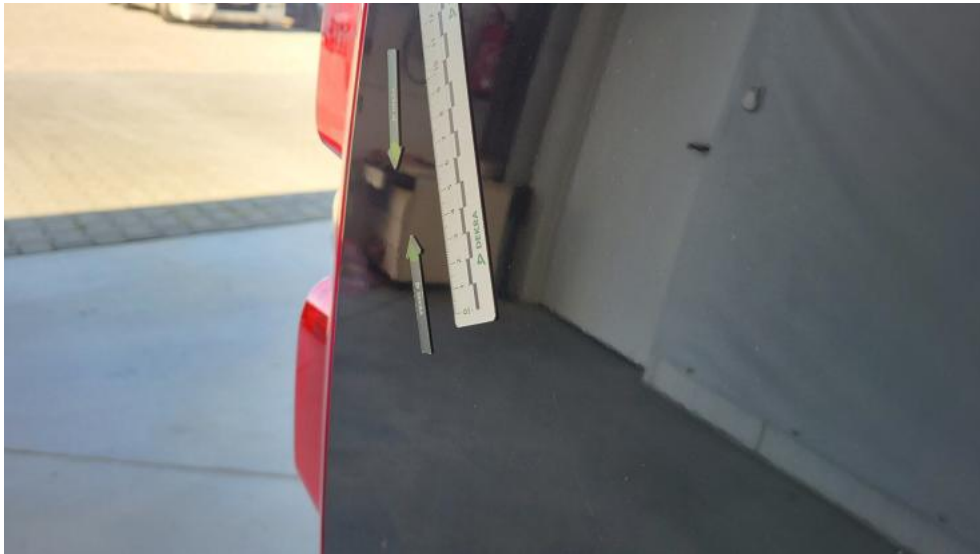
**Photo 61.**

Błotnik tylny P / Ściana boczna P - Wgniecenie/odkształcenie 1

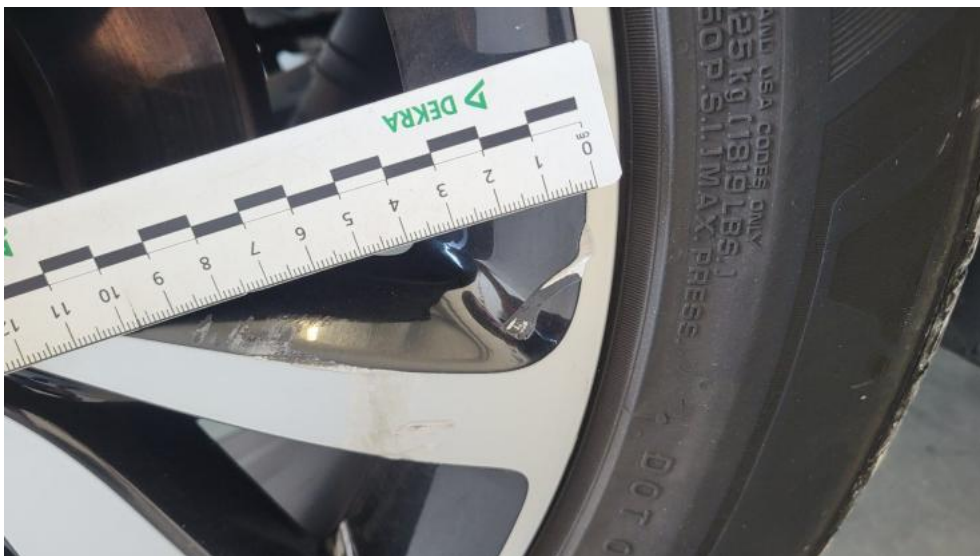
**Photo 62.**

Felga aluminiowa tylna P - Rysa/odprysk 1

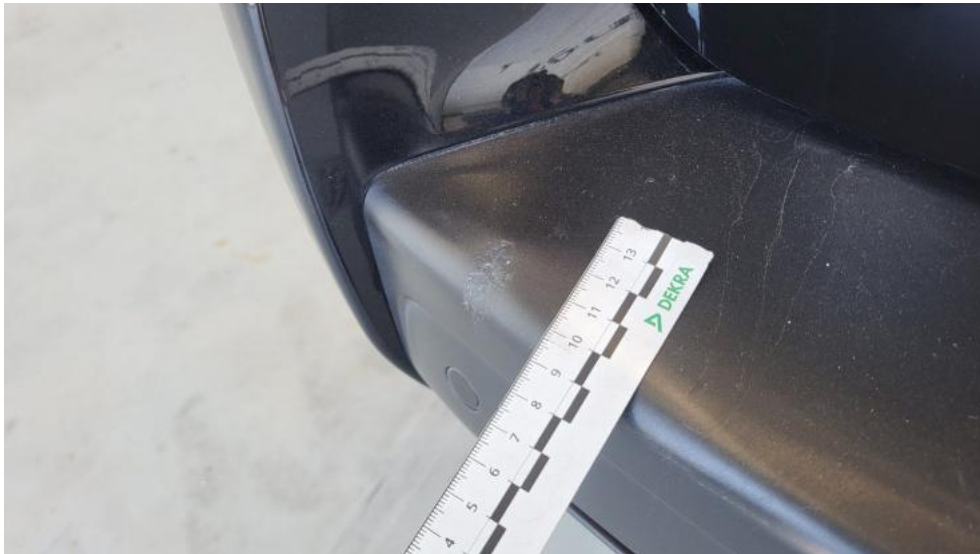
**Photo 65.**

Zderzak tylny - Wgniecenie/odkształcenie 1

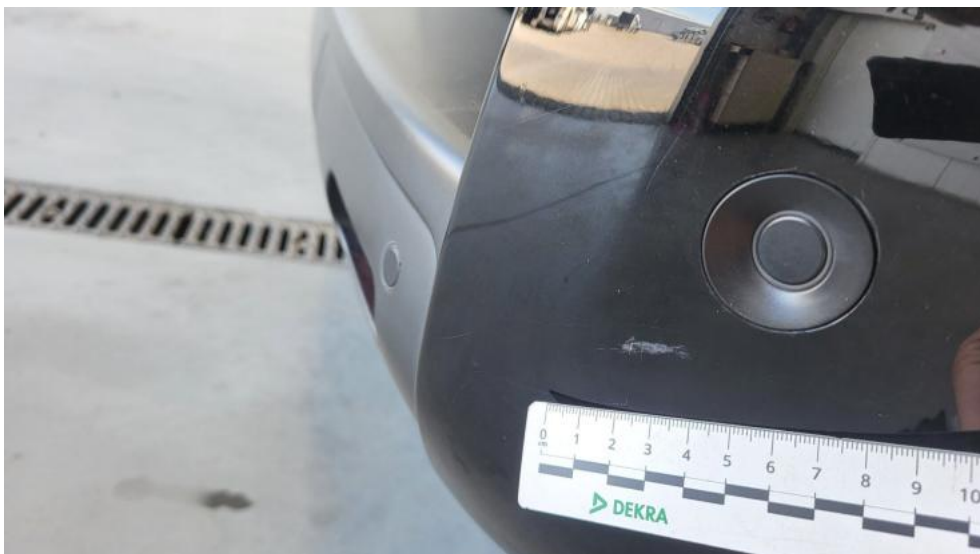
**Photo 66.**

Zderzak tylny cz P - Rysa/odprysk 1

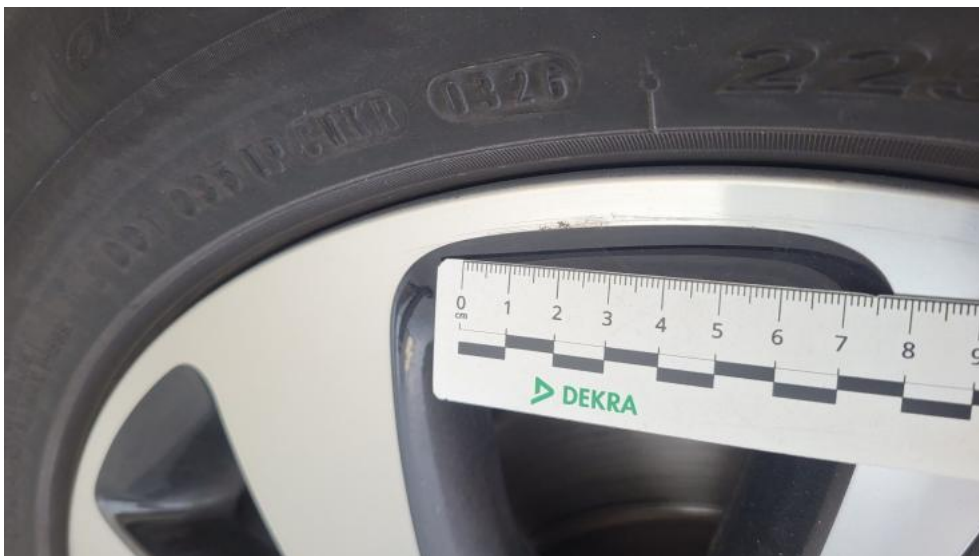
**Photo 68.**

Felga aluminiowa tylna L - Rysa/odprysk 1

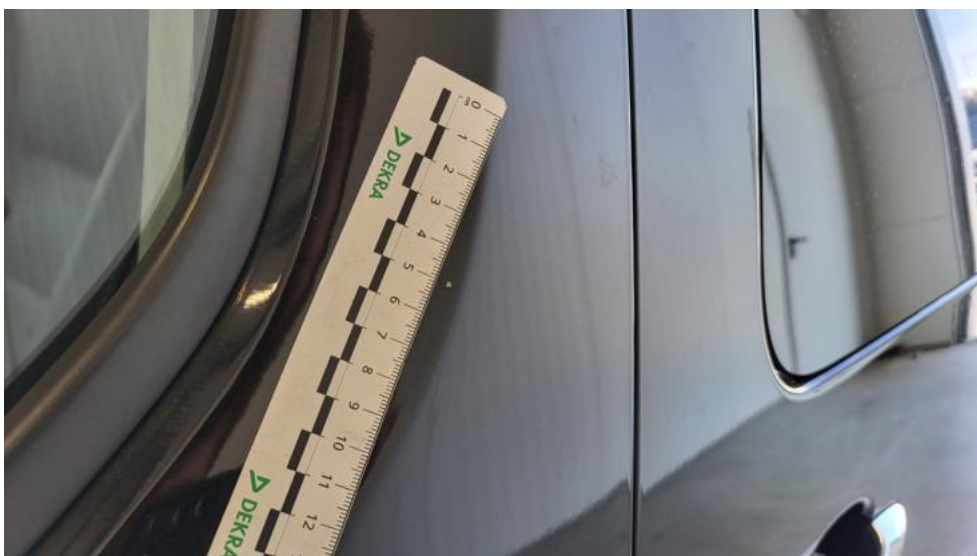
**Photo 70.**

Drzwi przed L - Rysa/odprysk 2

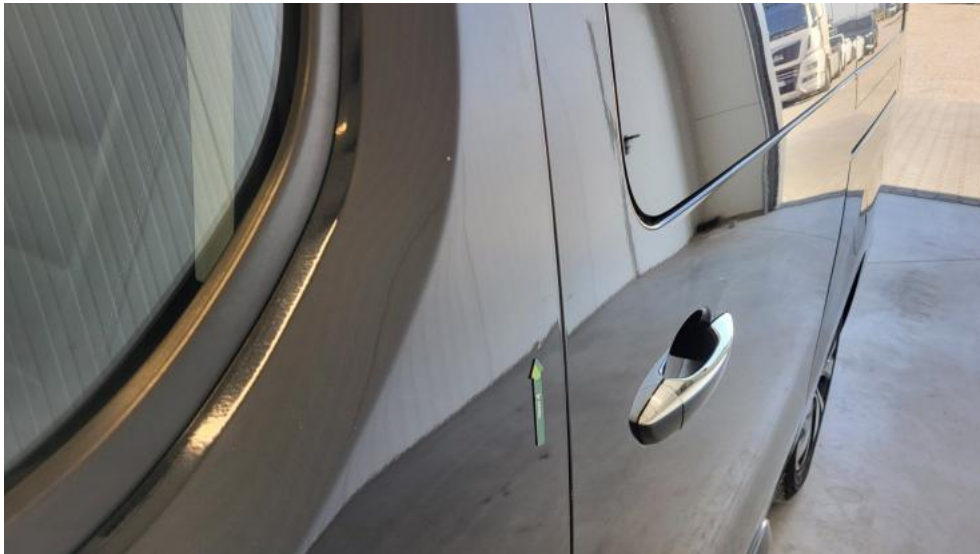
**Photo 71.**

Drzwi przed L - Wgniecenie/odkształcenie 1

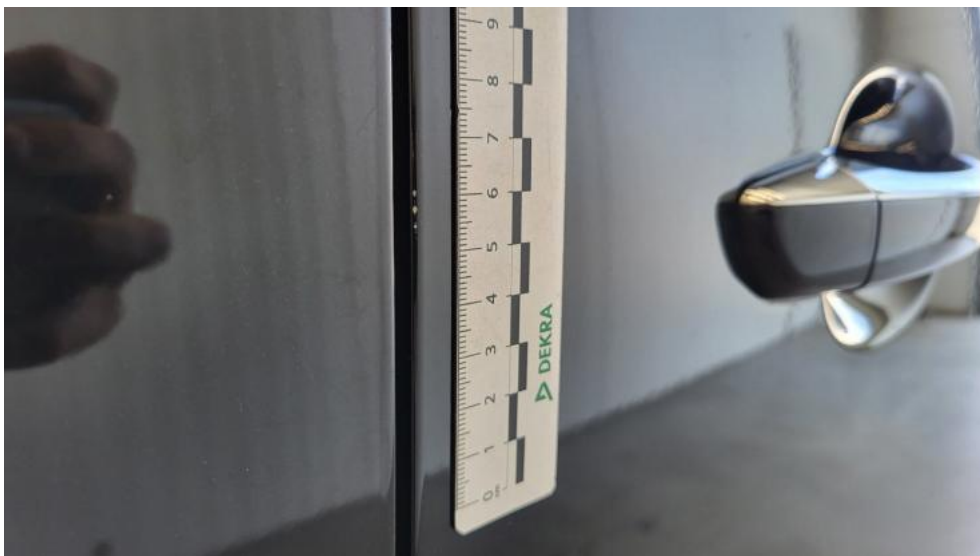
**Photo 72.**

Drzwi tylne L - Rysa/odprysk 1

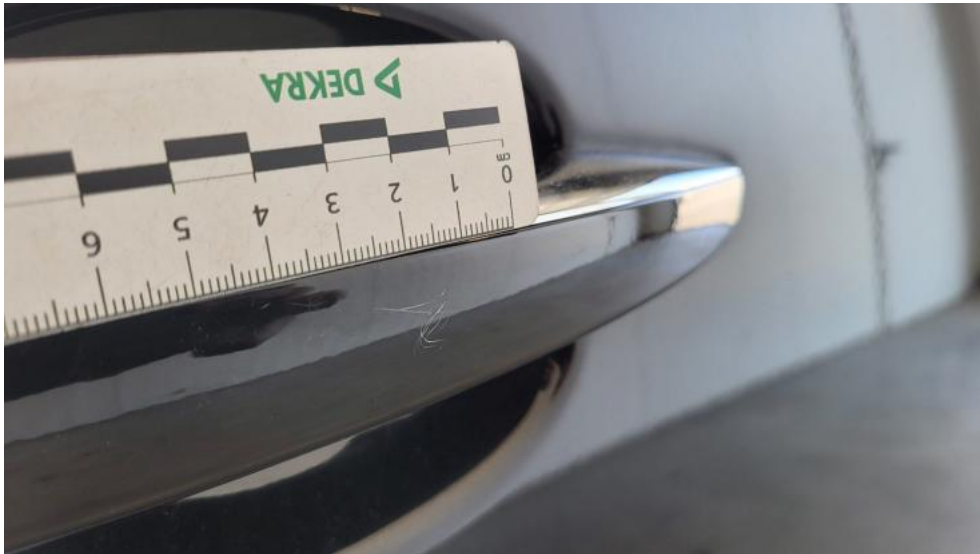
**Photo 73.**

Klamka drzwi tyl L - Rysa/odprysk 1

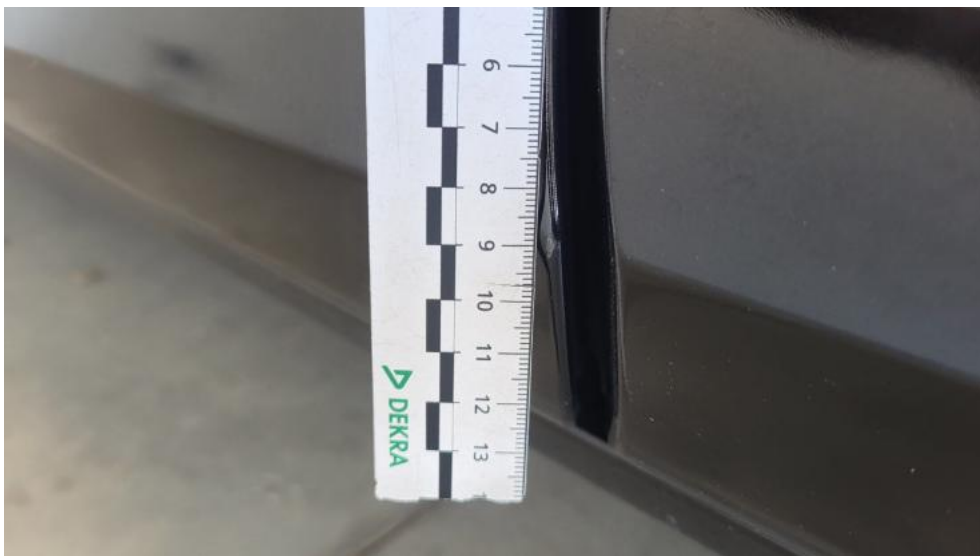
**Photo 74.**

Listwa drzwi przednich L - Rysa/odprysk 1

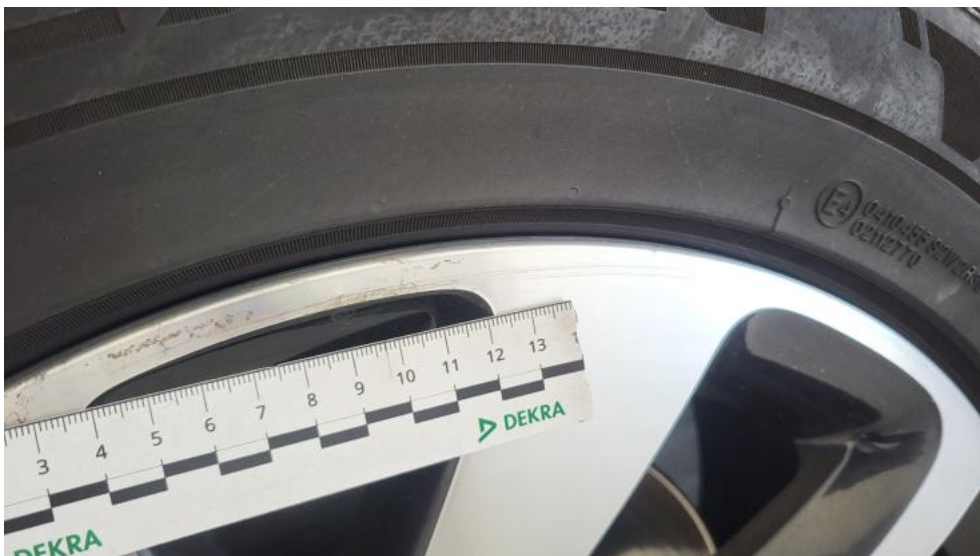
**Photo 78.**

Felga Aluminiowa przednia L - Rysa/odprysk 1

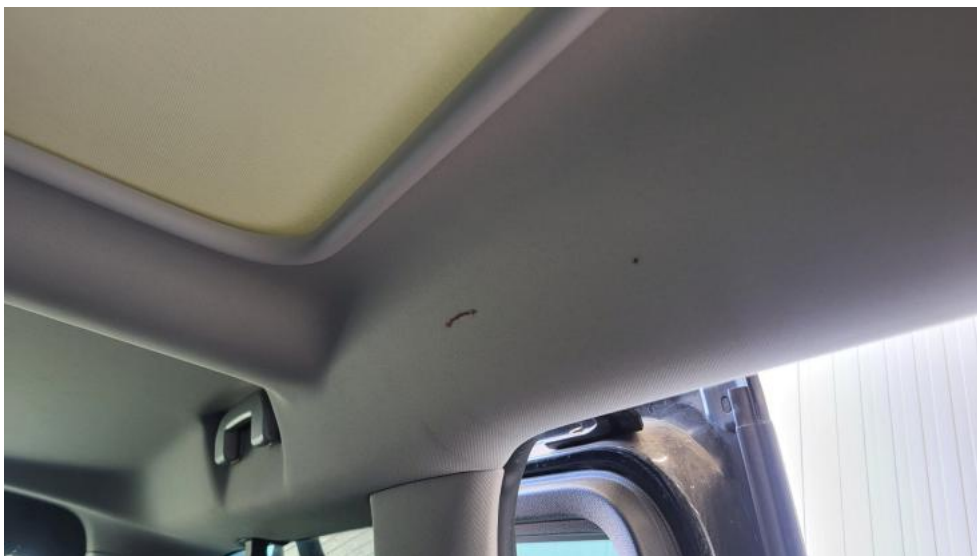
**Photo 79.**

Podsufitka - Inne 1

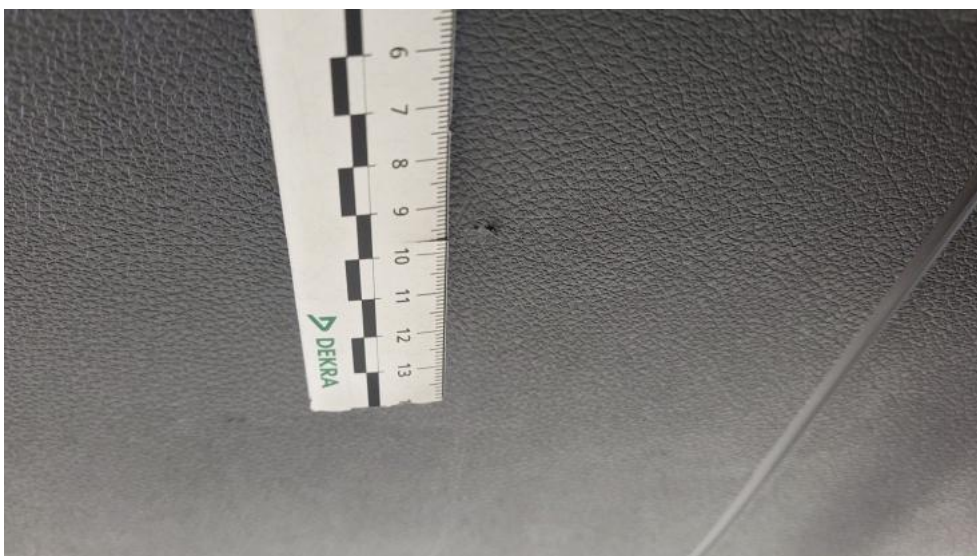
**Photo 80.**

Wykładzina pokrywy tylnej - Rysa/odprysk 1
