DEKRA's commission No. : PKOL(W)/LODZ/89097/26/09/22(60760)  
commission/ damage No. : 21/020341  
Date of commission: 22-09-2026 12:29:13

| Model | Mustang Fastback 18-24 |
| Type / version | Mustang 5.0 V8 Bullitt |
| Registration /record No. | OP4498P |

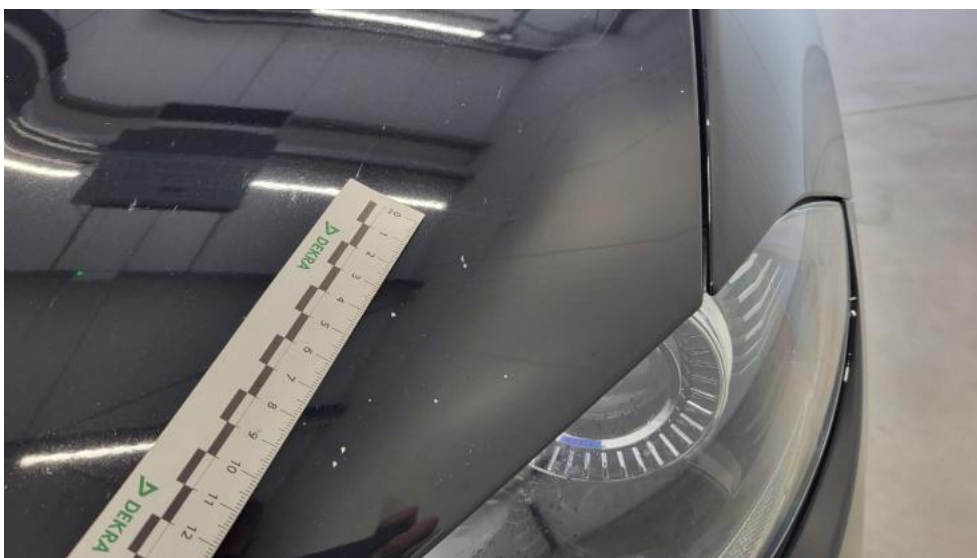
**Photo 36.**

Pokrywa komory silnika - Rysa/odprysk 1

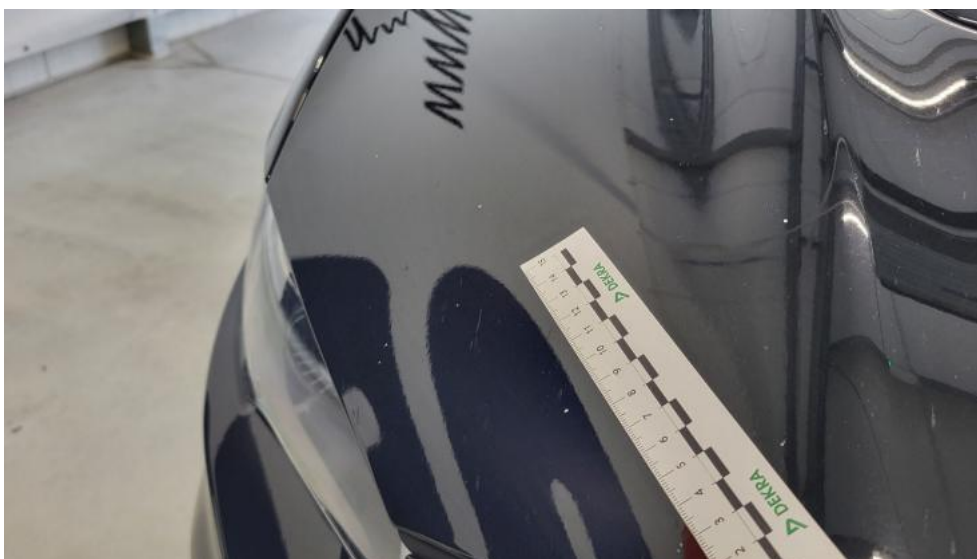
**Photo 37.**

Pokrywa komory silnika - Rysa/odprysk 2

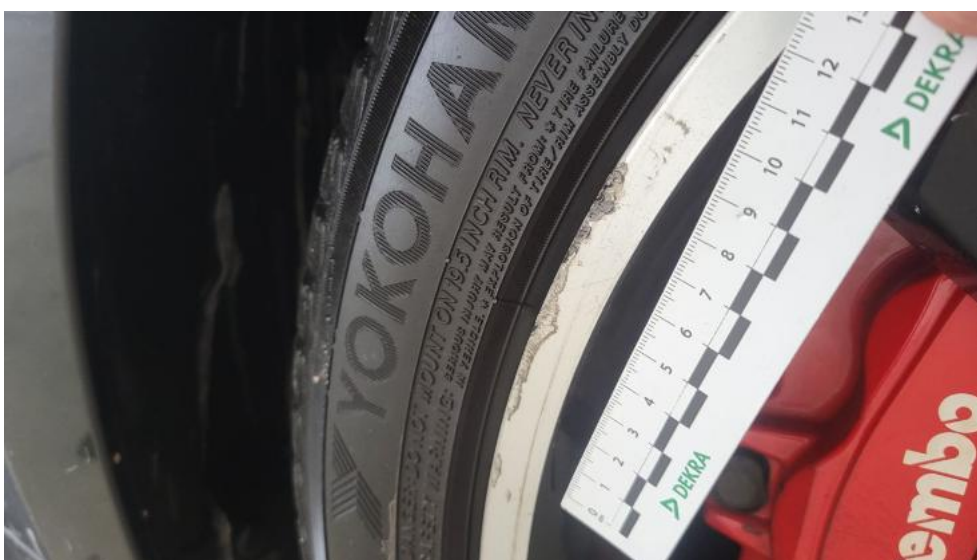
**Photo 38.**

Felga aluminiowa przednia P - Rysa/odprysk 1

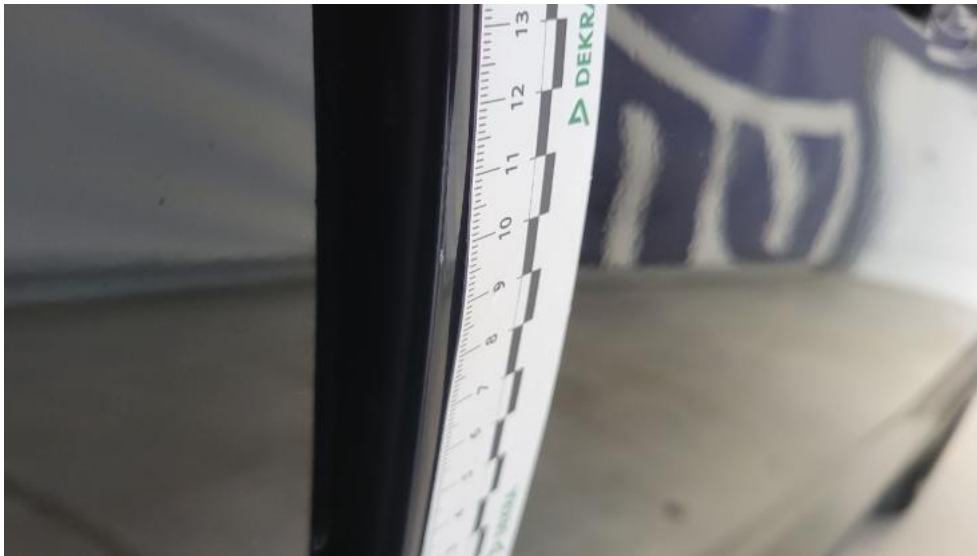
**Photo 39.**

Drzwi przednie P - Rysa/odprysk 1

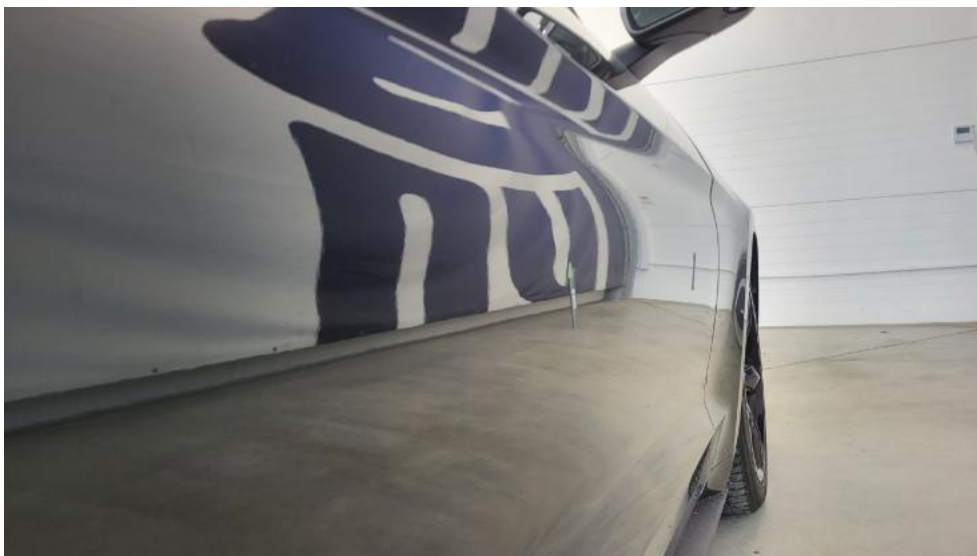
**Photo 40.**

Drzwi przednie P - Wgniecenie/odkształcenie 1

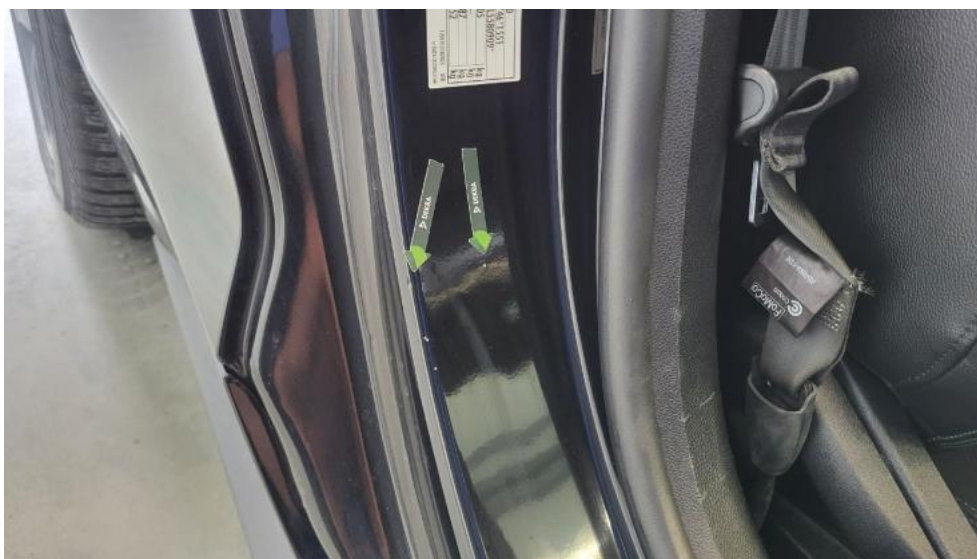
**Photo 41.**

Słupek środkowy P - Wgniecenie/odkształcenie 1

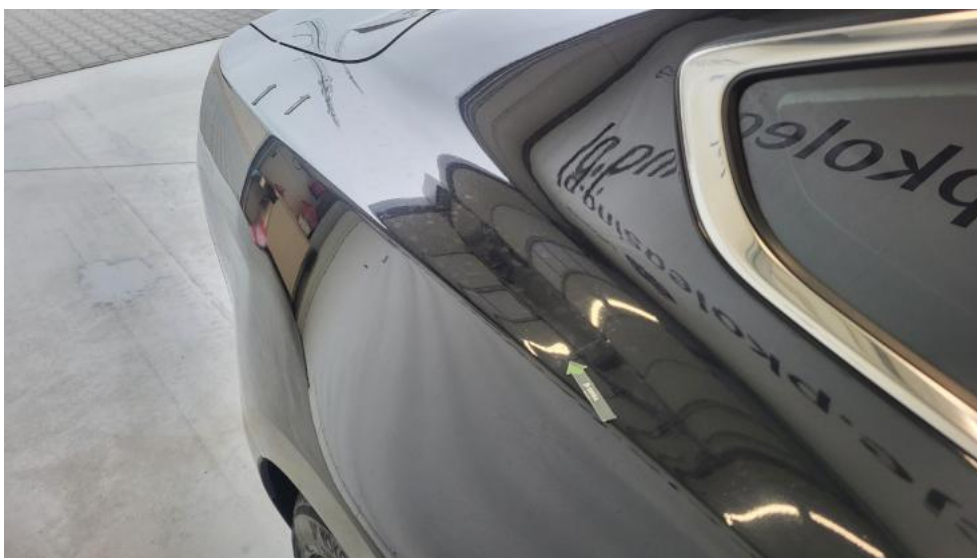
**Photo 42.**

Łotnik tylny P / Ściana boczna P - Wgniecenie/odkształcenie 1

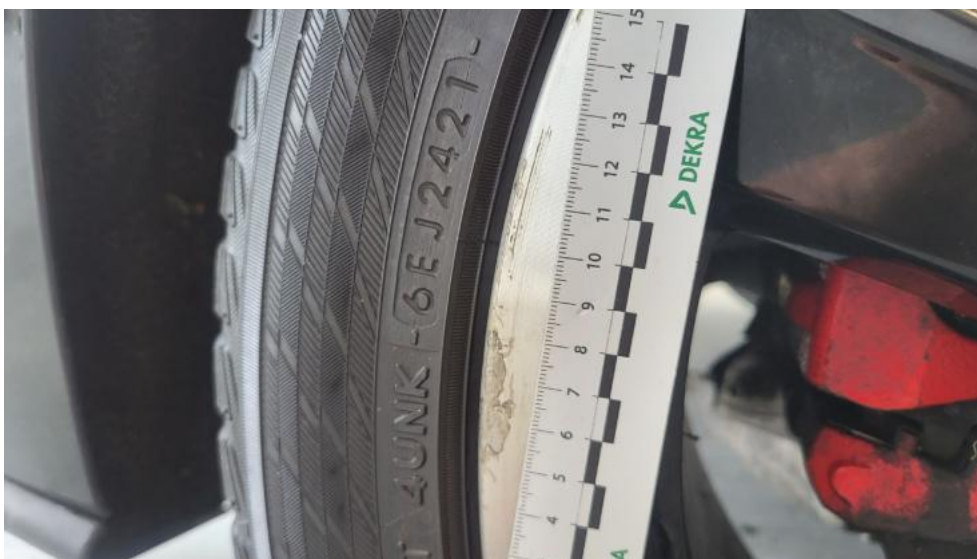
**Photo 43.**

Felga aluminiowa tylna P - Rysa/odprysk 1

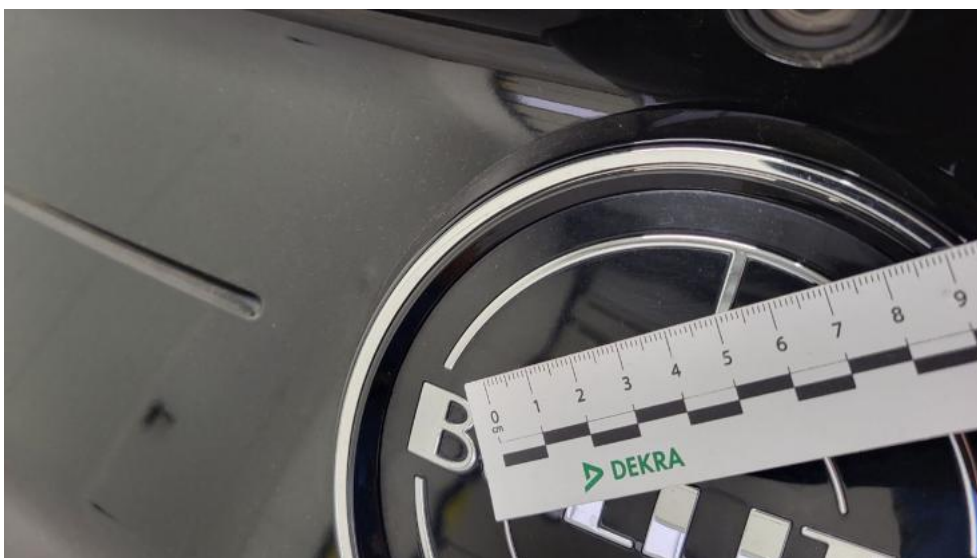
**Photo 44.**

Emblemat tylny - Wgniecenie/odkształcenie 1

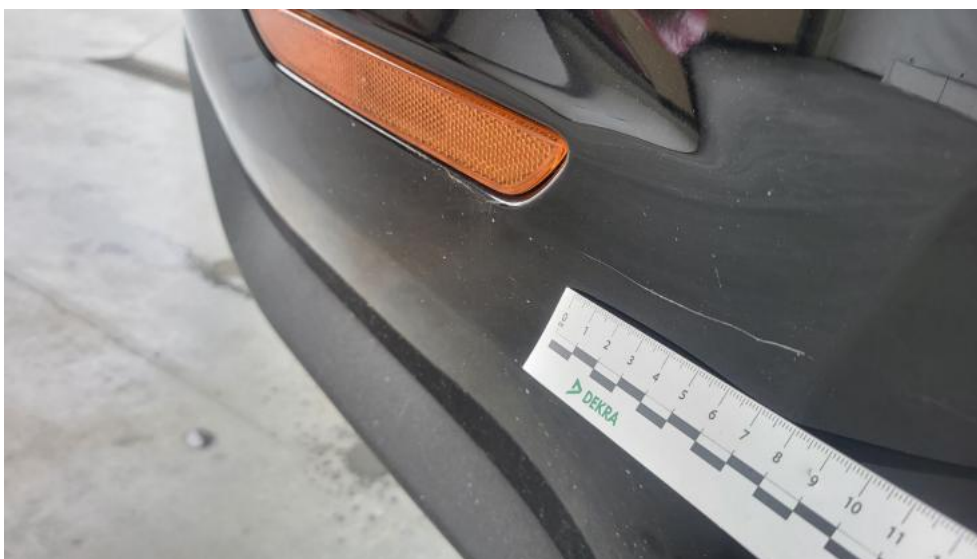
**Photo 45.**

Zderzak tylny - Rysa/odprysk 1

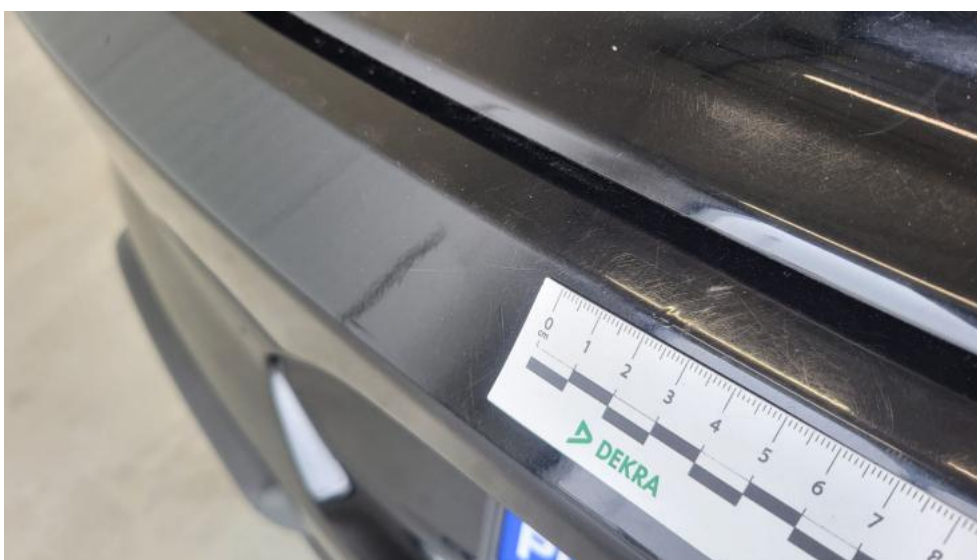
**Photo 46.**

Zderzak tylny - Wgniecenie/odkształcenie 1

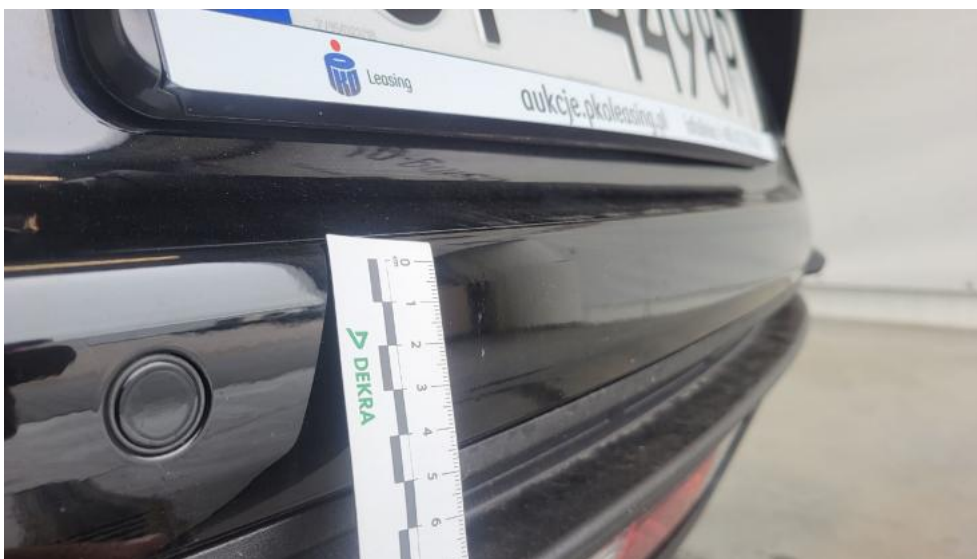
**Photo 47.**

Zderzak tylny - Wgniecenie/odkształcenie 2

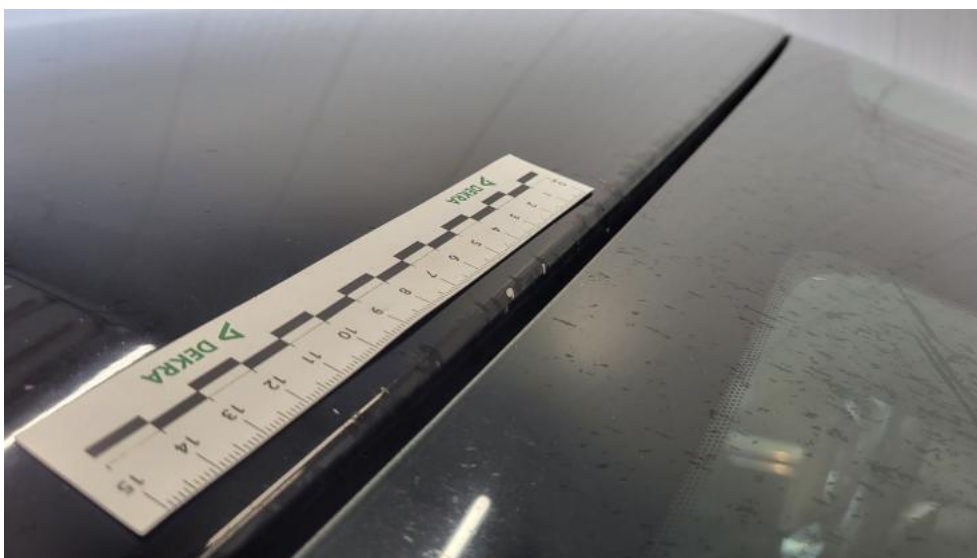
**Photo 48.**

Dach - Rysa/odprysk 1

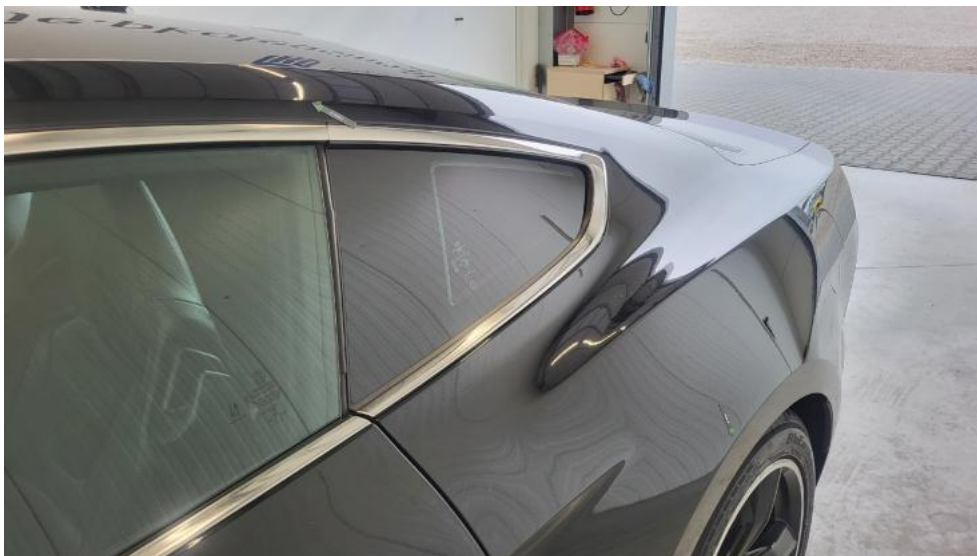
**Photo 49.**

Błotnik tylny L / Ściana boczna L - Wgniecenie/odkształcenie 1

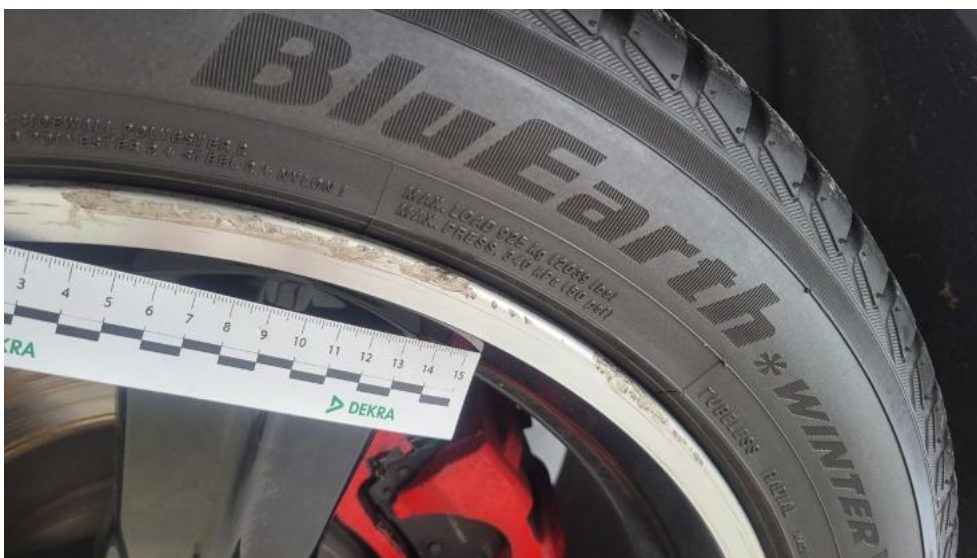
**Photo 50.**

Felga aluminiowa tylna L - Rysa/odprysk 1

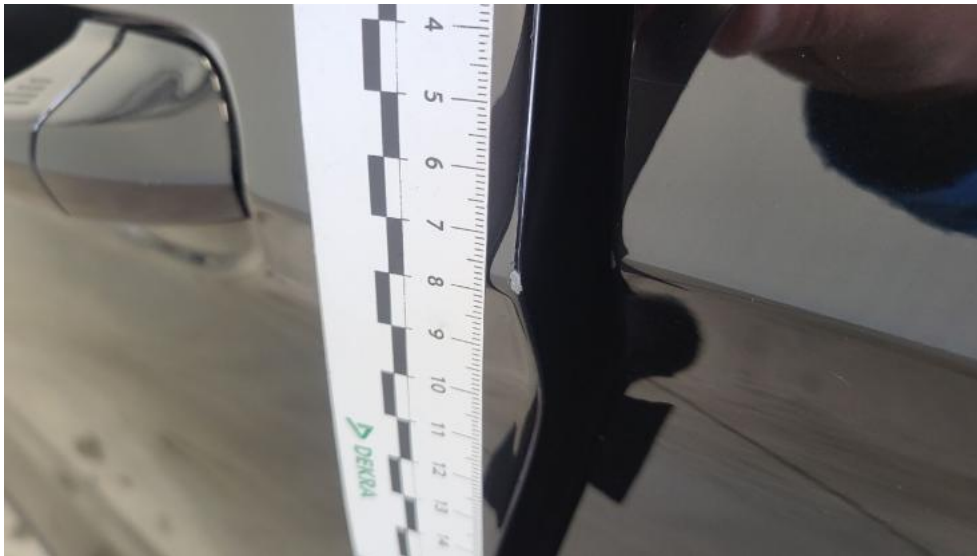
**Photo 51.**

Drzwi przed L - Rysa/odprysk 1

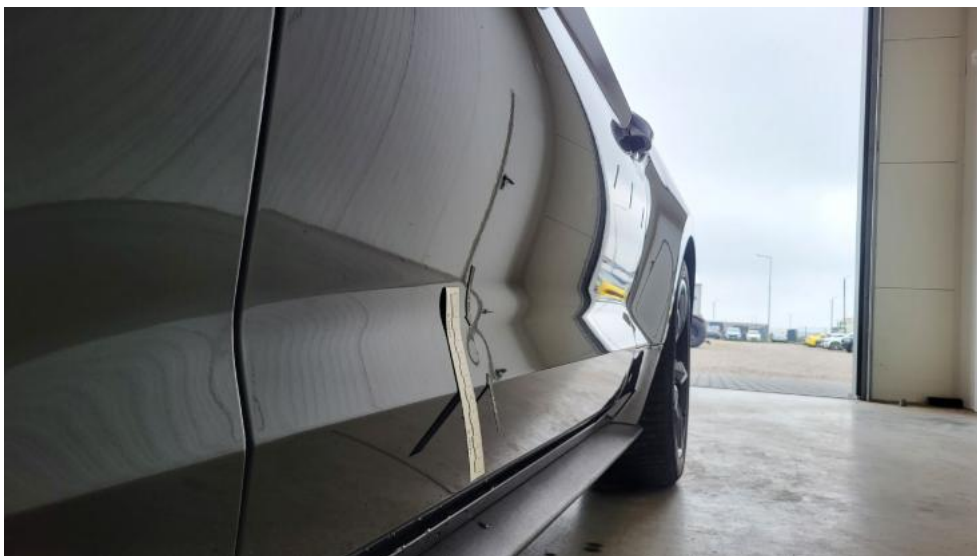
**Photo 52.**

Drzwi przed L - Wgniecenie/odkształcenie 1

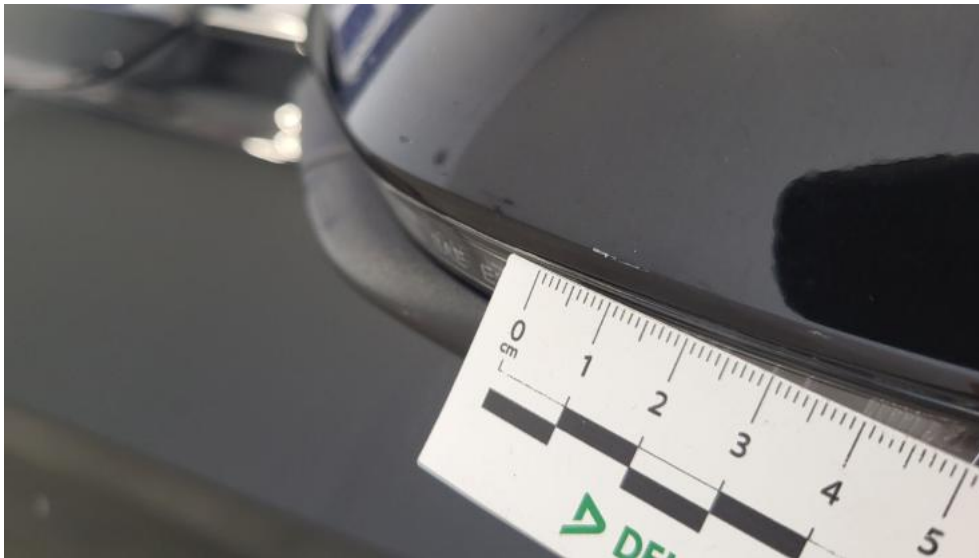
**Photo 53.**

Lusterko zew L - Rysa/odprysk 1

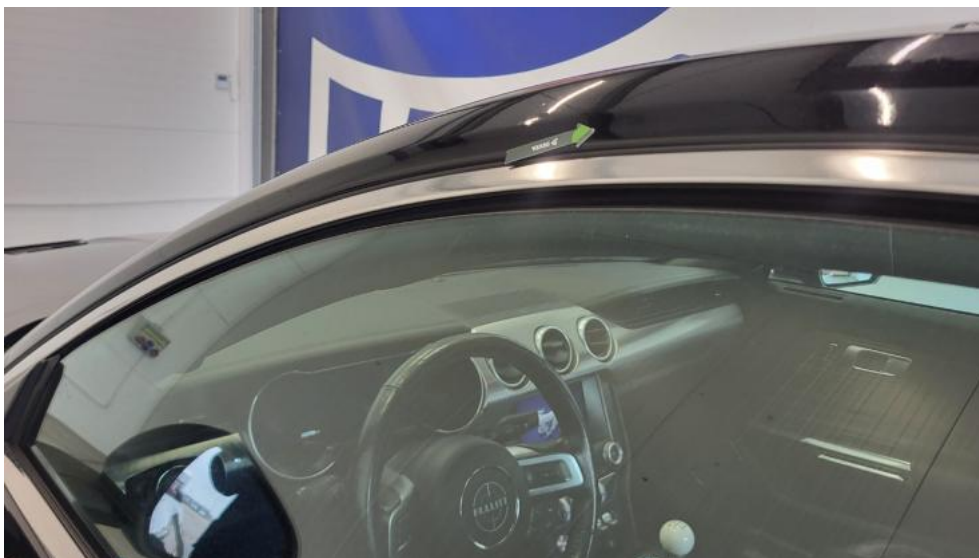
**Photo 54.**

Słupek przedni L - Wgniecenie/odkształcenie 1

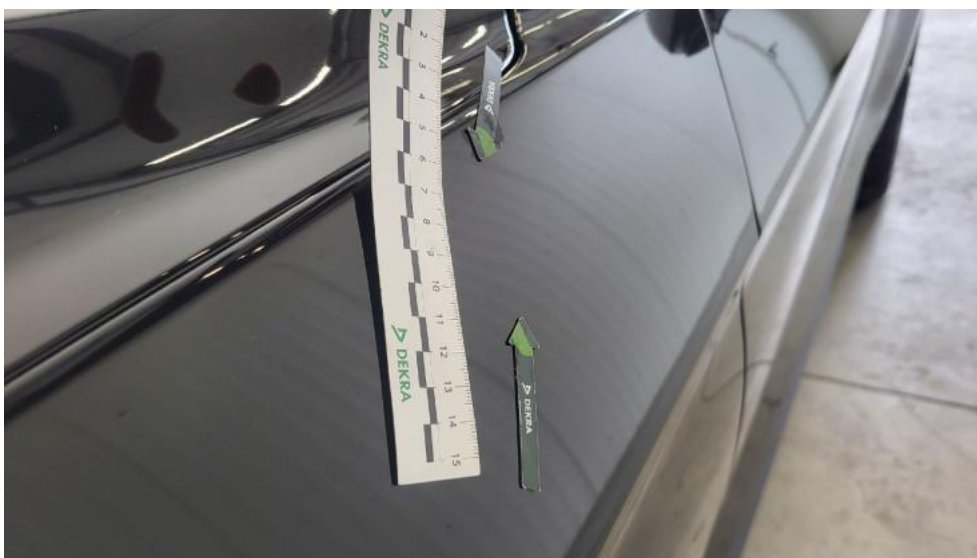
**Photo 56.**

Błotnik przedni L - Wgniecenie/odkształcenie 1

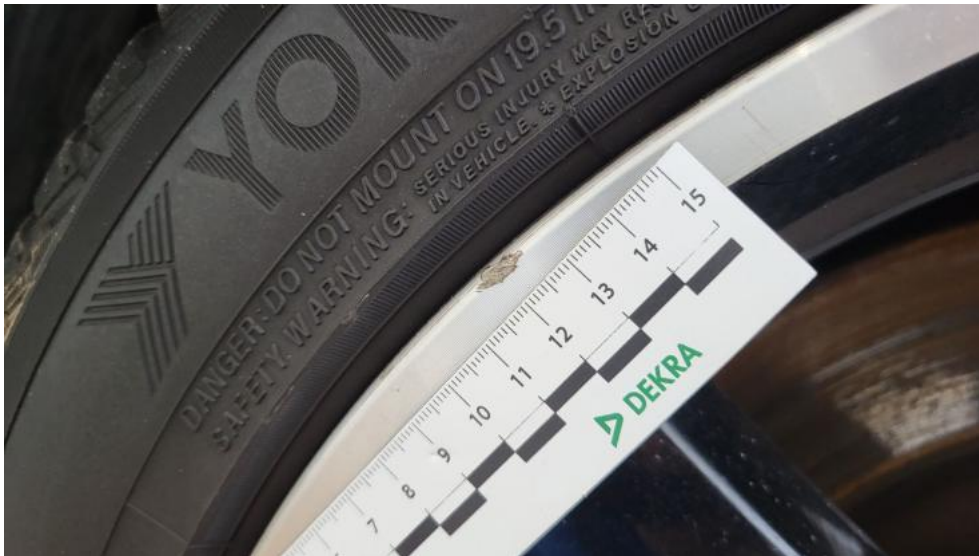
**Photo 57.**

Felga Aluminiowa przednia L - Rysa/odprysk 1

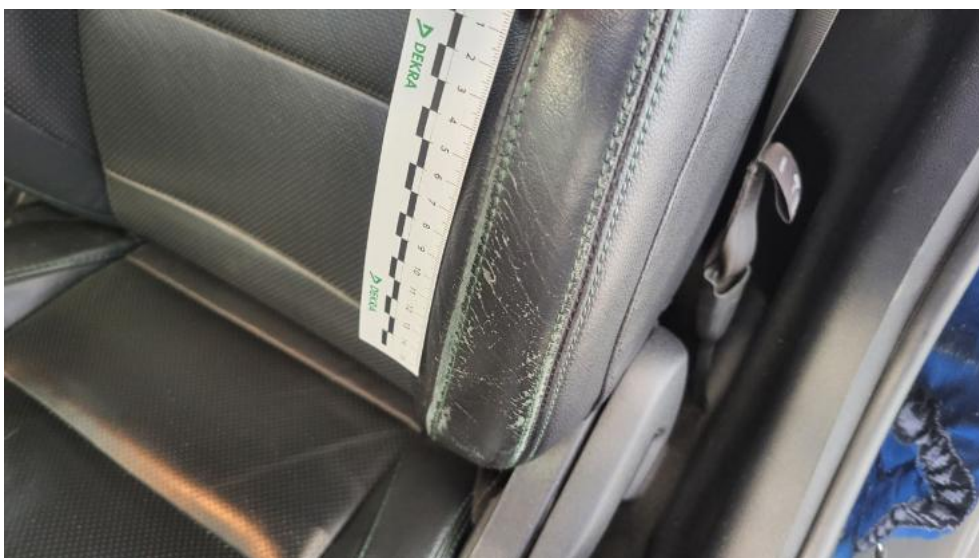
**Photo 58.**

Fotel prz. lew. - Rysa/odprysk 1

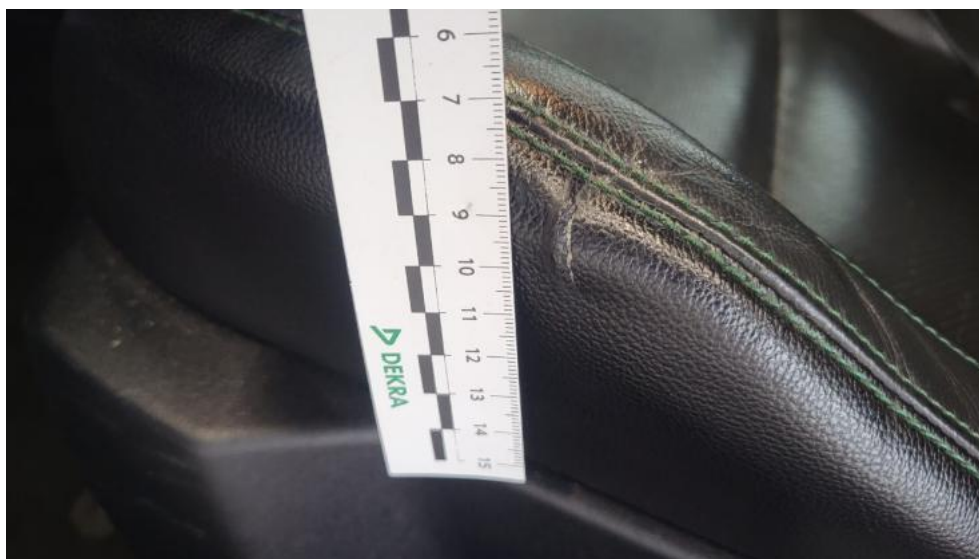
**Photo 59.**

Fotel prz. lew. - Pęknięcie/rozerwanie 1

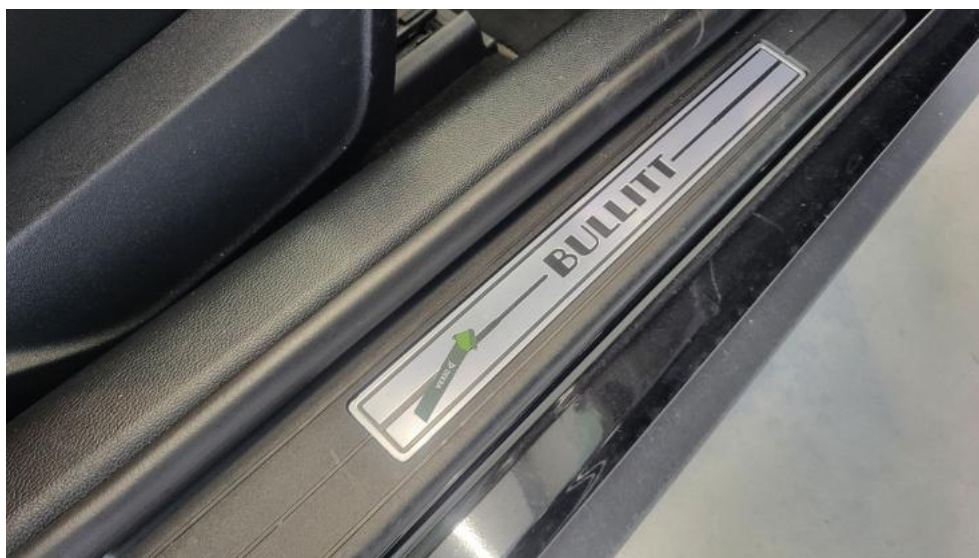
**Photo 60.**

Listwy progowe praw. - Wgniecenie/odkształcenie 1

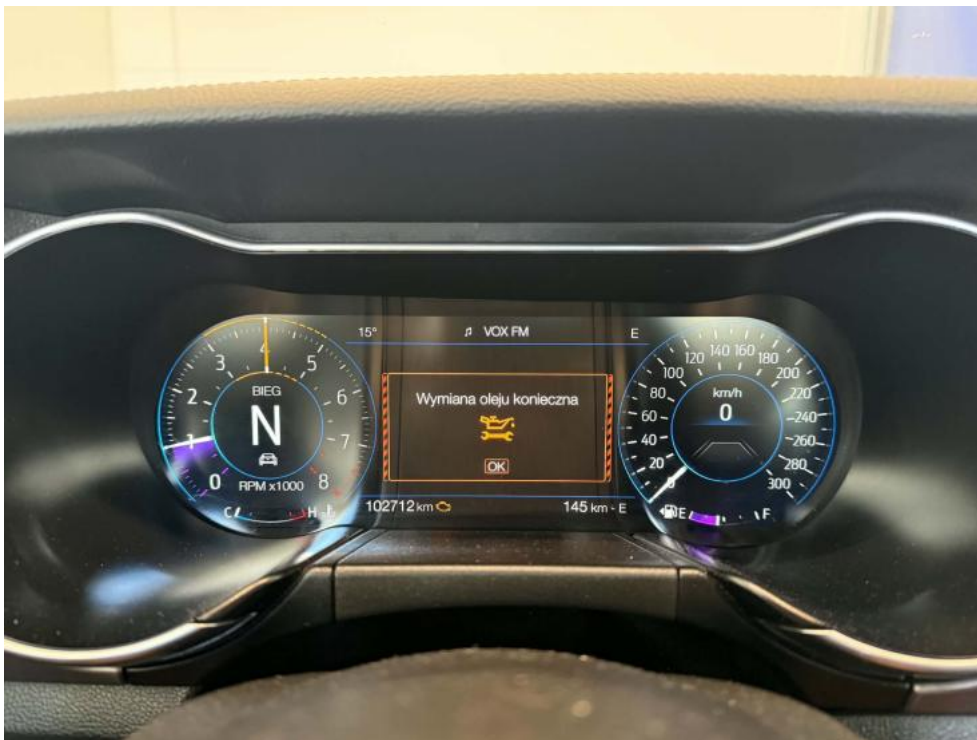
**Photo 61.**

Rysy na samochodzie. Niesprawne przyciski funkcyjne w jednym z kluczyków, grot prawidłowy. Wymiana oleju konieczna. Informacja filtr DPF przekroczony limit, wymagany serwis. Odpryski na szybie czołowej. Długotrwały rozruch, do weryfikacji serwisowej. Poziom oleju poniżej minimum, zalecane weryfikacja serwisowa. Silnik nierówna praca.

Komunikat wymiany oleju

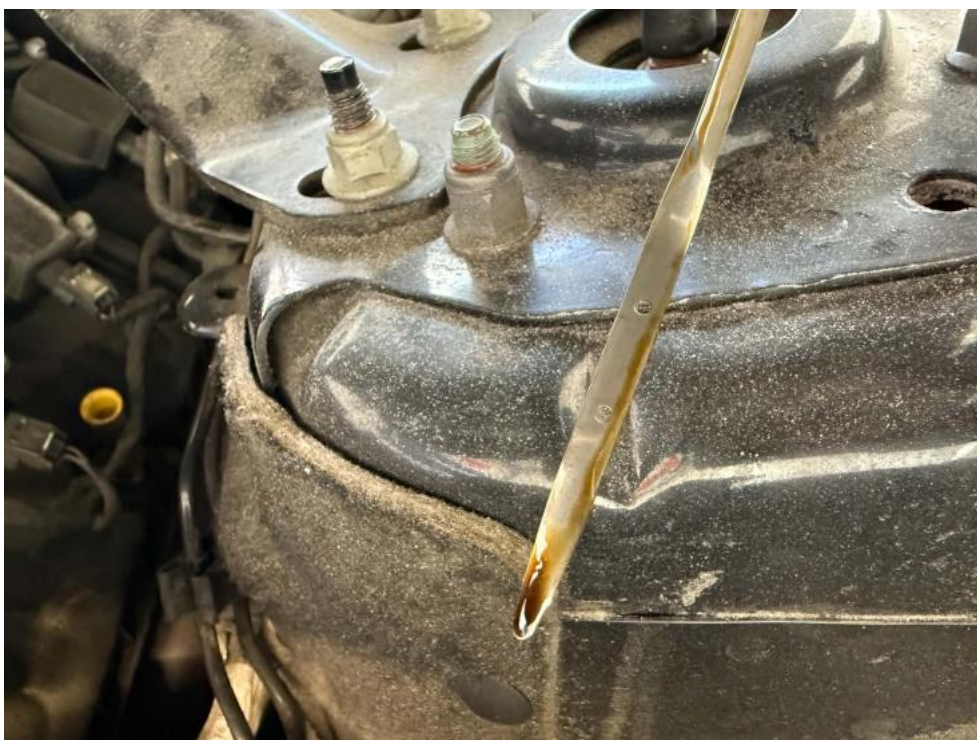
**Photo 62.**

Niski poziom oleju silnikowego.
