DEKRA's commission No. : PKOL(W)/LODZ/30484/21/05/14
commission/ damage No. : PS19/05912
Date of commission: 14-05-2021

Client :
PKO Leasing Finance
PKO Leasing SA
Al. Śmigłego-Rydza 20
93-281 Łódź

Group of objects (Eurotax)	jeeps
EC code (Eurotax)	0131042
Manufacturer	BMW
Model	X4 [G02] 18-
Type / version	X4 xDrive20d M Sport sport-aut
Body type	KOM
Number of doors / seats	5/5
Curb weight [kg]	1770
Gross vehicle weight [kg]	2400
Wheelbase 1/2	2864
Engine type	Automatic ignition
Pollution reduction system	DPF
Engine capacity [ccm]	1995
Engine Power [hp/kW]	190/140
Gearbox	automatic 8- gear
Registration /record No.	DW8FF91
VIN / serial number	WBAVJ91040LD25321
Date of first registration	29-07-2019
Date of next. tech. test	29-07-2022
Year of manufacture	2019
Readout [km]	38 553 (read)
Body color / type of coating	white/plain

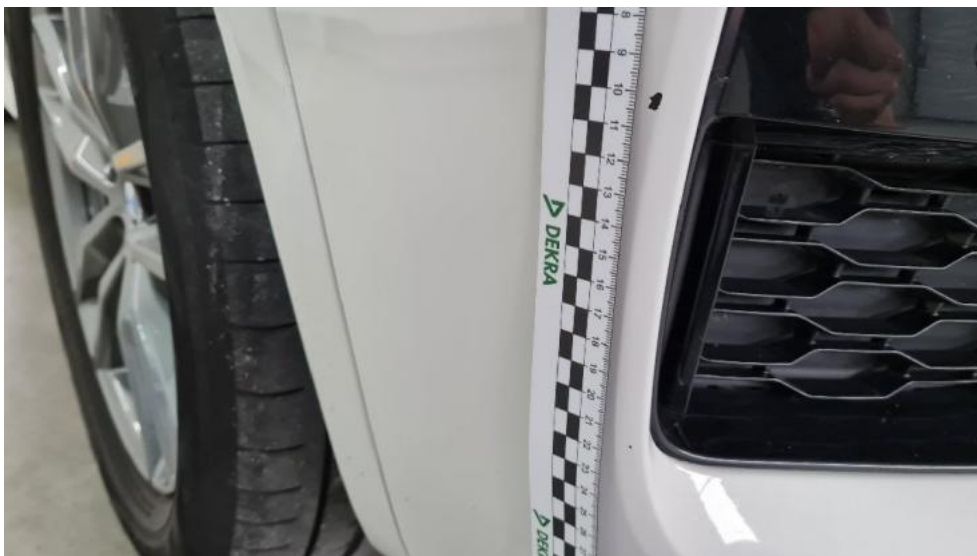
Photo 25.
Zderzak (Rysa/Odprysk)

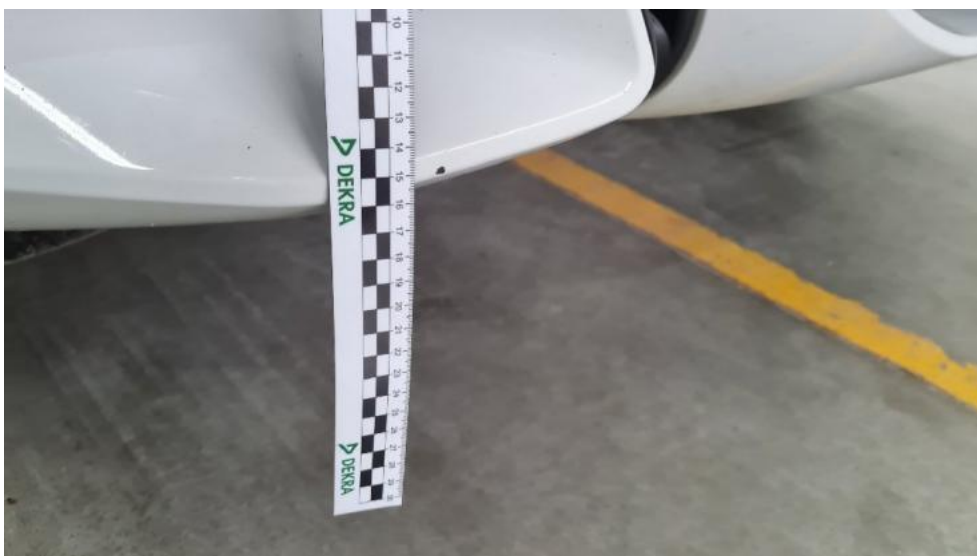
Photo 26.
Zderzak (Rysa/Odprysk 1)

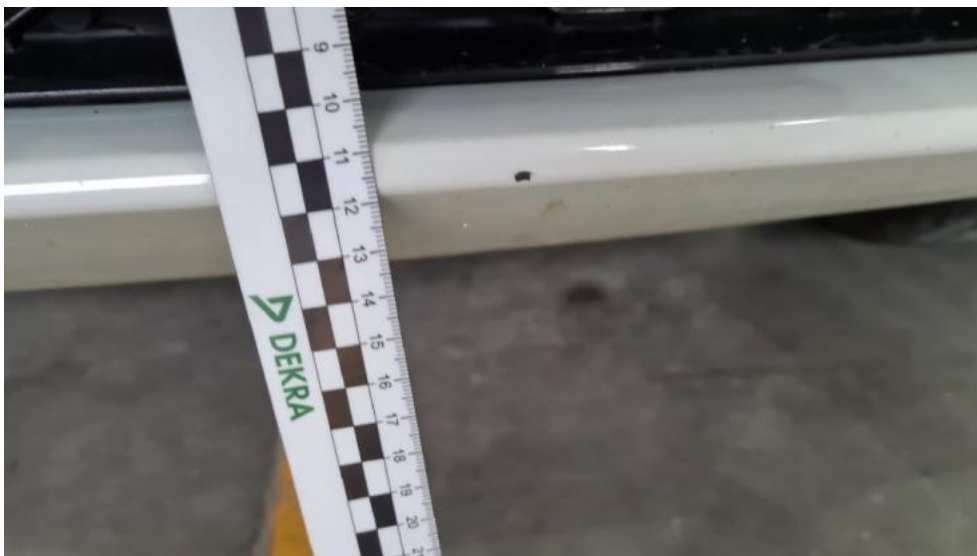
Photo 27.
Zderzak (Rysa/Odprysk 2)

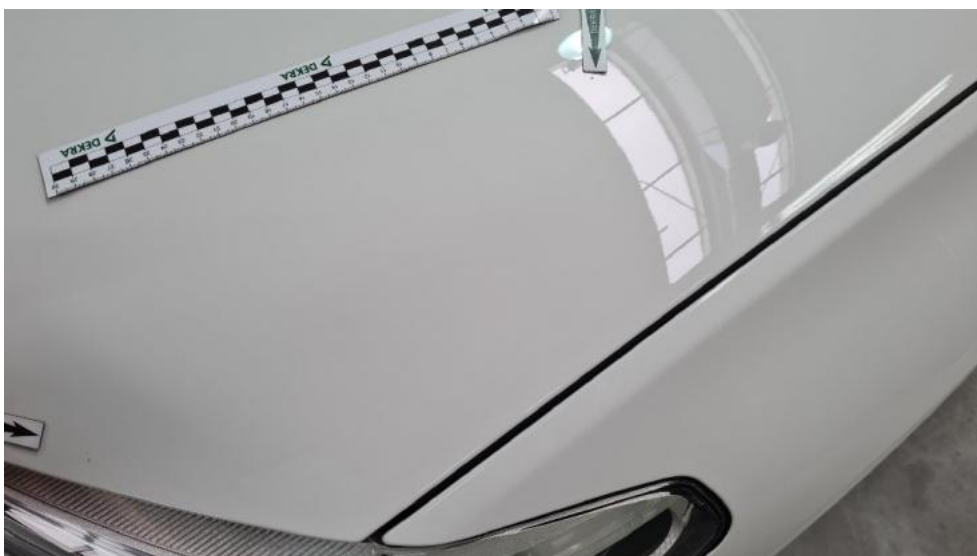
Photo 28.
Pokrywa komory silnika (Rysa/Odprysk)

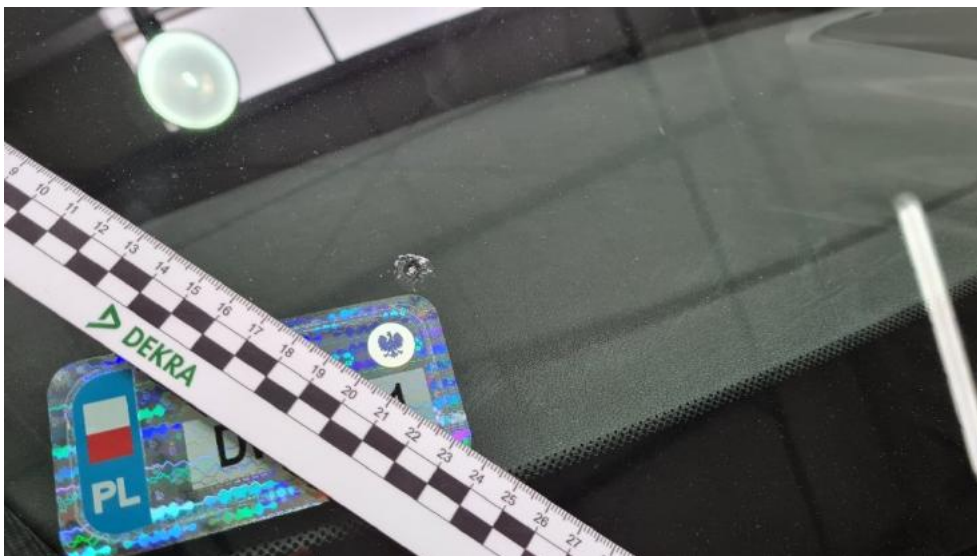
Photo 29.
Szyba czołowa (Rysa/Odprysk)

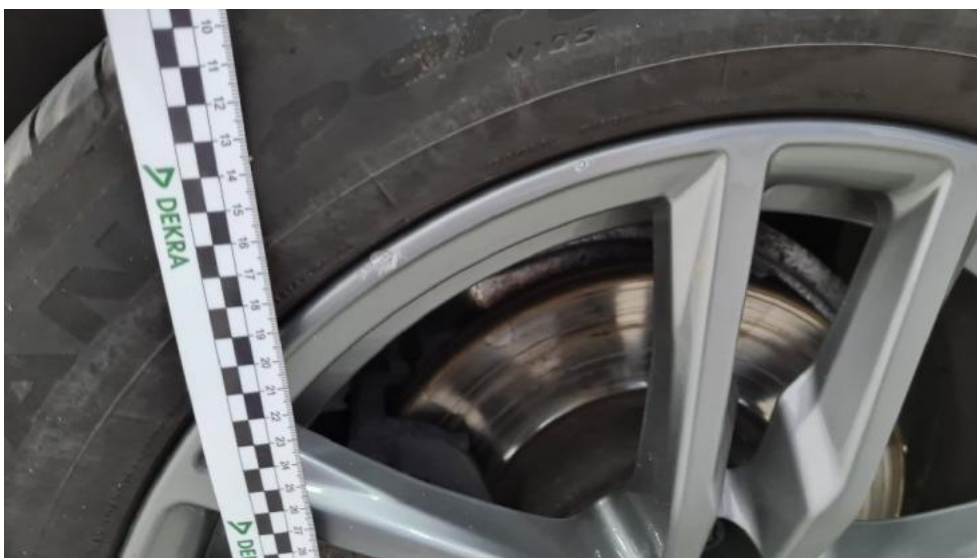
Photo 30.
Felga przednia prawa (Rysa/Odprysk)

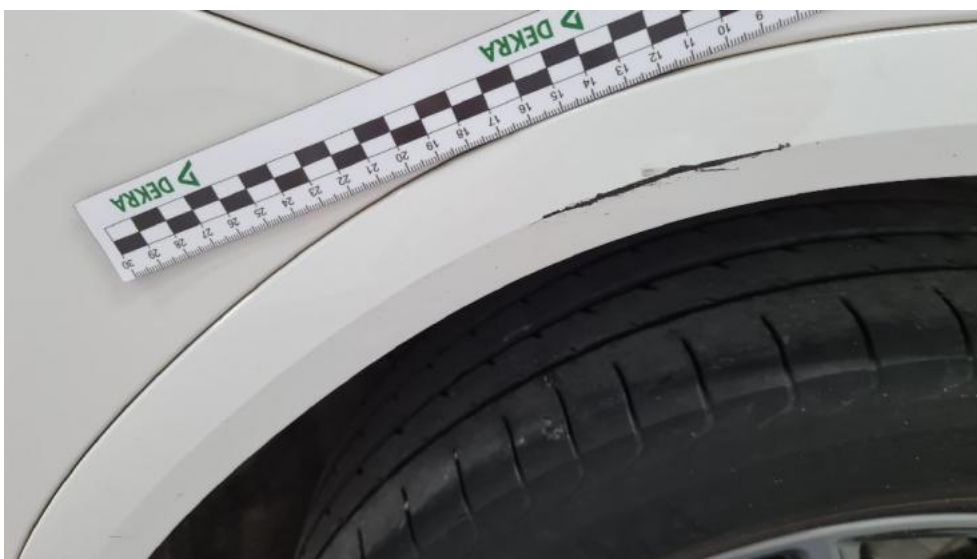
Photo 31.
Listwa ściany boczna prawa (Rysa/Odprysk)

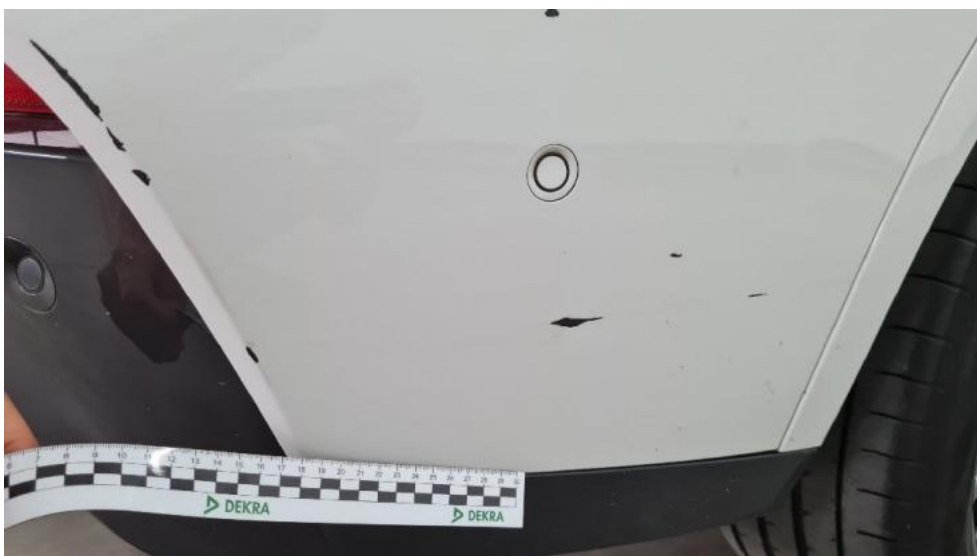
Photo 32.
Zderzak tylny (Rysa/Odprysk)

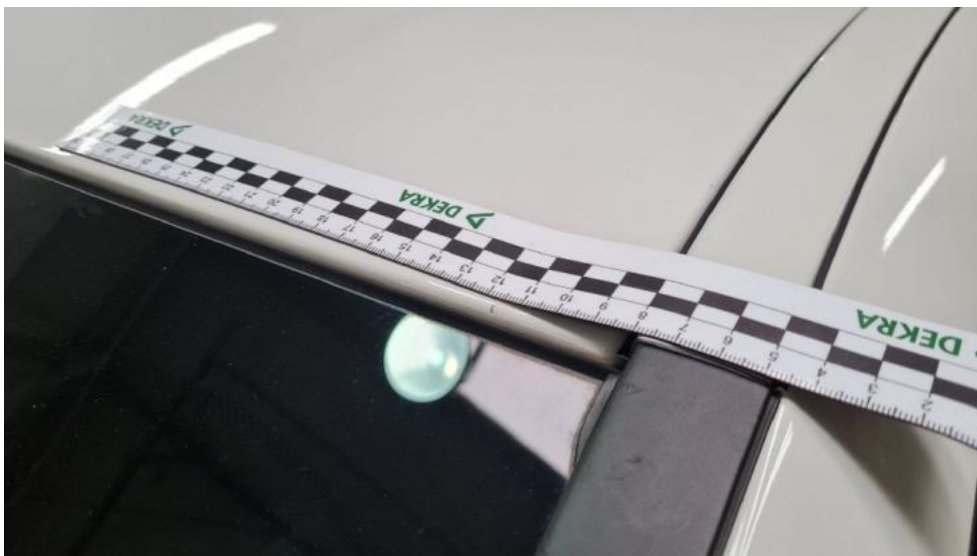
Photo 33.
Dach (Rysa/Odprysk)

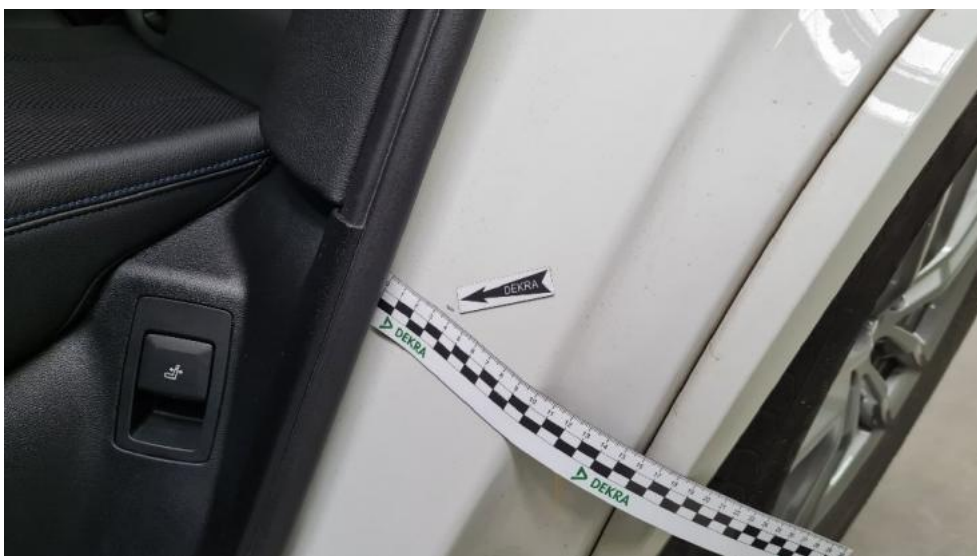
Photo 34.
Błotnik tylny lewy/ściana boczna lewa (Rysa/Odprysk)

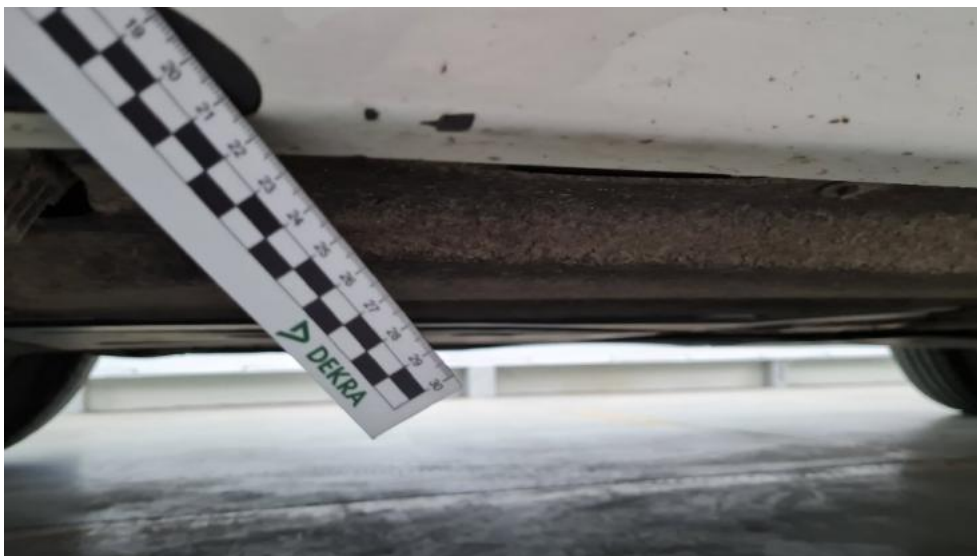
Photo 35.
Próg lewy (Rysa/Odprysk)

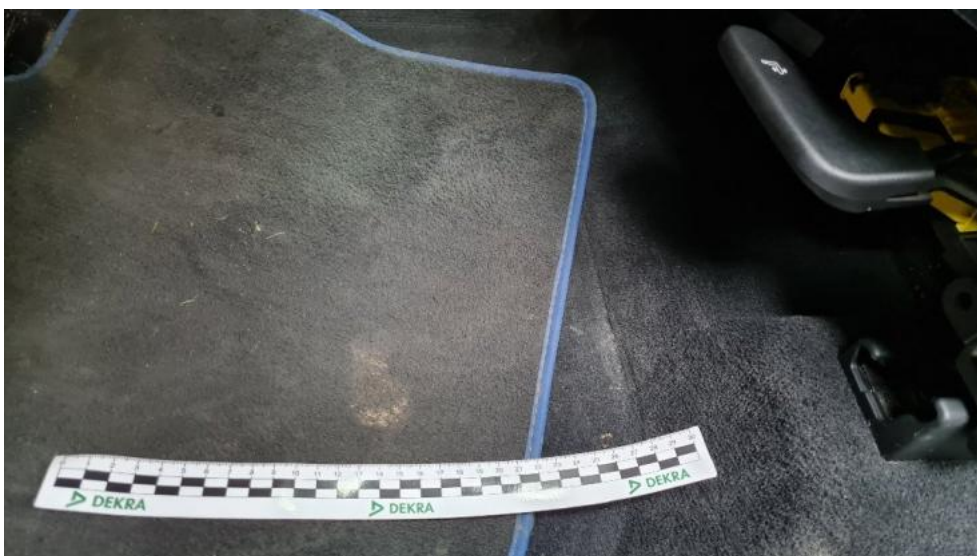
Photo 36.
Wykładzina podłogi (zabrudzenia)
