DEKRA's commission No. : PKOL(W)/LODZ/01743/21/01/12  
commission/ damage No. : 16/023769  
Date of commission: 12-01-2021

**DEKRA Poland - Headquarters**  
02-673 Warszawa, ul. Konstruktorska 12A

| Manufacturer | VOLVO |
| Type / version | S60 D2 Drive-E Momentum aut |

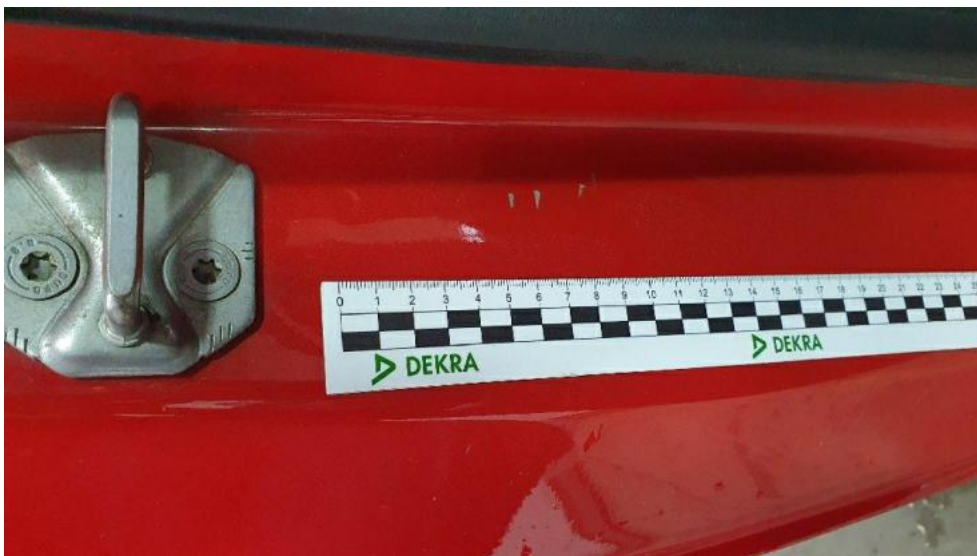
**Photo 23.**

Błotnik tylny prawy/ściana boczna prawa (Rysa/Odprysk)

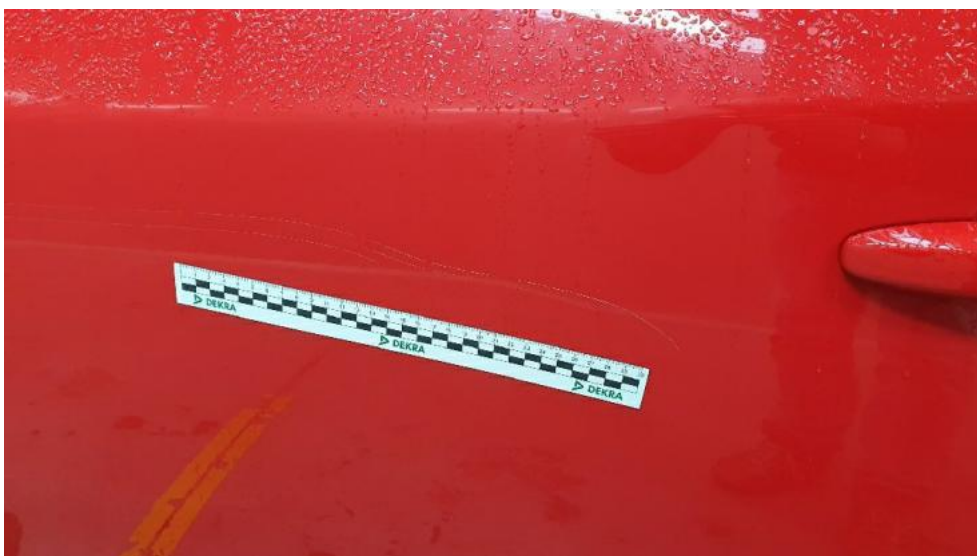
**Photo 24.**

Drzwi tylne lewe (Rysa/Odprysk)

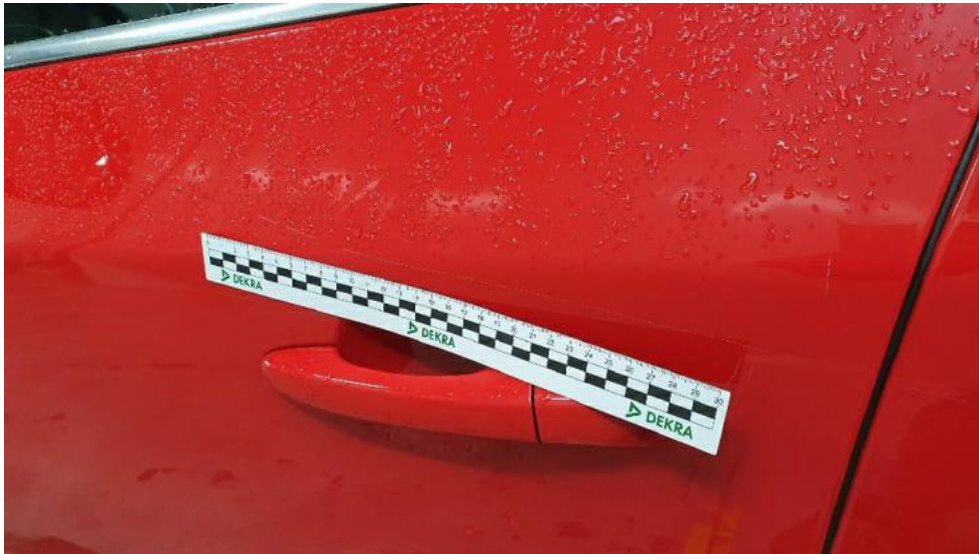
**Photo 25.**

Drzwi przednie lewe (Rysa/Odprysk)

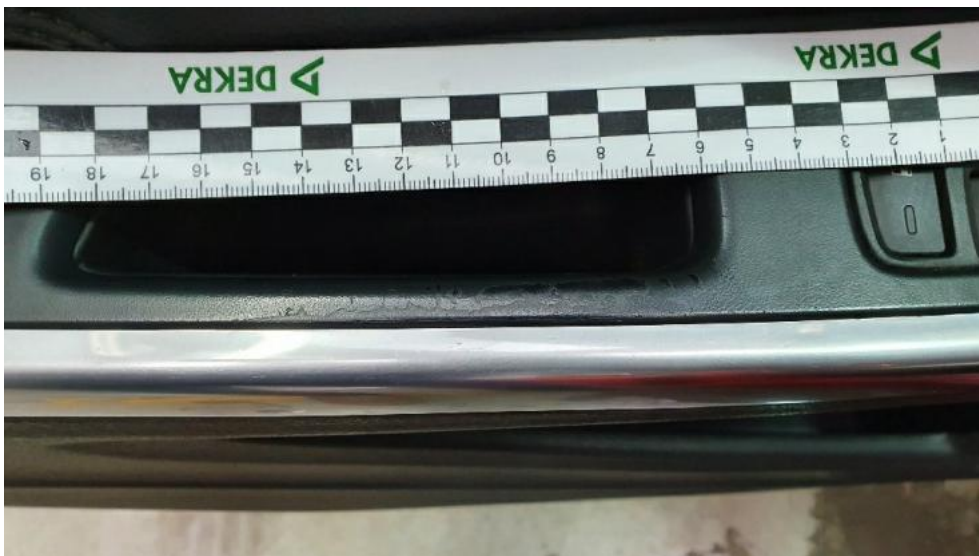
**Photo 26.**

Tapicerka drzwi przednich lewych (Przetarcie)

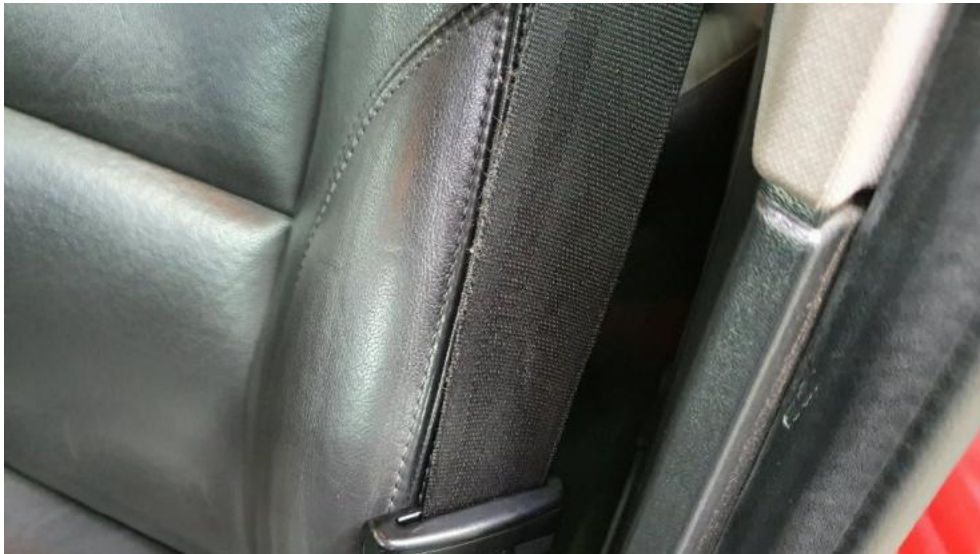
**Photo 27.**

Pas bezpieczeństwa przedni lewy (Przetarcie)

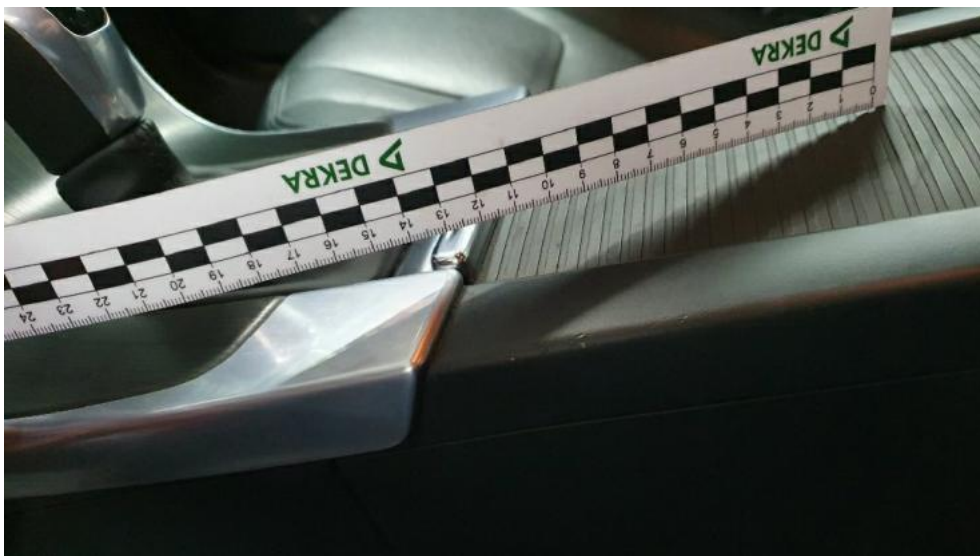
**Photo 28.**

Konsola środkowa (Rysa/Odprysk)

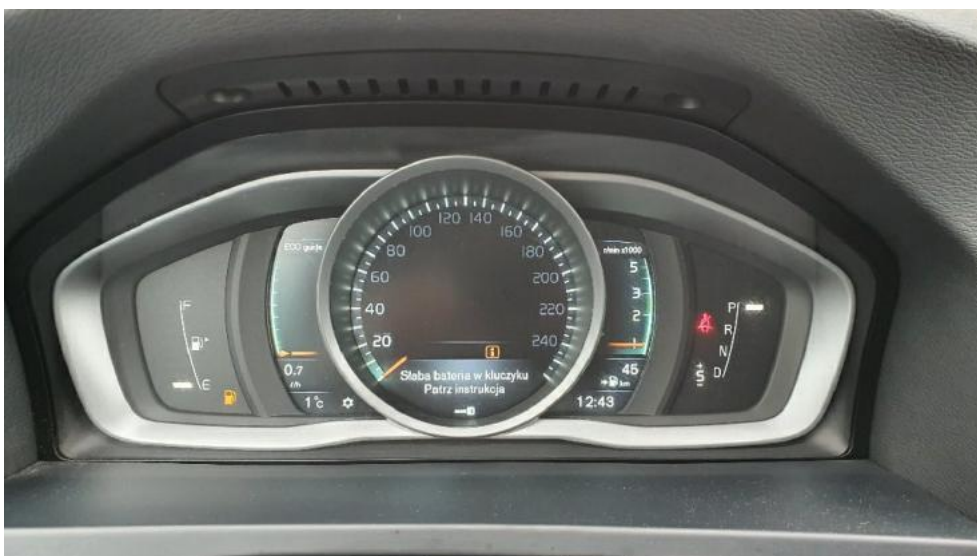
Słaba bateria w kluczyku.

**Photo 30.**  
Bateria kluczyka do wymiany
