DEKRA's commission No. : PKOL(W)/LODZ/19544/25/03/18
commission/ damage No. : 19/023079
Date of commission: 18-03-2025

Vehicle data

Measurement of thickness of the vehicle lacquer coating

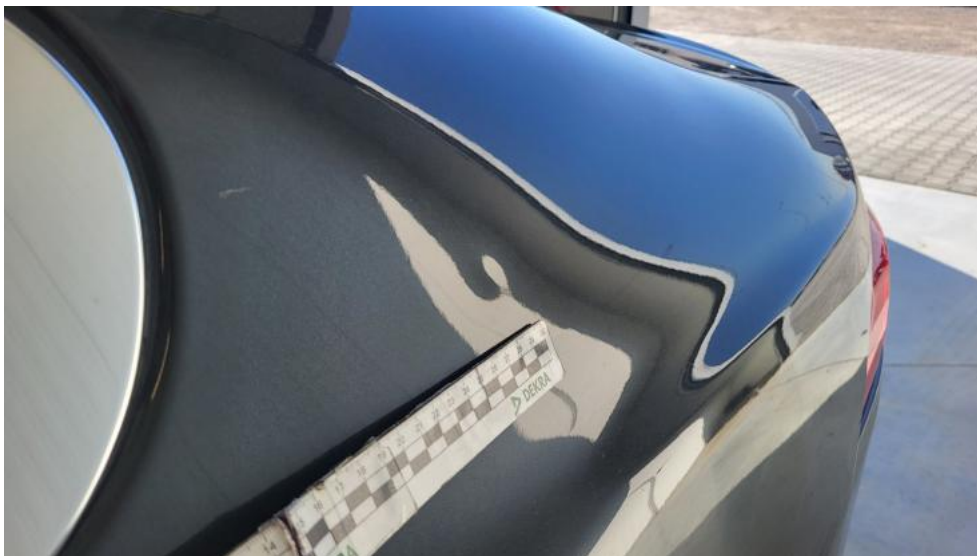
Photo 55.
Błotnik tylny L / Ściana boczna L - Wgniecenie/odkształcenie 2

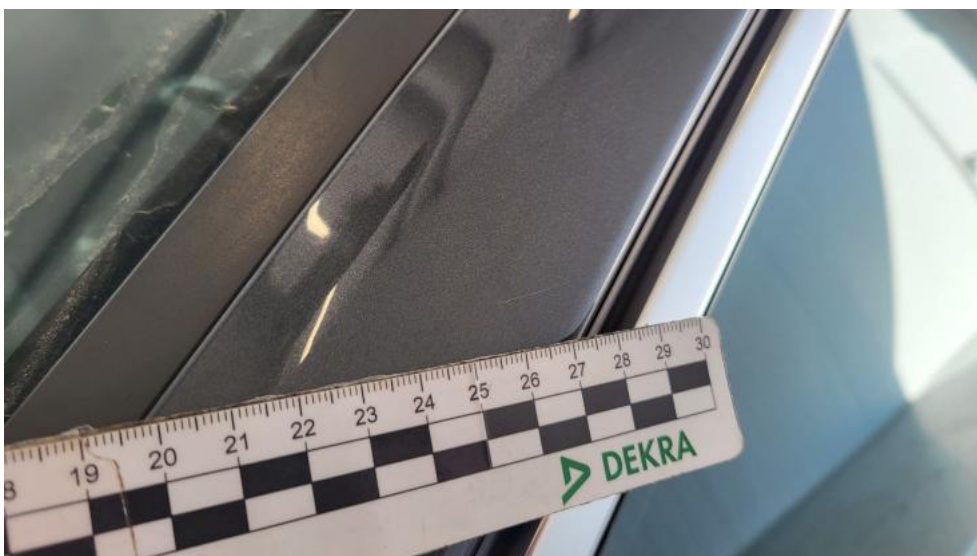
Photo 64.
Słupek przedni L - Rysa/odprysk 1
