DEKRA's commission No. : PKOL(W)/LODZ/11137/26/02/11  
commission/ damage No. : 20/053881  
Date of commission: 11-02-2026

**DEKRA Poland - Headquarters**  
02-673 Warszawa, ul. Konstruktorska 12A

Group of objects (Eurotax)	cars
EC code (Eurotax)	0145353
Manufacturer	BMW
Model	Seria 5 [G30/F90] 20-23
Type / version	520d xDrive mHEV M Sport sport-aut
Body type	sedan
Number of doors / seats	4/5
Curb weight [kg]	1735
Gross vehicle weight [kg]	2405
Wheelbase 1/2	2975
Engine type	Automatic ignition
Pollution reduction system	KSC
Engine capacity [ccm]	1995
Engine Power [hp/kW]	190/140
Gearbox	automatic
Registration /record No.	PO9SN61
VIN / serial number	WBA51BL000WX07510
Date of first registration	30-12-2020
Date of next. tech. test	23-12-2026
Year of manufacture	2020 (year has been verified with the manufacturer's base)
Readout [km]	272 823 (read)
Body color / type of coating	black/double-layered, metallized

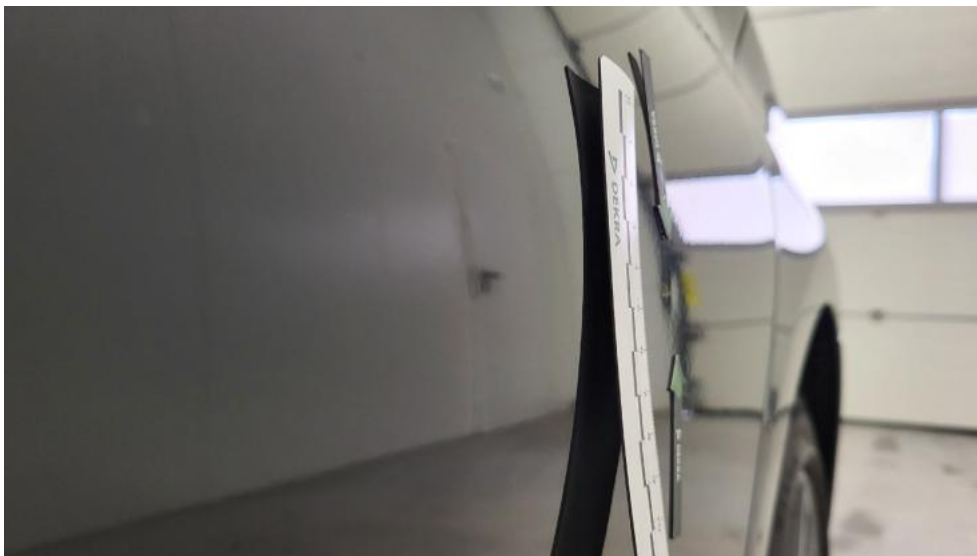
**Photo 67.**  
Drzwi tylne L - Wgniecenie/odkształcenie 1
