DEKRA's commission No. : PKOL(W)/LODZ/07113/26/01/28
commission/ damage No. : 25/036819
Date of commission: 28-01-2026

Group of objects (Eurotax)	jeeps
EC code (Eurotax)	0148414
Manufacturer	AUDI
Model	Q7 19-24
Type / version	Q7 50 TDI mHEV Quattro Tiptr.
Body type	KOM
Number of doors / seats	5/5
Curb weight [kg]	2296
Gross vehicle weight [kg]	2850
Wheelbase 1/2	2995
Engine type	Automatic ignition
Pollution reduction system	KSC
Engine capacity [ccm]	2967
Engine Power [hp/kW]	286/210
Gearbox	automatic
Registration /record No.	FZ7666V
VIN / serial number	WAUZZZ4M1LD006964
Date of first registration	31-12-2020
Date of next. tech. test	29-01-2027
Year of manufacture	2019
Readout [km]	149 140 (read)
Body color / type of coating	granatowy/double-layered, metallized

Measurement of thickness of the vehicle lacquer coating

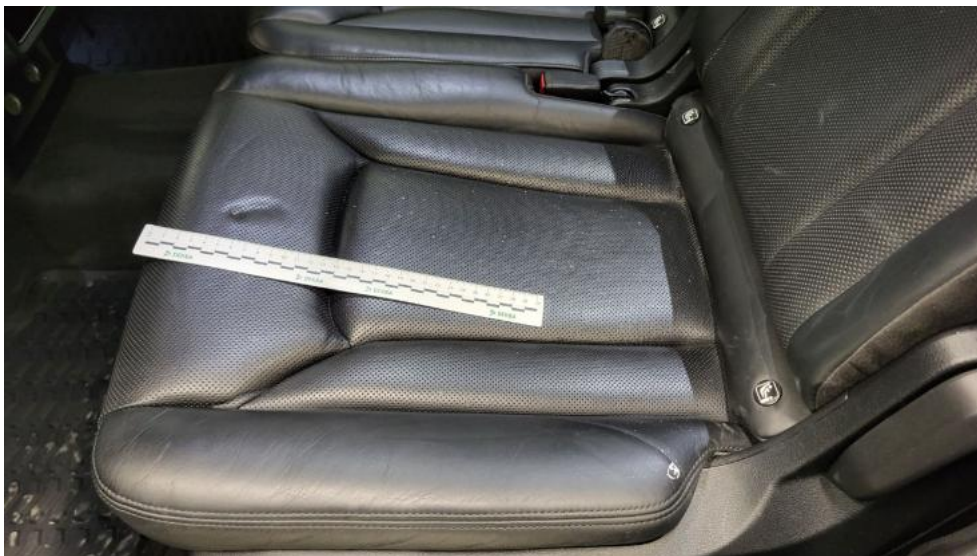
Photo 89.
Kanapa tyl. - Wgniecenie/odkształcenie 1

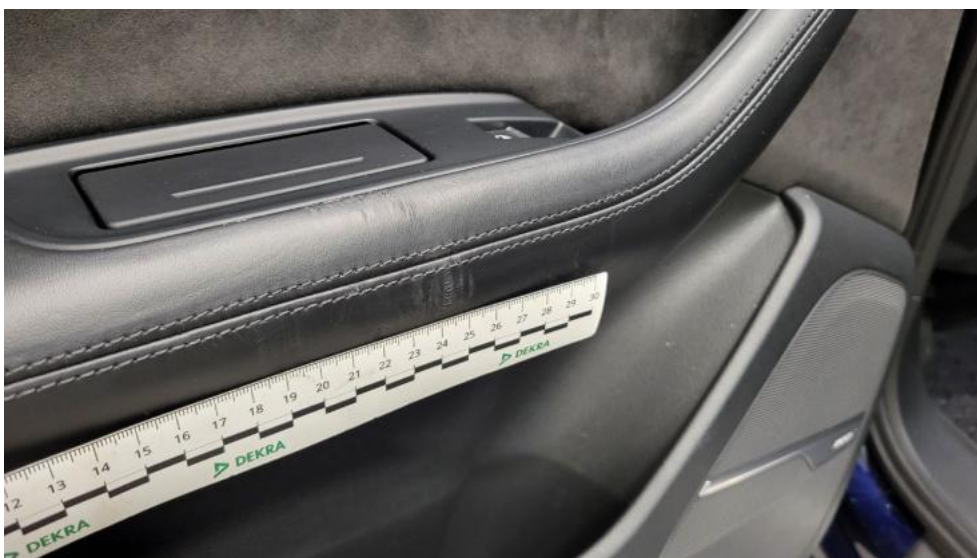
Photo 90.
Tapicerka drzwi tylnych L - Rysa/odprysk 1
