DEKRA's commission No. : PKOL(W)/LODZ/11082/25/02/13
 commission/ damage No. : 24/006087
 Date of commission: 13-02-2025

Vehicle data

Description of the technical condition

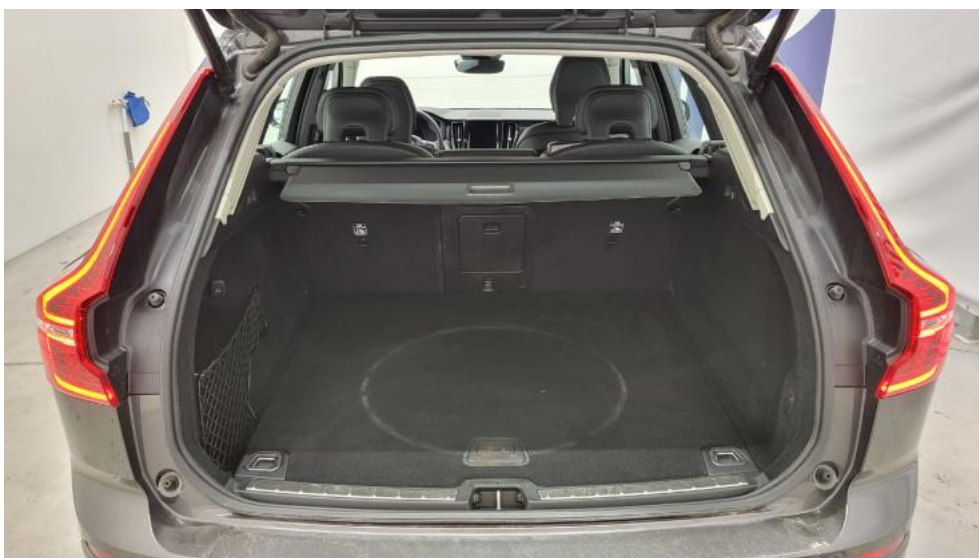
Photo 18.

Rysy na samochodzie. Koło dojazdowe zamontowane na samochodzie. Uszkodzone koło prawy przód w bagażniku. Aktywna kontrolka ciśnienia w kołach. Przekroczenie terminu przeglądu okresowego.
