DEKRA's commission No. : PKOL(W)/LODZ/100054/24/12/30  
commission/ damage No. : 50598  
Date of commission: 30-12-2024

**Vehicle data**

Group of objects (Eurotax)	jeeps
EC code (Eurotax)	0135296
Manufacturer	LEXUS
Model	UX 18-24
Type / version	UX 250h GPF Prestige AWD
Body type	KOM
Number of doors / seats	5/5
Curb weight [kg]	1629
Gross vehicle weight [kg]	2110
Wheelbase 1/2	2640
Engine type	spark ignition
Pollution reduction system	GPF
Engine marking	hybrydowy
Engine capacity [ccm]	1987
Engine Power [hp/kW]	152/112
Gearbox	automatic
Registration /record No.	WR369AY
VIN / serial number	JTHU95BHX02008729
Date of first registration	24-06-2019
Date of next. tech. test	28-06-2025
Year of manufacture	2019 (year has been verified with the manufacturer's base)
Readout [km]	107 000 (read)
Body color / type of coating	green/double-layered, metallized

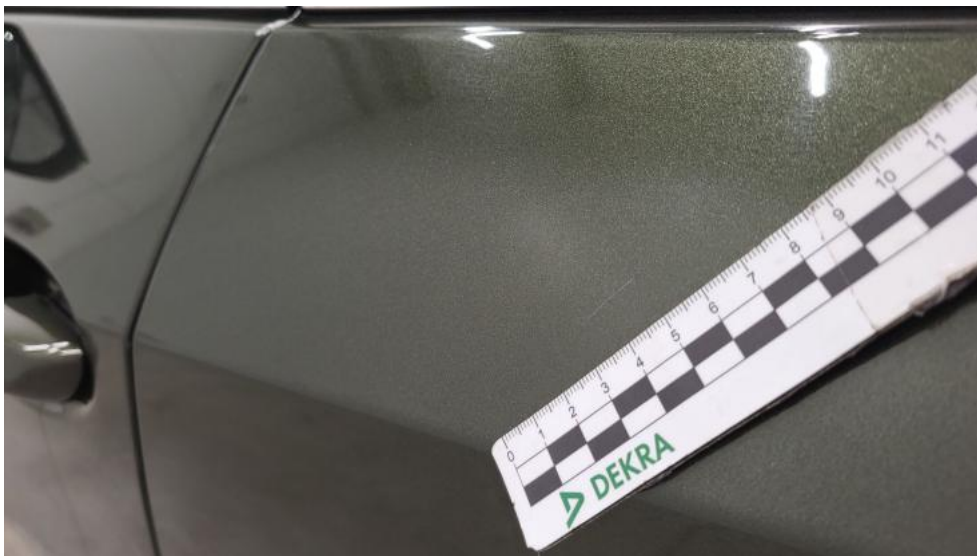
**Photo 71.**  
Drzwi tylne L - Rysa/odprysk 1
