DEKRA's commission No. : PKOL(W)/LODZ/33586/26/04/16
 commission/ damage No. : PS25/02325
 Date of commission: 16-04-2026

Vehicle data

Description of the technical condition

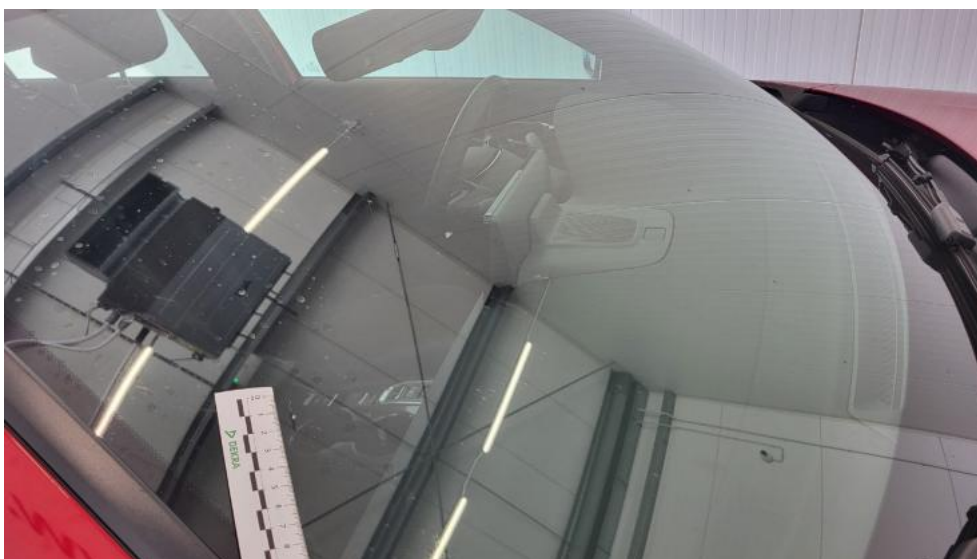
Photo 37.
Szyba czołowa - zdjęcie poglądowe 1

Item name	Description of item	Damage type	Location / Size	Comments
Glass	front	broken		
Bumper	front	loss/chipping) of the lacquer coating
