DEKRA's commission No. : PKOL(W)/LODZ/15587/26/02/19
 commission/ damage No. : 24/019994
 Date of commission: 19-02-2026

Group of objects (Eurotax)	cars
EC code (Eurotax)	0134587
Manufacturer	VOLVO
Model	S90 16-20
Type / version	S90 D5 SCR AWD Inscription aut
Body type	sedan
Number of doors / seats	4/5
Curb weight [kg]	1847
Gross vehicle weight [kg]	2360
Wheelbase 1/2	2941
Engine type	Automatic ignition
Pollution reduction system	KSC
Emission standard	EURO 6
Engine capacity [ccm]	1969
Engine Power [hp/kW]	235/173
Gearbox	automatic 8- gear
Registration /record No.	WP7005S
VIN / serial number	LVYPS68UCKP058434
Date of first registration	26-09-2018
Date of next. tech. test	22-10-2025
Year of manufacture	2018 (year has been verified with the manufacturer's base)
Readout [km]	224 797 (read)
Body color / type of coating	blue/2-warstwowy metalik

Date: 13-03-2026

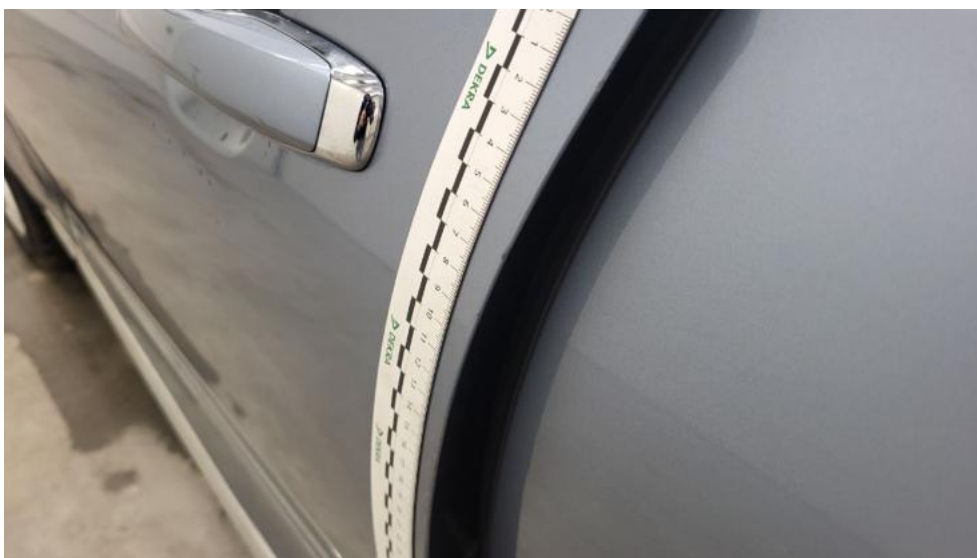
Photo 74.
Drzwi przed L - Rysa/odprysk 1
