DEKRA's commission No. : PKOL(W)/LODZ/85578/26/09/11  
commission/ damage No. : 25/003741  
Date of commission: 11-09-2026

| Model | Mustang Fastback 18-24 |
| Type / version | Mustang 5.0 V8 Mach 1 aut |
| Registration /record No. | W2DZIK2 |

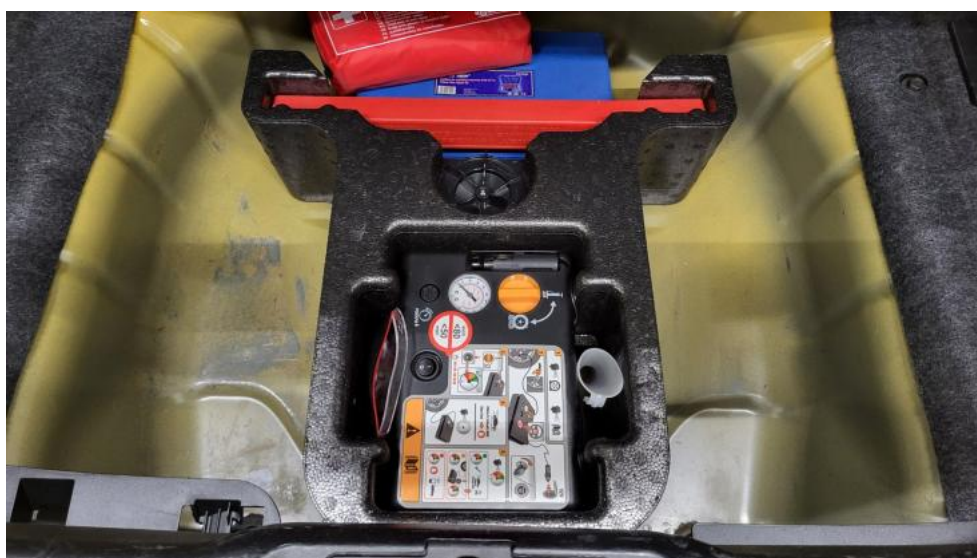
**Photo 34.**  
Zestaw naprawczy koła

Rysy na samochodzie. Aktywna kontrolka silnika. Niesprawne przyciski funkcyjne w jednym z kluczyków, grot prawidłowy. Brak płynu zestawu naprawczego. Informacja bateria kluczyka rozładowana. Odpryski na szybie czołowej.
