DEKRA's commission No. : PKOL(W)/LODZ/82237/24/10/23  
 commission/ damage No. : B/O/WR/2018/08/0014  
 Date of commission: 23-10-2024

**Vehicle data**

Group of objects (Eurotax)	jeeps
EC code (Eurotax)	0103316
Manufacturer	BMW
Model	X5 [F15/F85] 13-18
Type / version	X5 xDrive40d
Body type	KOM
Number of doors / seats	5/5
Curb weight [kg]	2110
Gross vehicle weight [kg]	2865
Wheelbase 1/2	2933
Engine type	Automatic ignition
Pollution reduction system	DPF
Engine capacity [ccm]	2993
Engine Power [hp/kW]	313/230
Gearbox	automatic 8- gear
Registration /record No.	DSWJH87
VIN / serial number	WBAKS610200N68039
Date of first registration	17-03-2017
Date of next. tech. test	15-03-2025
Year of manufacture	2017 (year has been verified with the manufacturer's base)
Readout [km]	220 608 (read)
Body color / type of coating	black/double-layered, metallized

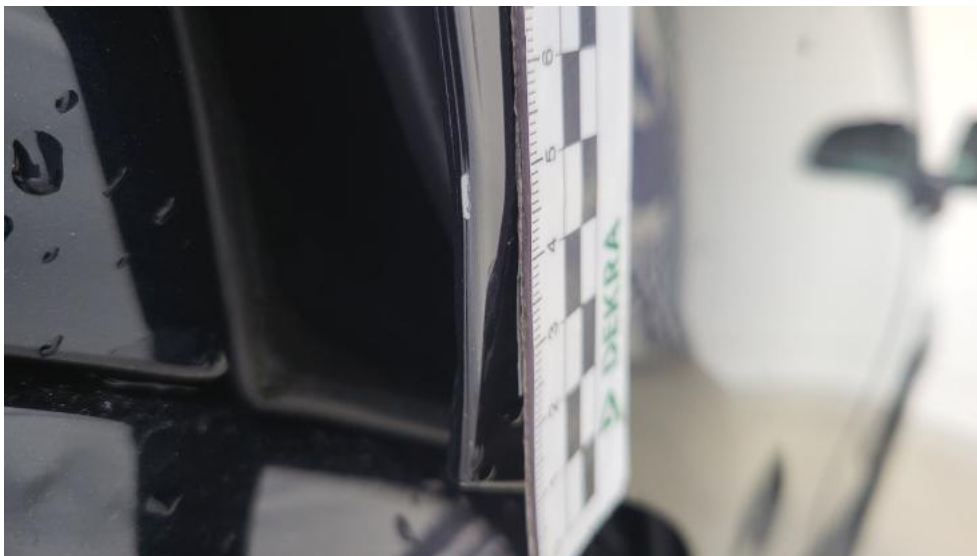
**Photo 55.**  
Drzwi tylne P - Rysa/odprysk 2

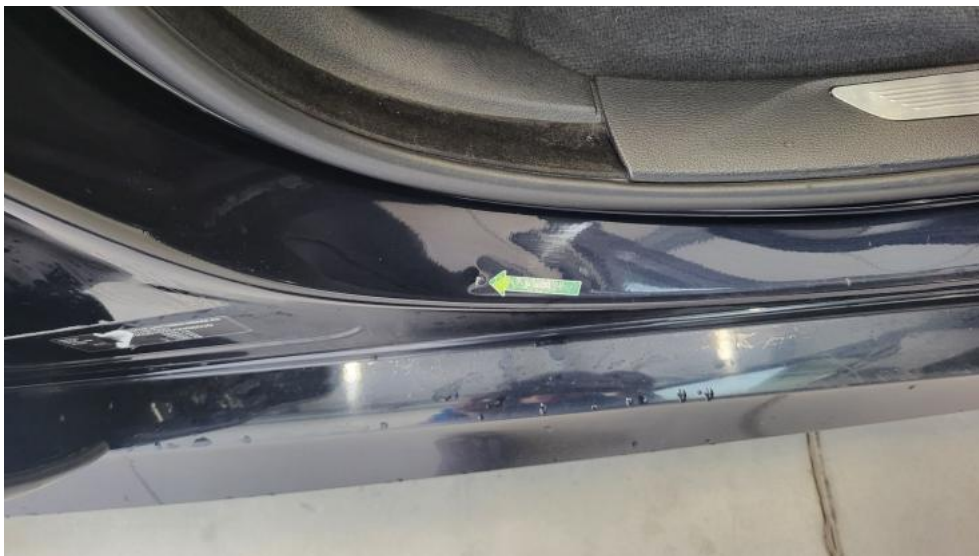
**Photo 59.**  
Próg P - Wgniecenie/odkształcenie 1
