DEKRA's commission No. : PKOL(W)/LODZ/19291/25/03/17  
commission/ damage No. : FUTURA  
Date of commission: 17-03-2025

PKO Leasing SA  
Świętokrzyska 36  
00-116 Warszawa

**Vehicle data**

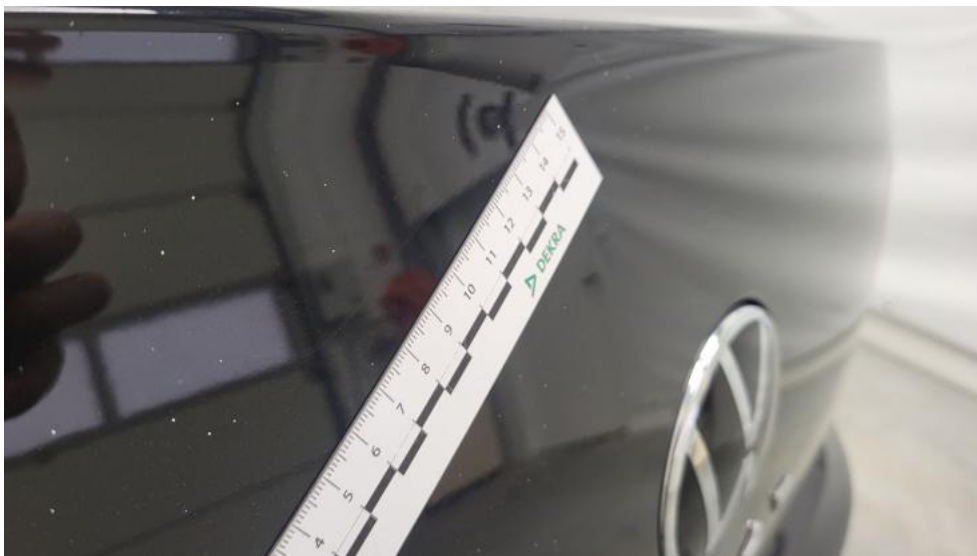
**Photo 57.**  
Pokrywy bagażnika - Rysa/odprysk 1
