DEKRA's commission No. : PKOL(W)/LODZ/17211/25/03/07
 commission/ damage No. : 23/033957
 Date of commission: 07-03-2025

Vehicle data

Group of objects (Eurotax)	jeeps
EC code (Eurotax)	0109187
Manufacturer	VOLVO
Model	XC90 14-19
Type / version	XC90 T8 AWD Plug-In Hybrid Inscription 7os
Body type	KOM
Number of doors / seats	5/7
Curb weight [kg]	2244
Gross vehicle weight [kg]	3010
Wheelbase 1/2	2984
Engine type	spark ignition
Pollution reduction system	three-way catalytic converter
Engine capacity [ccm]	1969
Engine Power [hp/kW]	320/236
Gearbox	automatic
Registration /record No.	RZ288EY
VIN / serial number	YV1LFBABDH1131575
Date of first registration	05-10-2016
Date of next. tech. test	28-03-2024
Year of manufacture	2016 (year has been verified with the manufacturer's base)
Readout [km]	255 828 (read)
Body color / type of coating	white/double-layered, metallized

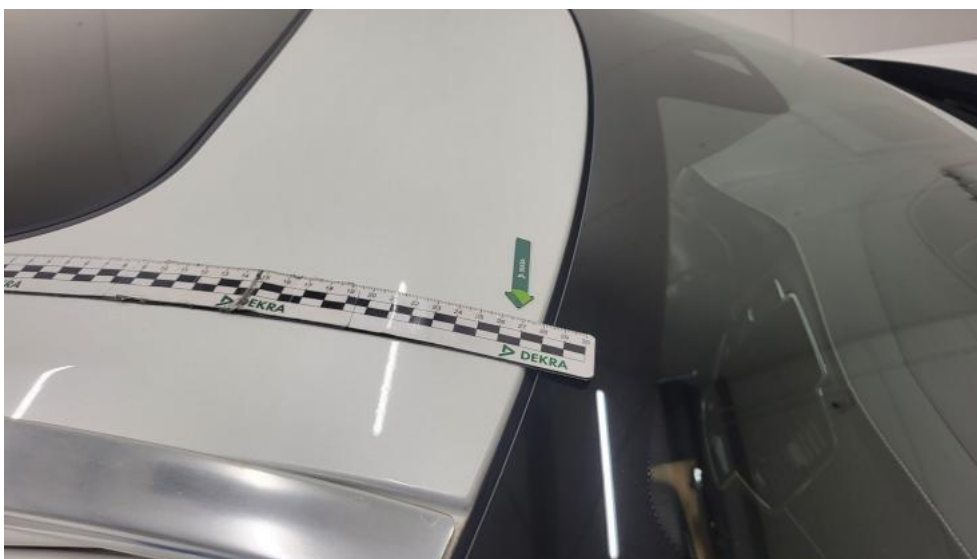
Photo 65.
Dach - zdjęcie poglądowe 1

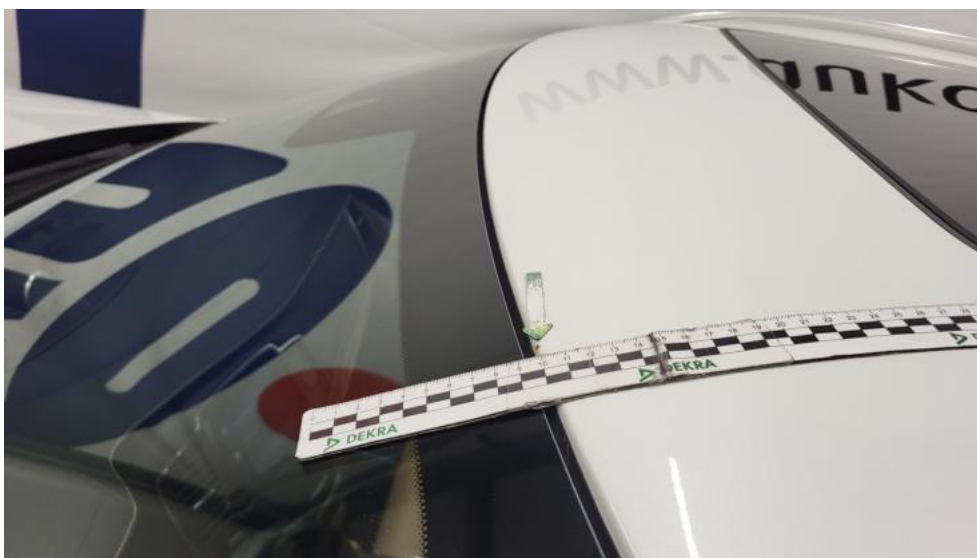
Photo 66.
Dach - zdjęcie poglądowe 2
