DEKRA's commission No. : PKOL(W)/LODZ/82841/24/10/25  
 commission/ damage No. : 21/048549  
 Date of commission: 25-10-2024

Group of objects (Eurotax)	cars
EC code (Eurotax)	0149193
Manufacturer	FORD
Model	Mondeo Kombi 19-21
Type / version	Mondeo 2.0 EcoBlue Executive Plus aut
Body type	KOM
Number of doors / seats	5/5
Curb weight [kg]	1677
Gross vehicle weight [kg]	2330
Wheelbase 1/2	2850
Engine type	Automatic ignition
Supercompression	turbocompressor with intercooler
Pollution reduction system	KSC
Emission standard	EURO 6
Engine capacity [ccm]	1995
Engine Power [hp/kW]	190/140
Gearbox	automatic 8- gear
Registration /record No.	GA558HL
VIN / serial number	WF0FXXWPCFMJ44676
Date of first registration	28-05-2021
Date of next. tech. test	22-05-2026
Year of manufacture	2021 (year has been verified with the manufacturer's base)
Readout [km]	124 603 (read)
Body color / type of coating	blue/METALIK

Date: 04-11-2024

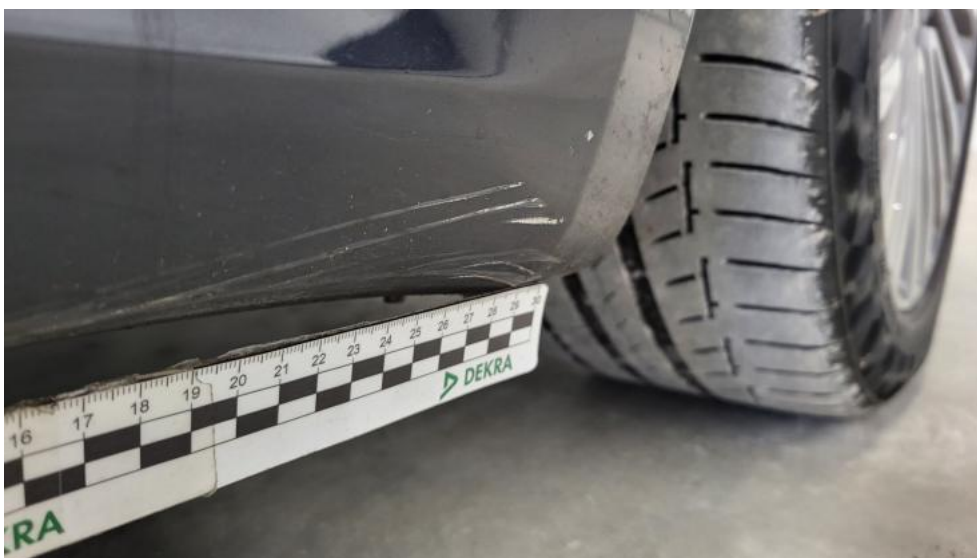
**Photo 58.**  
Próg P - Rysa/odprysk 2
