DEKRA's commission No. : PKOL(W)/LODZ/83675/24/10/29  
commission/ damage No. : 49053  
Date of commission: 29-10-2024

**Vehicle data**

Group of objects (Eurotax)	cars
EC code (Eurotax)	0128698
Manufacturer	VOLKSWAGEN
Model	Passat Alltrack [B8] 15-19
Type / version	Passat Alltrack 2.0 TDI SCR 4Mot. DSG7
Body type	KOM
Number of doors / seats	5/5
Curb weight [kg]	1700
Gross vehicle weight [kg]	2320
Wheelbase 1/2	2789
Engine type	Automatic ignition
Supercompression	turbocompressor with intercooler
Pollution reduction system	KSC
Emission standard	EURO 6
Engine capacity [ccm]	1968
Engine Power [hp/kW]	190/140
Gearbox	automatic 7- gear
Registration /record No.	KR4KH41
VIN / serial number	WVWZZZ3CZKE044636
Date of first registration	05-03-2019
Date of next. tech. test	15-03-2025
Year of manufacture	2019
Readout [km]	85 022 (read)
Body color / type of coating	black/METALIK

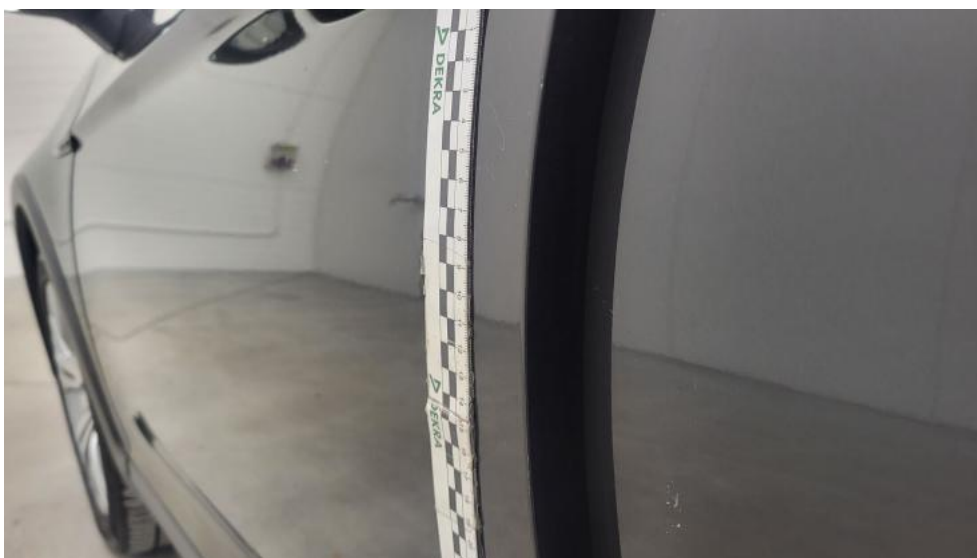
**Photo 78.**  
Drzwi przed L - Rysa/odprysk 1

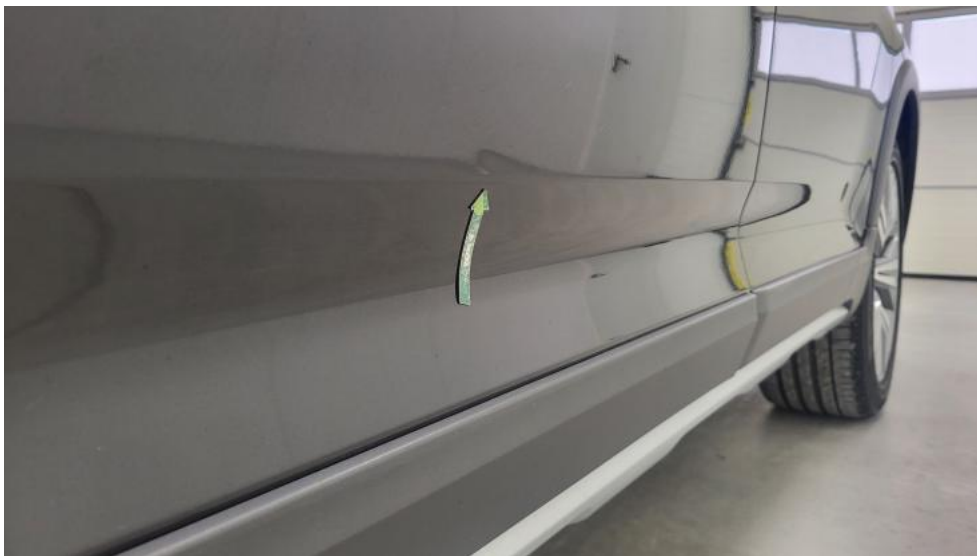
**Photo 79.**  
Drzwi przed L - Wgniecenie/odkształcenie 1

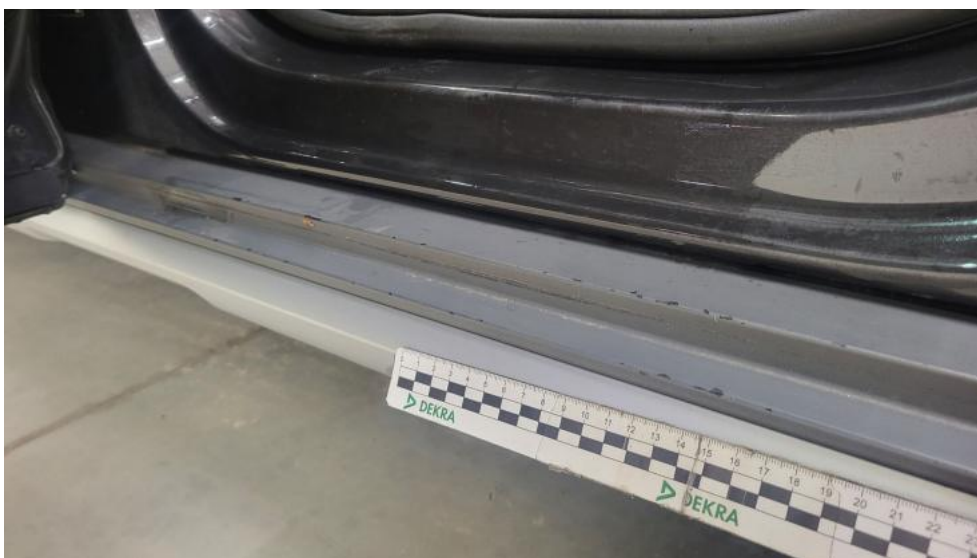
**Photo 84.**  
Próg L - Rysa/odprysk 1
