DEKRA's commission No. : PKOL(W)/LODZ/84131/24/10/30
 commission/ damage No. : 00472/LF/23
 Date of commission: 30-10-2024

Vehicle data

Measurement of thickness of the vehicle lacquer coating

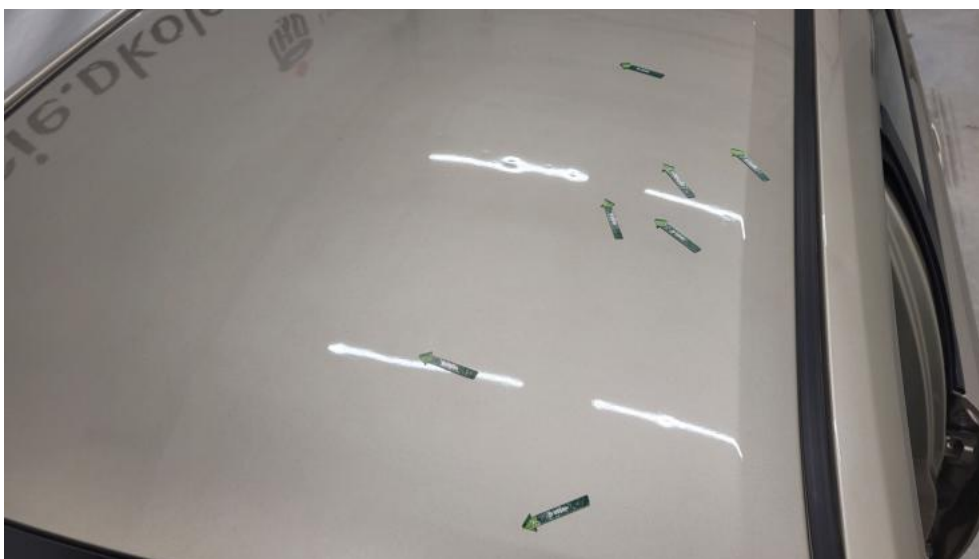
Photo 67.
Dach - zdjęcie poglądowe 1
