DEKRA's commission No. : PKOL(W)/LODZ/56231/26/06/18  
 commission/ damage No. : 23/018054  
 Date of commission: 18-06-2026

**Vehicle data**

Measurement of thickness of the vehicle lacquer coating

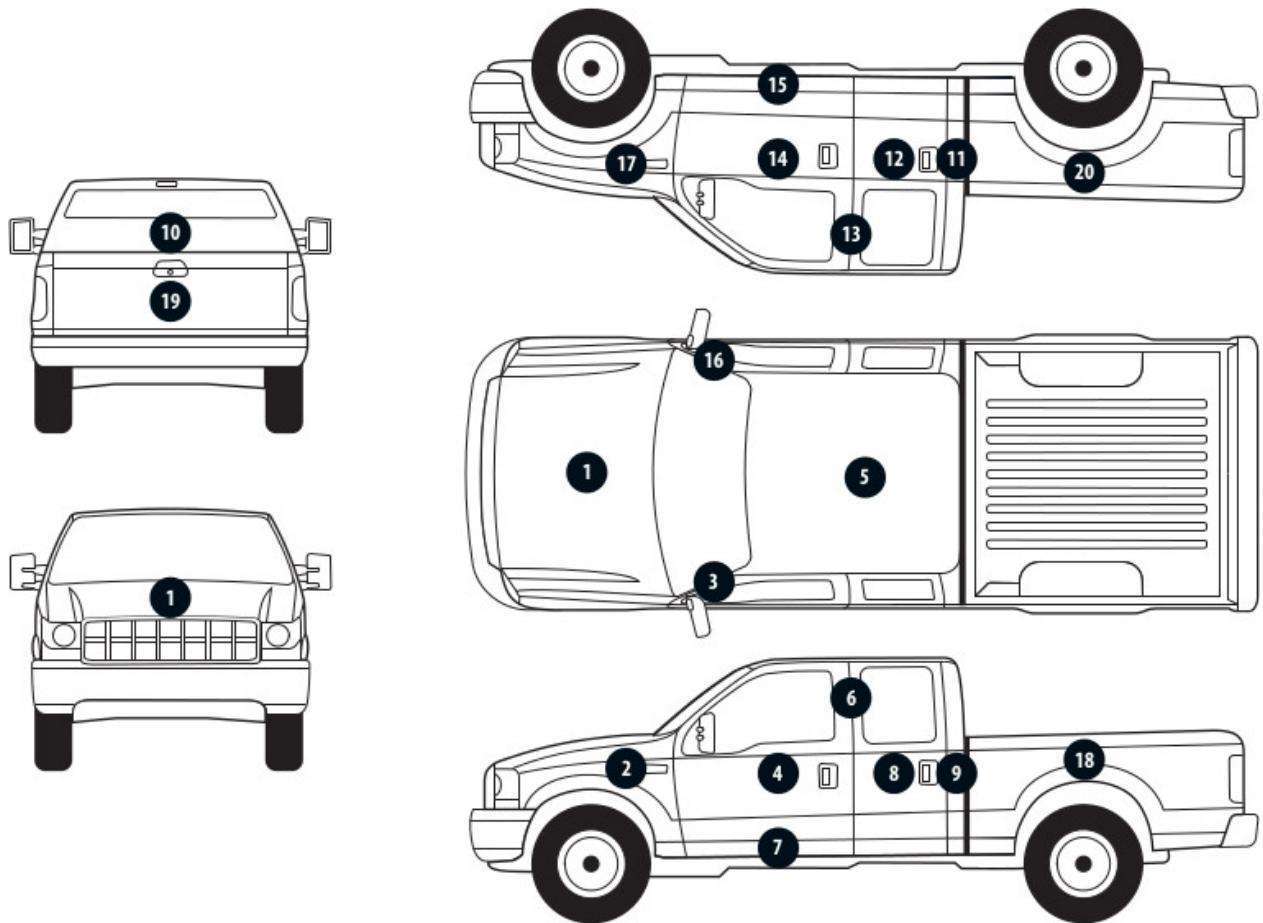
No. of controlled item	Controlled item	Measured range of thickness of the lacquer coat [ $\mu\text{m}$ ]
1	Front cover	150 - 300
2	Left front fender	150 - 300
3	Left front pillar	150 - 300
4	Left front door	150 - 300
5	Roof	150 - 300
6	Left middle pillar	to 150
7	Left side sill	to 150
8	Rear left door	150 - 300
9	Left side wall	150 - 300
10	Rearwall	150 - 300
11	Right sidewall	150 - 300
12	Right reardoor	150 - 300
13	Right middle pillar	to 150
14	Right front door	150 - 300
15	Right side sill	to 150
16	Right front pillar	150 - 300
17	Right front fender	150 - 300

Pojazd oklejony folią, pomiar lakieru wykonany na folii oprócz elementów: próg lewy/prawy, słupek środkowy lewy/prawy. Odpryski na szybie czołowej. Widoczne ślady po grafice reklamowej. Rysy na samochodzie.

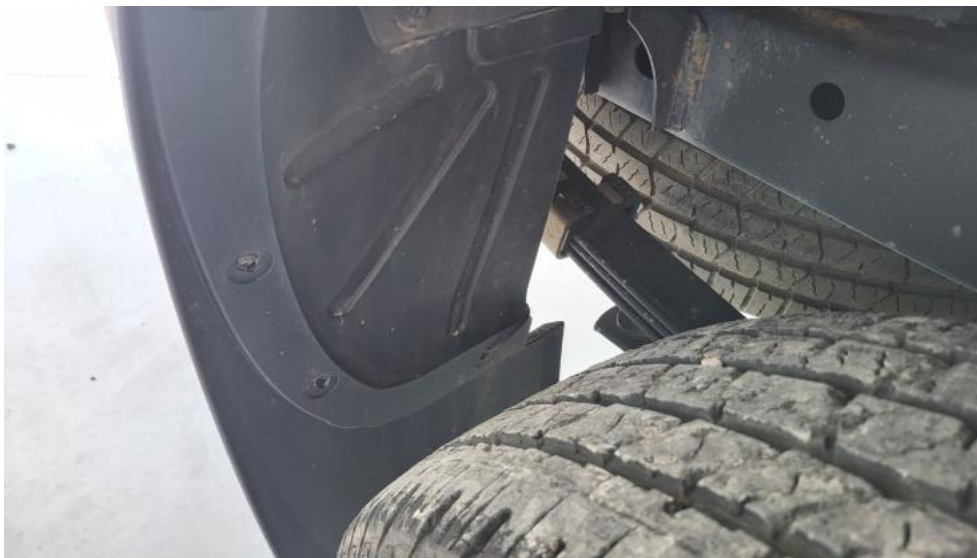
**Photo 47.**  
Nadkole tylne P - zdjęcie pogładowe 1
