DEKRA's commission No. : PKOL(W)/LODZ/83840/24/10/29
commission/ damage No. : 22/016986
Date of commission: 29-10-2024

Vehicle data

Group of objects (Eurotax)	cars
EC code (Eurotax)	0123825
Manufacturer	BMW
Model	Seria 5 [G30/F90] 16-20
Type / version	520d xDrive M Sport sport-aut
Body type	sedan
Number of doors / seats	4/5
Curb weight [kg]	1620
Gross vehicle weight [kg]	2325
Wheelbase 1/2	2975
Engine type	Automatic ignition
Supercompression	turbocompressor with intercooler
Pollution reduction system	DPF
Emission standard	EURO 6
Engine capacity [ccm]	1995
Engine Power [hp/kW]	190/140
Gearbox	automatic 8- gear
Registration /record No.	SK271XN
VIN / serial number	WBAJC51030WB86900
Date of first registration	15-02-2018
Date of next. tech. test	23-02-2025
Readout [km]	252 425 (read)
Body color / type of coating	black/METALIK

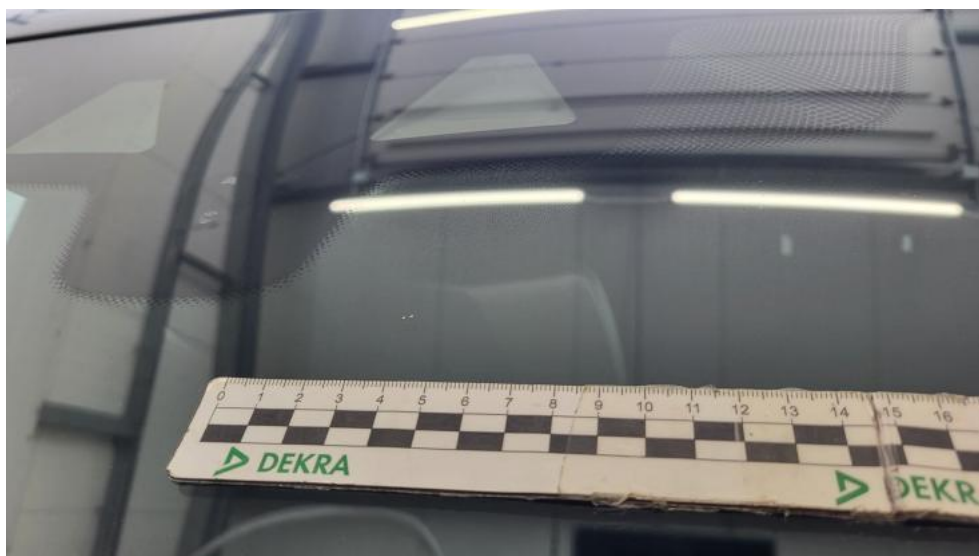
Photo 54.
Szyba czołowa - Rysa/odprysk 2

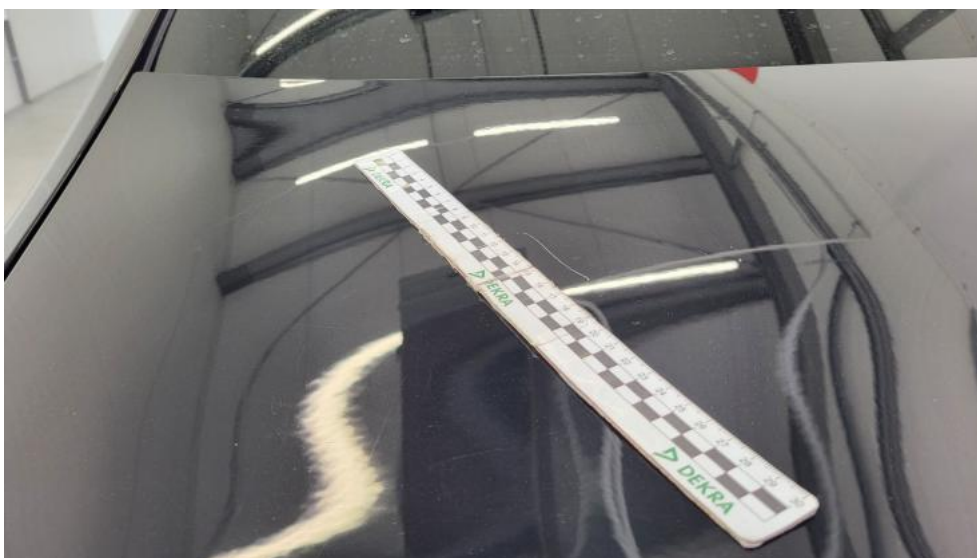
Photo 70.
Pokrywy bagażnika - Rysa/odprysk 1

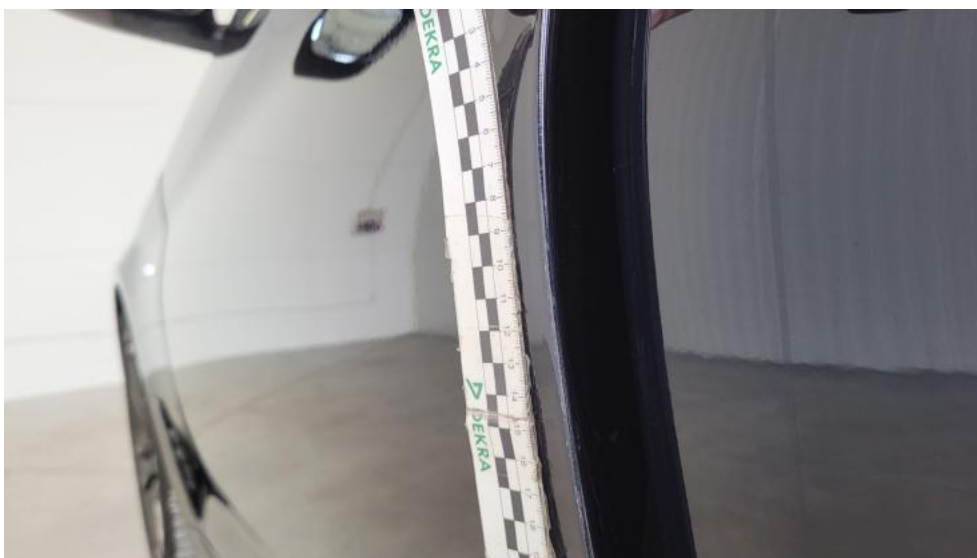
Photo 82.
Drzwi przed L - Rysa/odprysk 1

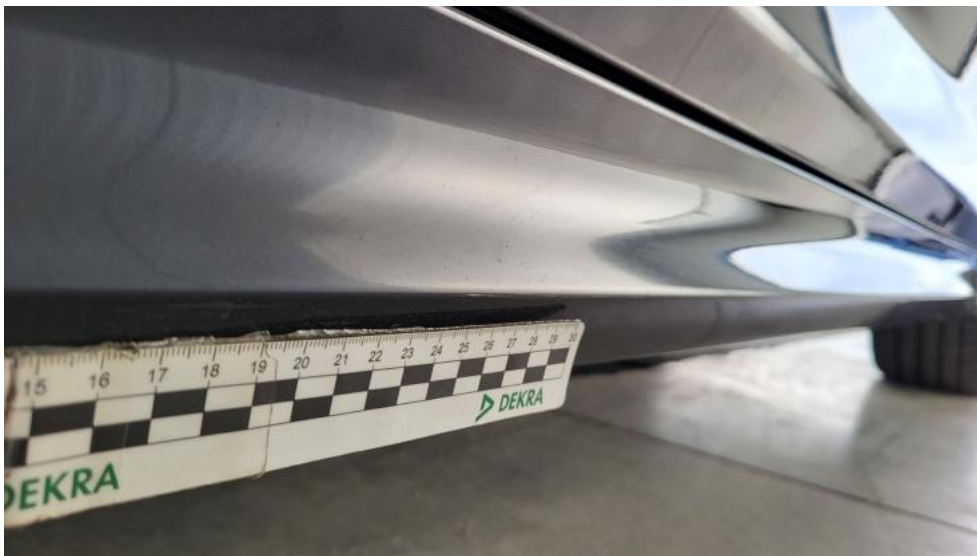
Photo 87.
Próg L - Rysa/odprysk 1

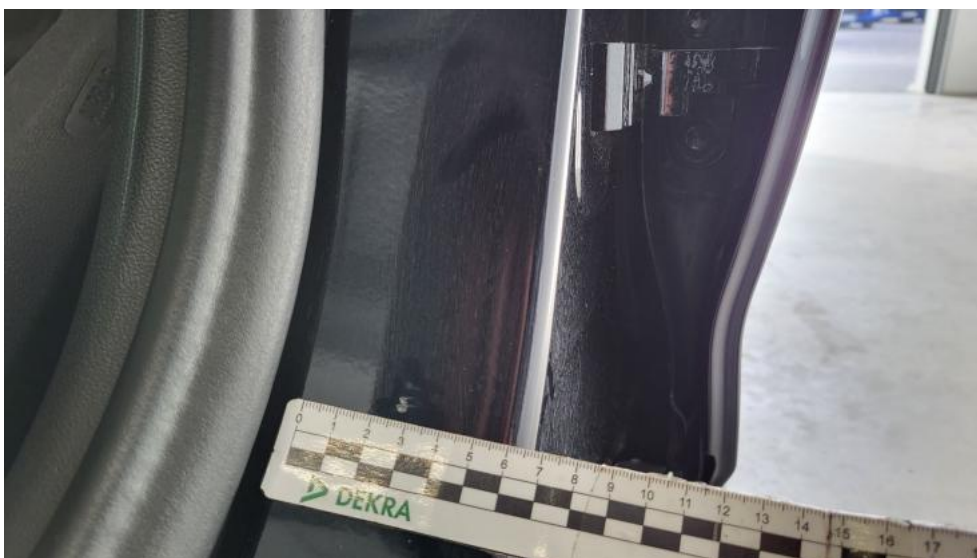
Photo 88.
Słupek środkowy L - Rysa/odprysk 1
