DEKRA's commission No. : PKOL(W)/LODZ/79505/24/10/14  
commission/ damage No. : 20/042185  
Date of commission: 14-10-2024

**DEKRA Poland - Headquarters**  
02-673 Warszawa, ul. Konstruktorska 12A

PKO Leasing SA  
Świętokrzyska 36  
00-116 Warszawa

| Model | Cayenne III 17-23 |

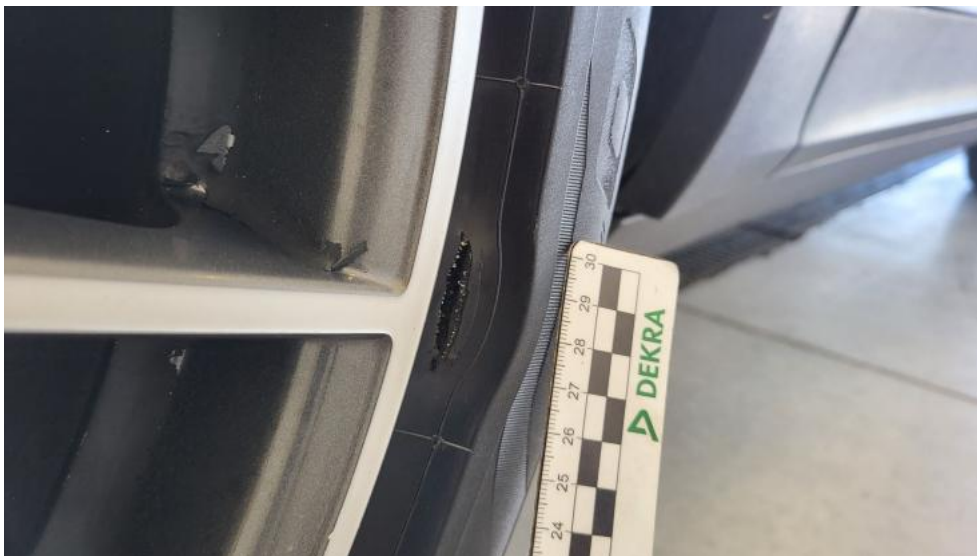
**Photo 75.**  
Opona przednia L - Wgniecenie/odkształcenie 1
