DEKRA's commission No. : PKOL(W)/LODZ/17842/25/03/11
 commission/ damage No. : 21/030808
 Date of commission: 11-03-2025

Vehicle data

Group of objects (Eurotax)	cars
EC code (Eurotax)	0123801
Manufacturer	BMW
Model	Seria 5 [G30/F90] 16-20
Type / version	520d xDrive Luxury Line aut
Body type	sedan
Number of doors / seats	4/5
Curb weight [kg]	1650
Gross vehicle weight [kg]	2330
Wheelbase 1/2	2975
Engine type	Automatic ignition
Pollution reduction system	DPF
Engine capacity [ccm]	1995
Engine Power [hp/kW]	190/140
Gearbox	automatic 8- gear
Registration /record No.	WZ433CW
VIN / serial number	WBAJF51040WW66223
Date of first registration	27-11-2019
Date of next. tech. test	27-11-2024
Year of manufacture	2019
Readout [km]	127 845 (read)
Body color / type of coating	black/UNI

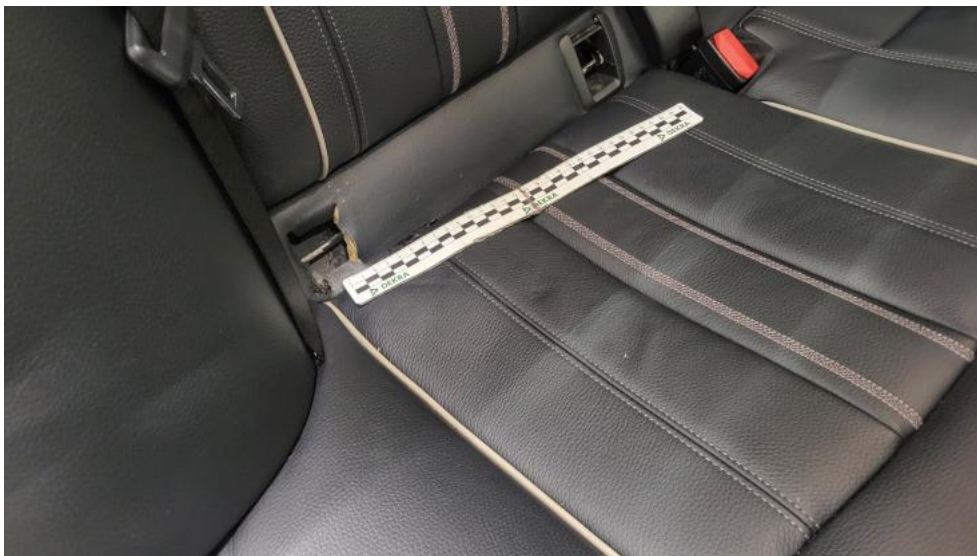
Photo 67.

Kanapa tyl. - zdjęcie poglądowe 1
