DEKRA's commission No. : PKOL(W)/LODZ/69918/26/07/28  
commission/ damage No. : 25/054498  
Date of commission: 28-07-2026

**Vehicle data**

| Model | Arteon Shooting Brake 20-24 |
| Type / version | Arteon 2.0 TSI Elegance DSG |

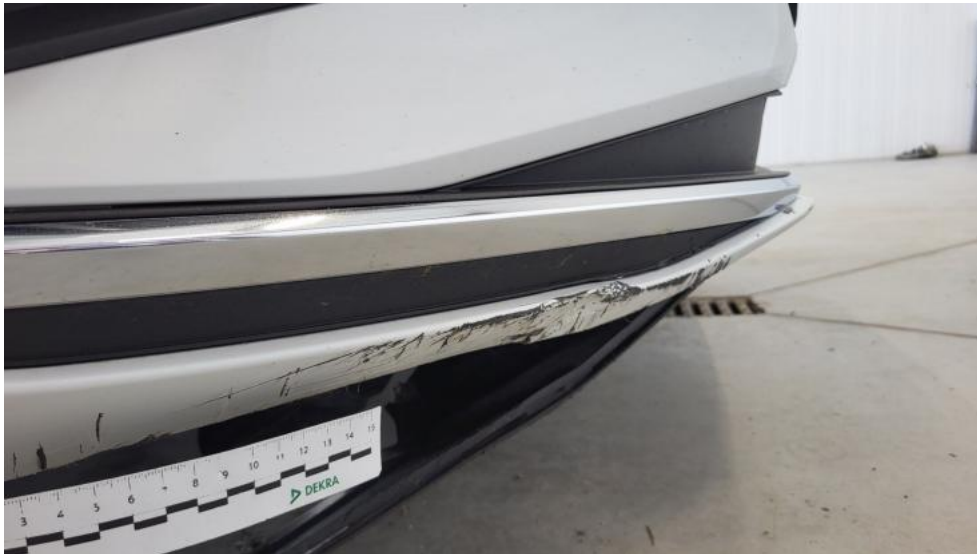
**Photo 51.**

Zderzak() - Rysa/odprysk 3
