DEKRA's commission No. : PKOL(W)/LODZ/69897/25/09/17  
commission/ damage No. : 24/041894  
Date of commission: 17-09-2025

| Manufacturer | KIA |
| Model | EV6 21-25 |
| Registration /record No. | WR057GU |

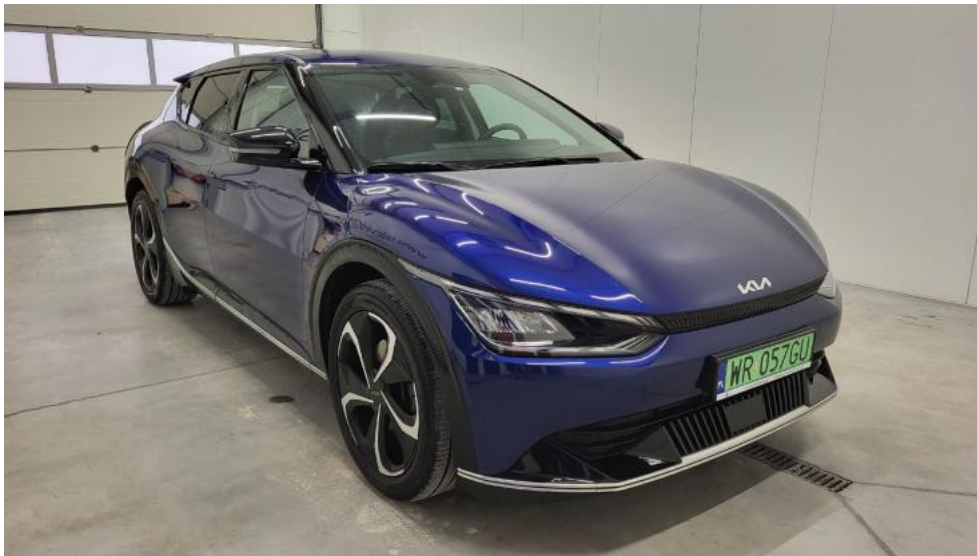
**Photo 3.**

Przekątna przednia prawa

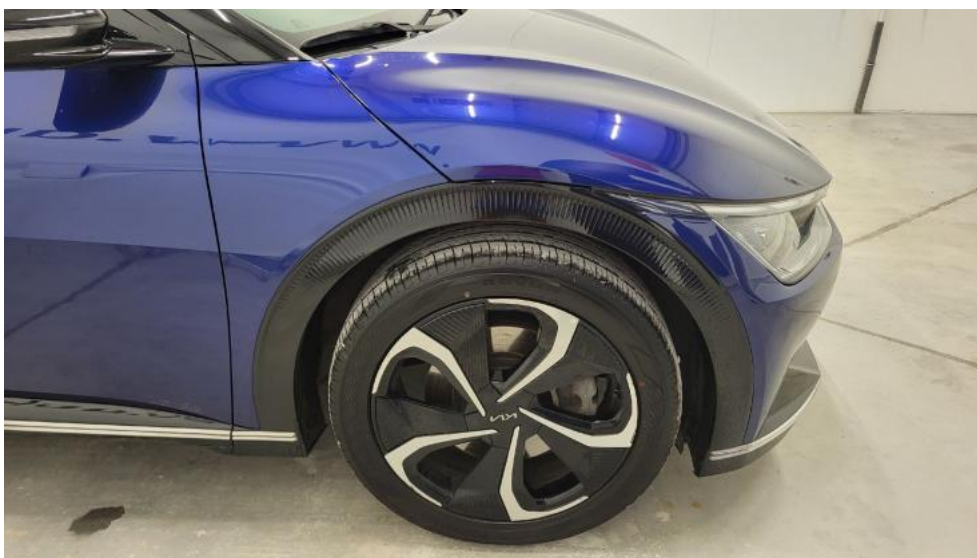
**Photo 4.**

Bok prawy z przodu

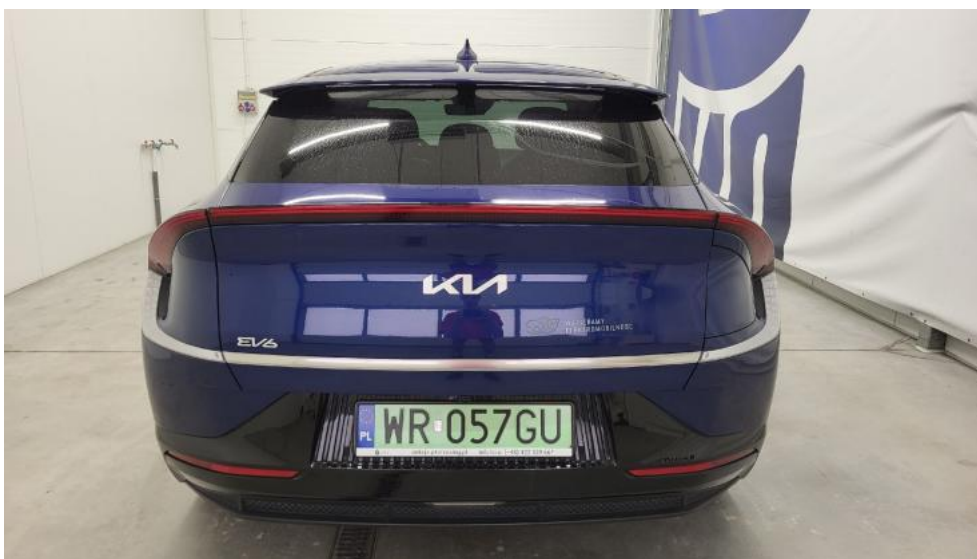
**Photo 7.**

Tył

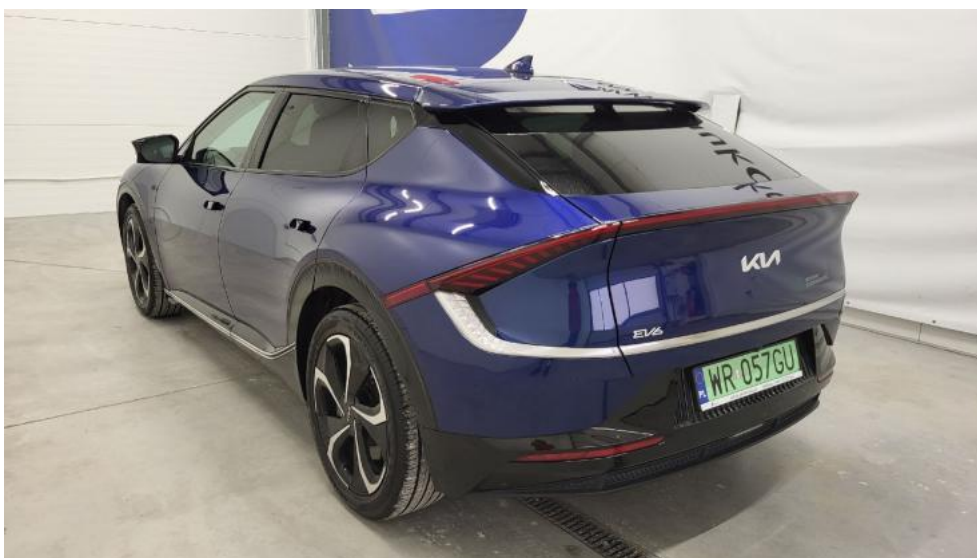
**Photo 8.**

Przekątna tylna lewa

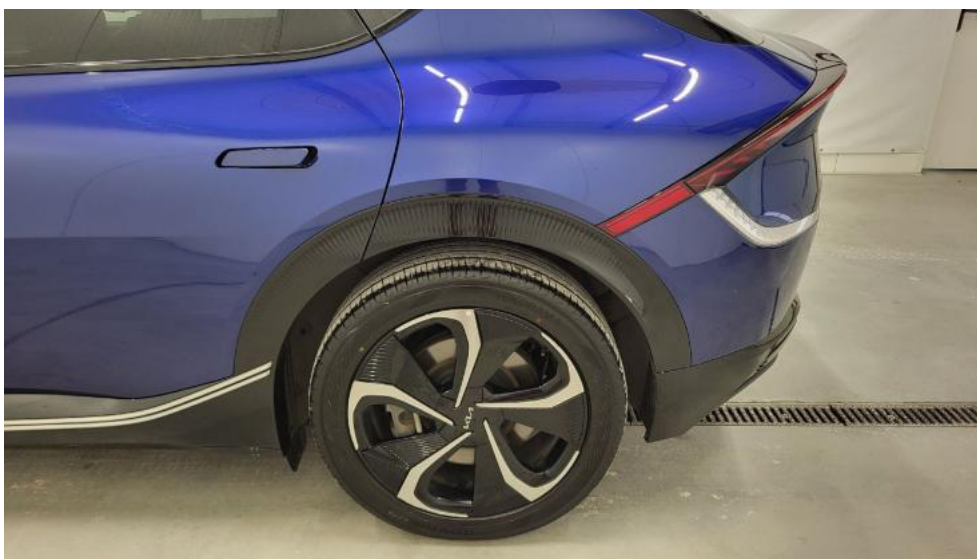
**Photo 9.**

Bok lewy z tyłu

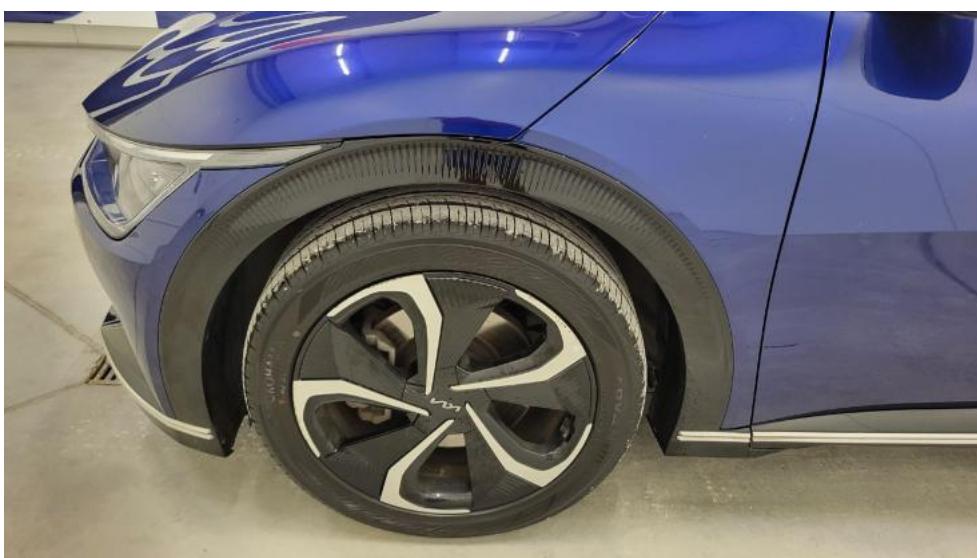
**Photo 10.**

Bok lewy z przodu

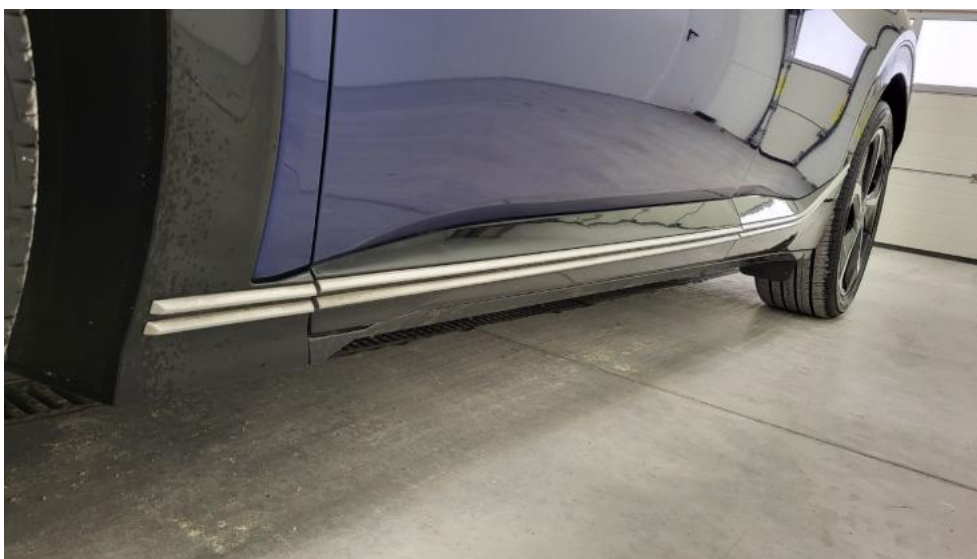
**Photo 11.**

Próg lewy (widok od przodu)

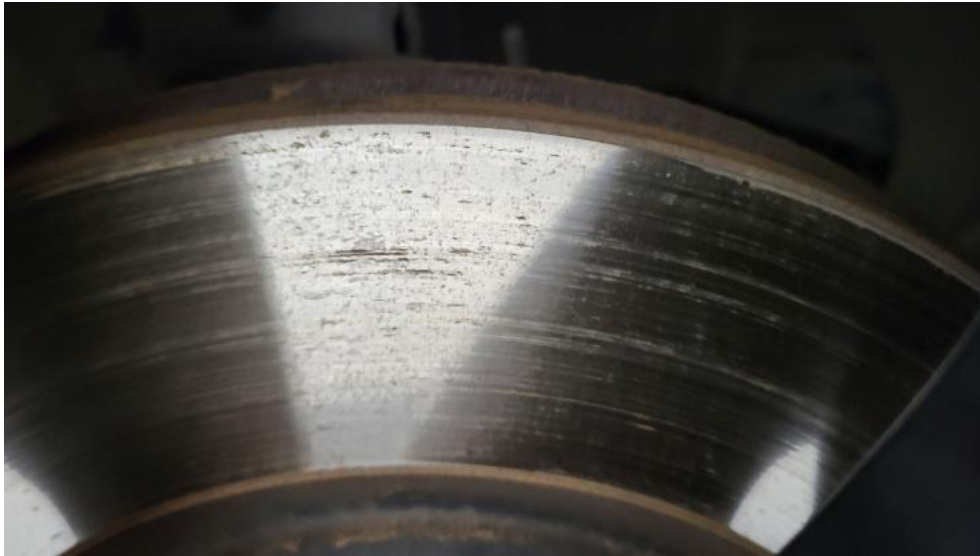
**Photo 15.**

Tarcza hamulcowa przednia prawa

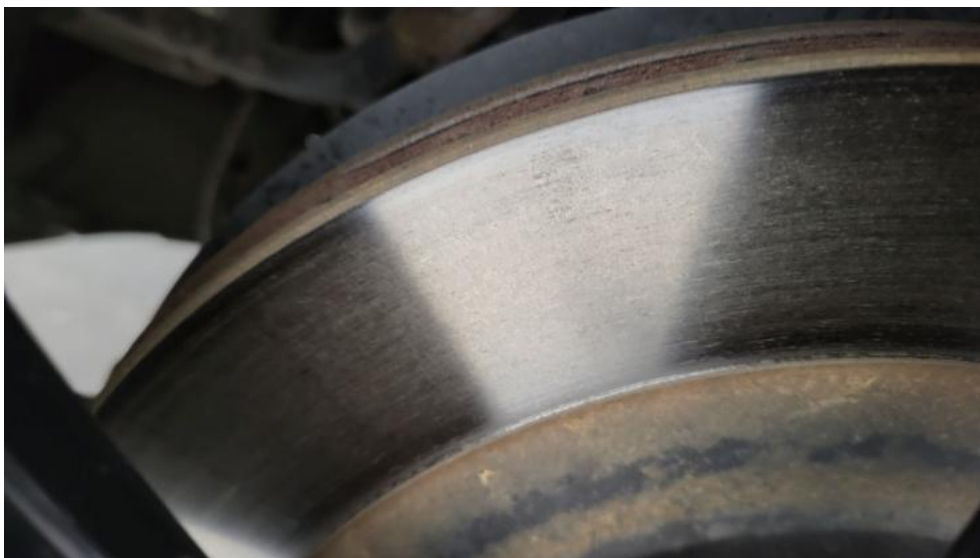
**Photo 16.**

Tarcza hamulcowa tylna prawa

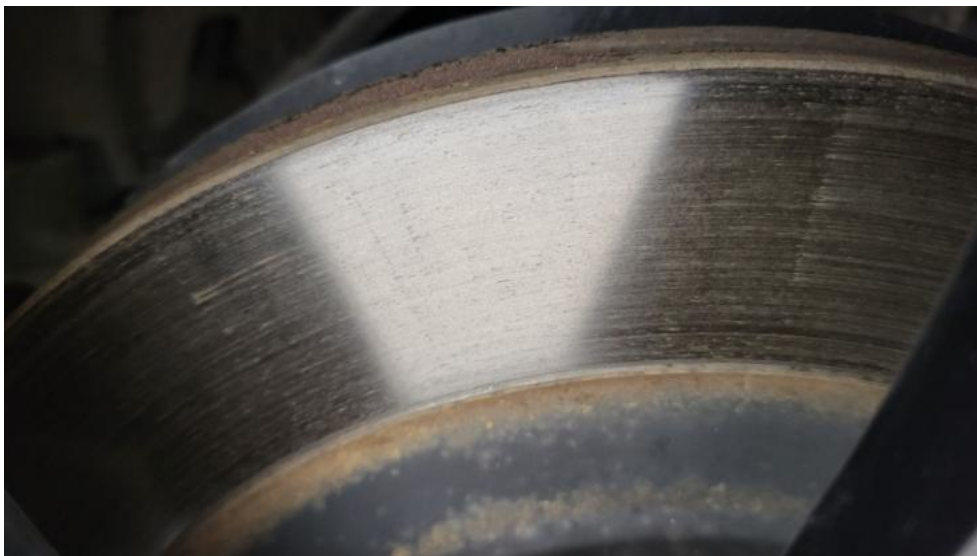
**Photo 17.**

Tarcza hamulcowa tylna lewa

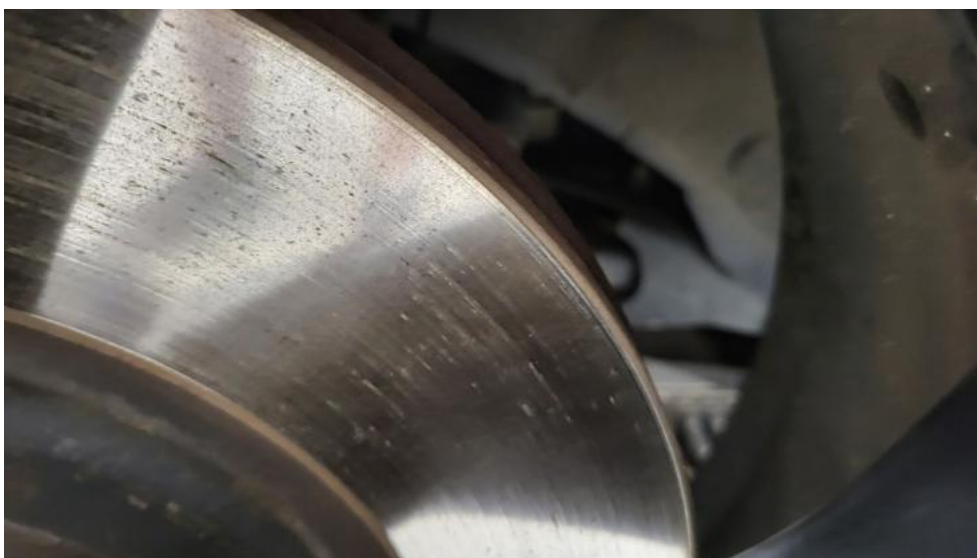
**Photo 18.**

Tarcza hamulcowa przednia lewa

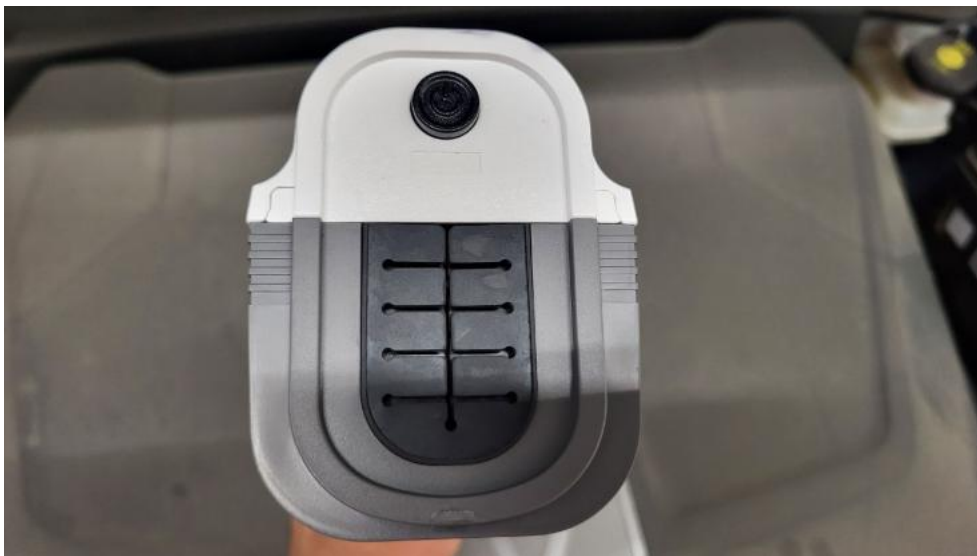
**Photo 39.**

Zdjęcie do protokołu

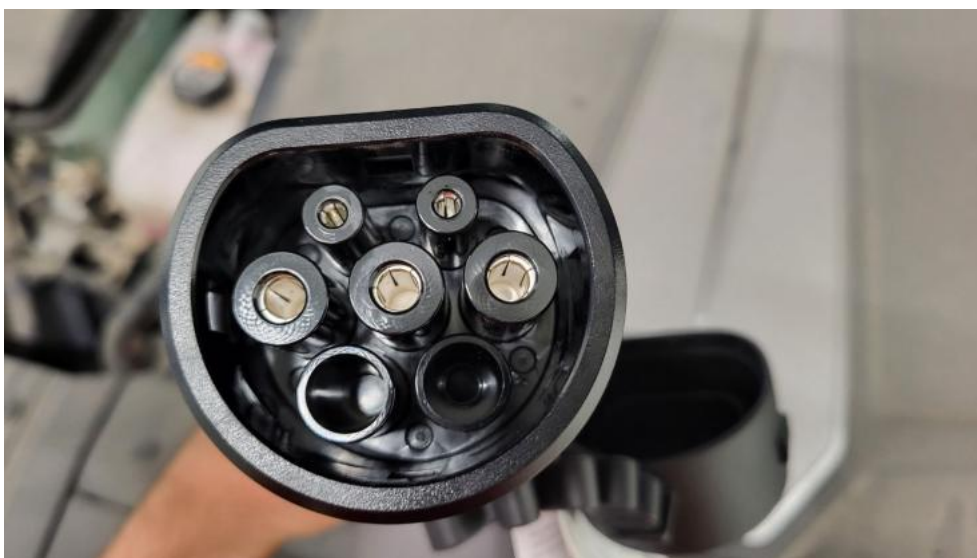
**Photo 40.**

Zdjęcie do protokołu

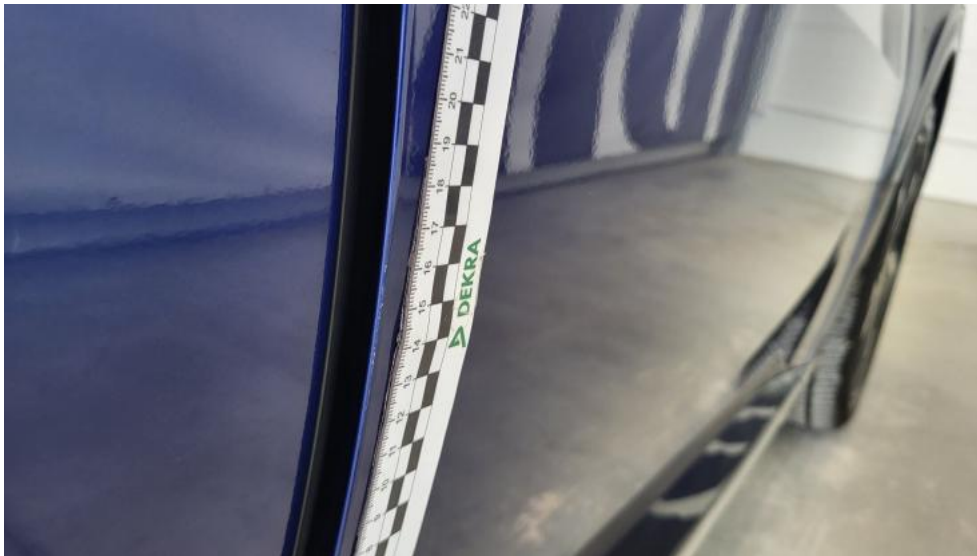
**Photo 49.**

Drzwi przednie P - Rysa/odprysk 1

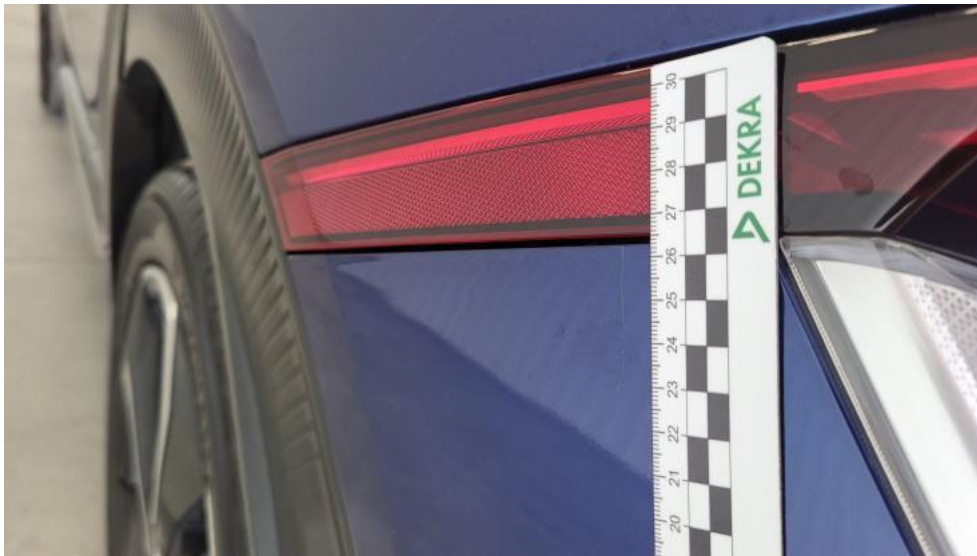
**Photo 59.**

Zderzak tylny() - Rysa/odprysk 3

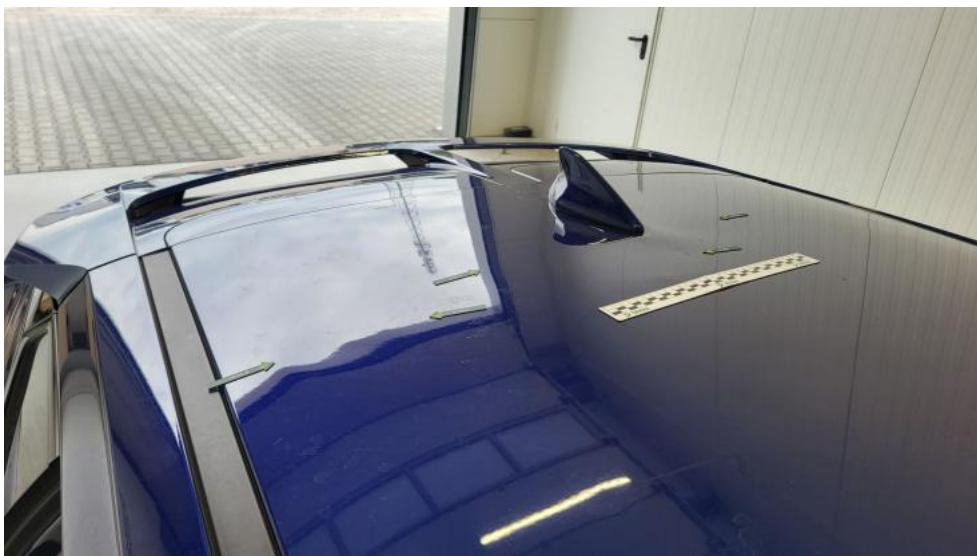
**Photo 60.**

Dach - Wgniecenie/odkształcenie 1
