DEKRA' s commission No. : PKOL(W)/LODZ/92778/24/12/02
 commission/ damage No. : 22/032372
 Date of commission: 02-12-2024

Vehicle data

Group of objects (Eurotax)	cars
EC code (Eurotax)	0138626
Manufacturer	OPEL
Model	Corsa F Hatchback 19-23
Type / version	Corsa 1.2 Edition S&S
Body type	hatchback
Number of doors / seats	5/5
Curb weight [kg]	1024
Gross vehicle weight [kg]	1550
Wheelbase 1/2	2538
Engine type	spark ignition
Pollution reduction system	GPF
Engine capacity [ccm]	1199
Engine Power [hp/kW]	75/55
Gearbox	manual 5- gear
Registration /record No.	EL6GF67
VIN / serial number	VXKUPHMHDN4353199
Date of first registration	29-09-2022
Date of next. tech. test	29-09-2025
Year of manufacture	2022 (year has been verified with the manufacturer's base)
Readout [km]	39 540 (read)
Body color / type of coating	white/UNI

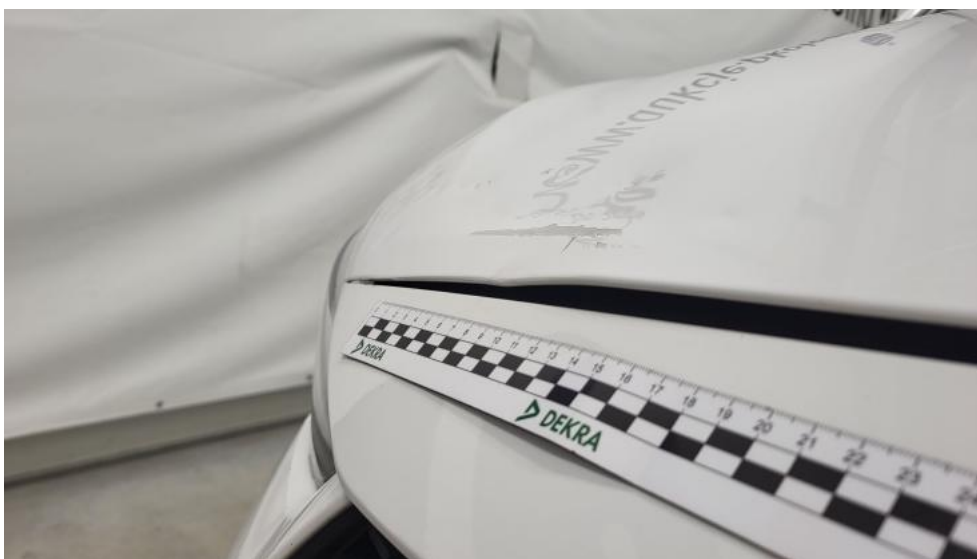
Photo 39.
Pokrywa komory silnika - zdjęcie poglądowe 1

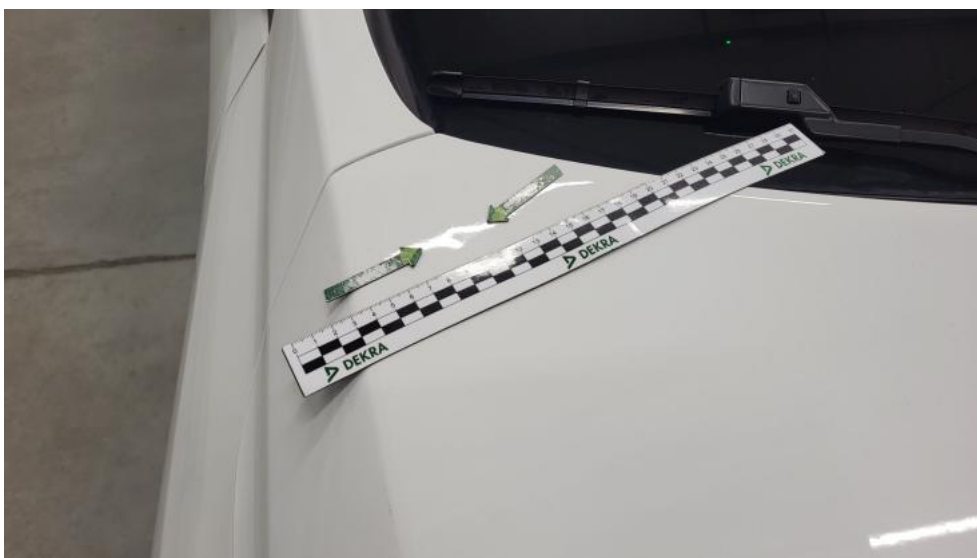
Photo 40.
Pokrywa komory silnika - zdjęcie poglądowe 2

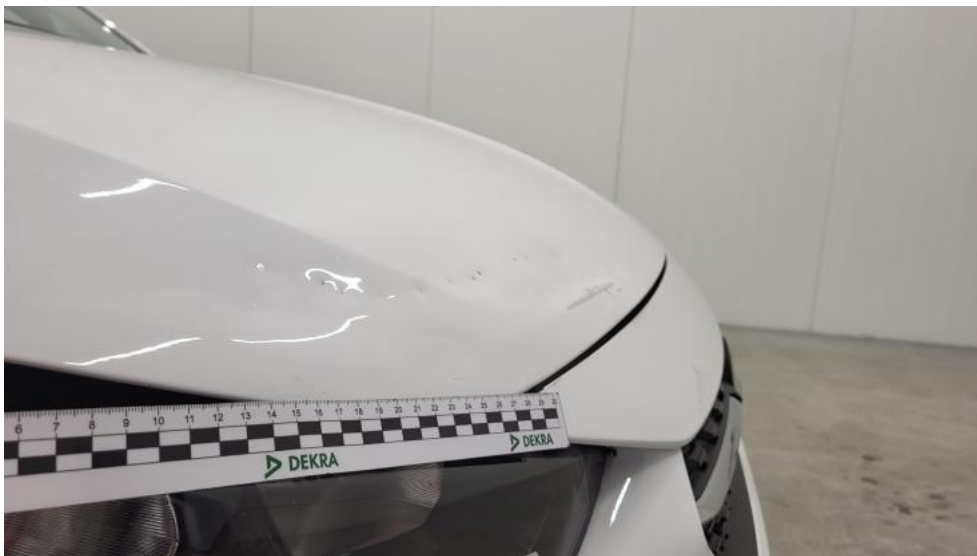
Photo 45.
Pokrywa komory silnika() - Wgniecenie/odkształcenie 3

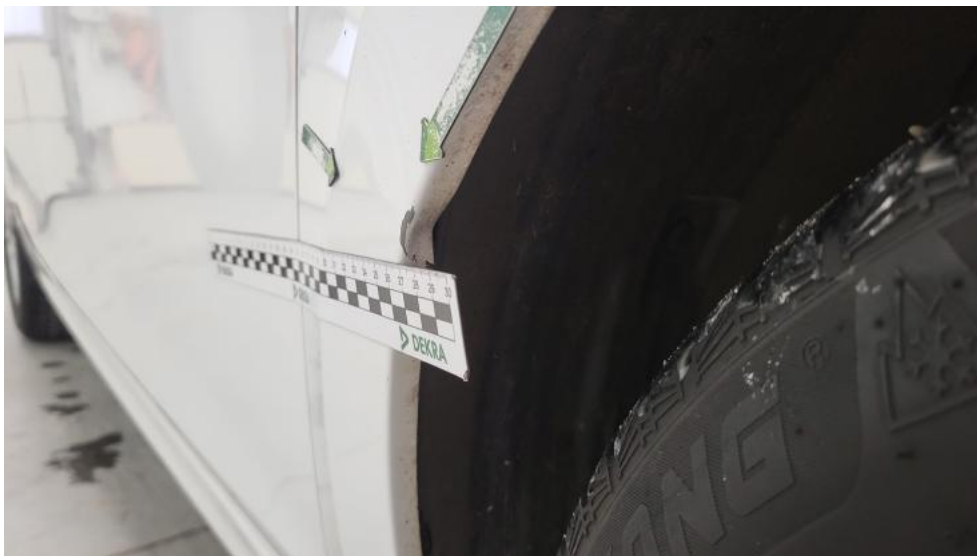
Photo 57.
Błotnik przedni P - Wgniecenie/odkształcenie 1

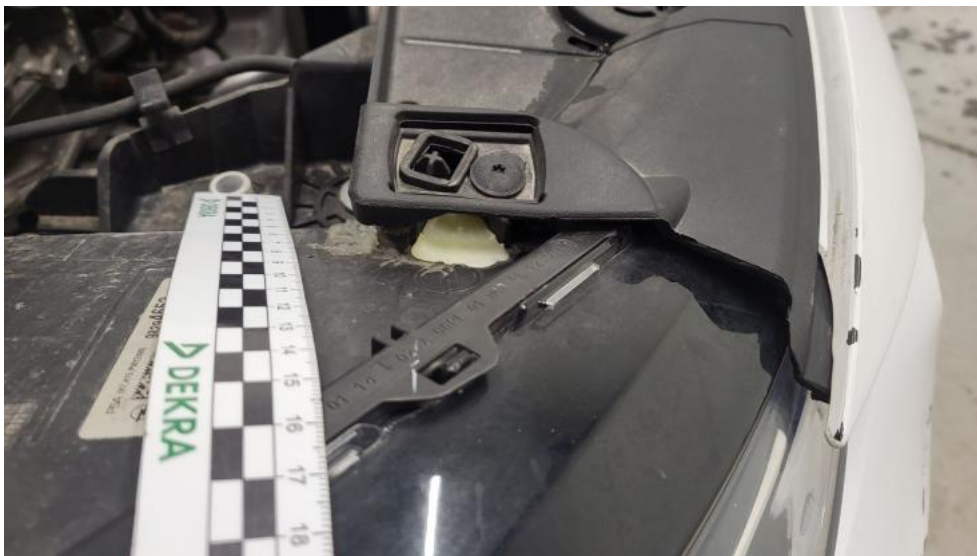
Photo 61.
Reflektor P - Inne 2

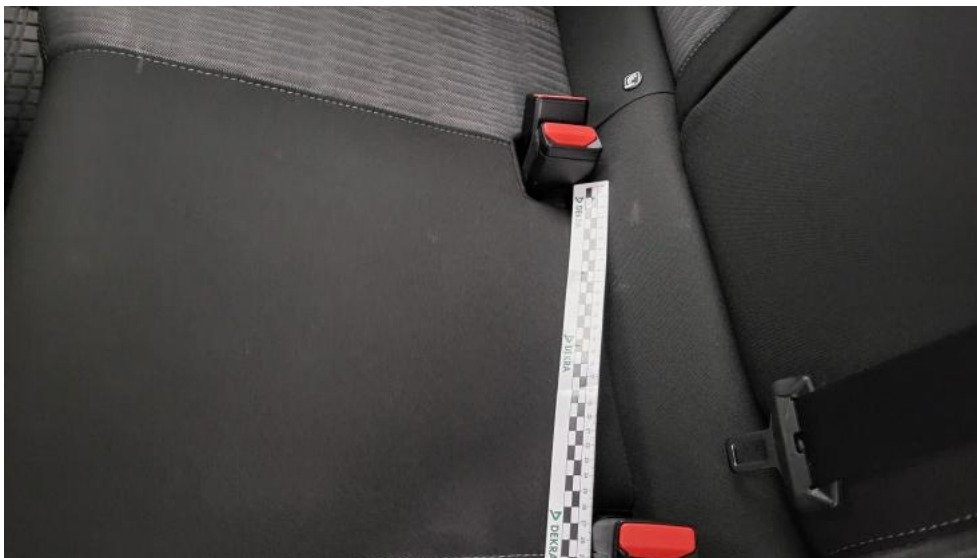
Photo 73.
Kanapa tyl. - Inne 1

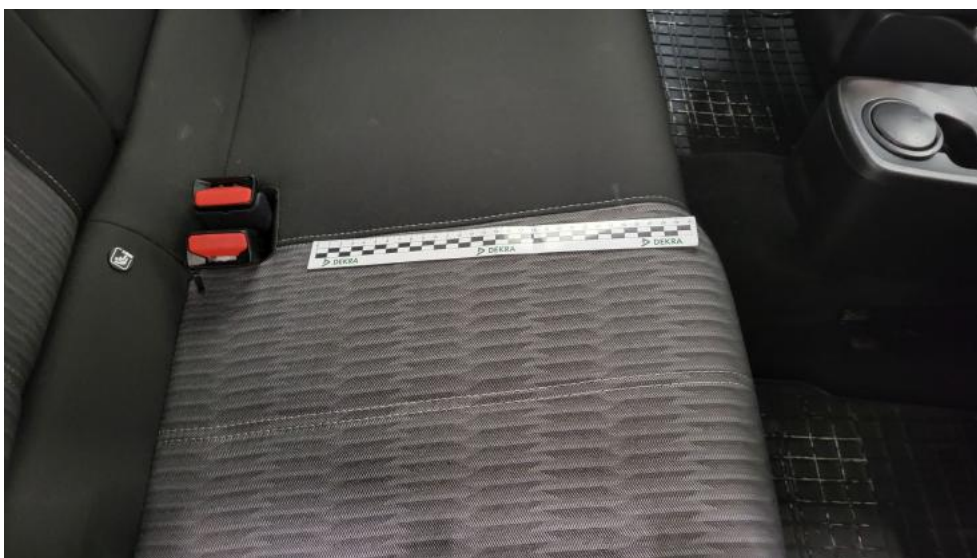
Photo 74.
Kanapa tyl. - Inne 2

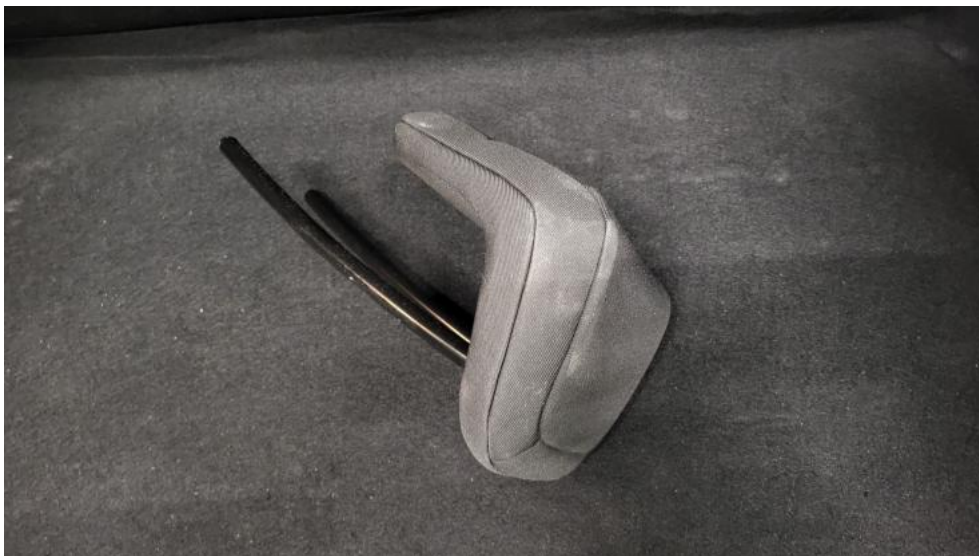
Photo 75.

Zaglówek lew. kanapy tyl. - zdjęcie poglądowe 1

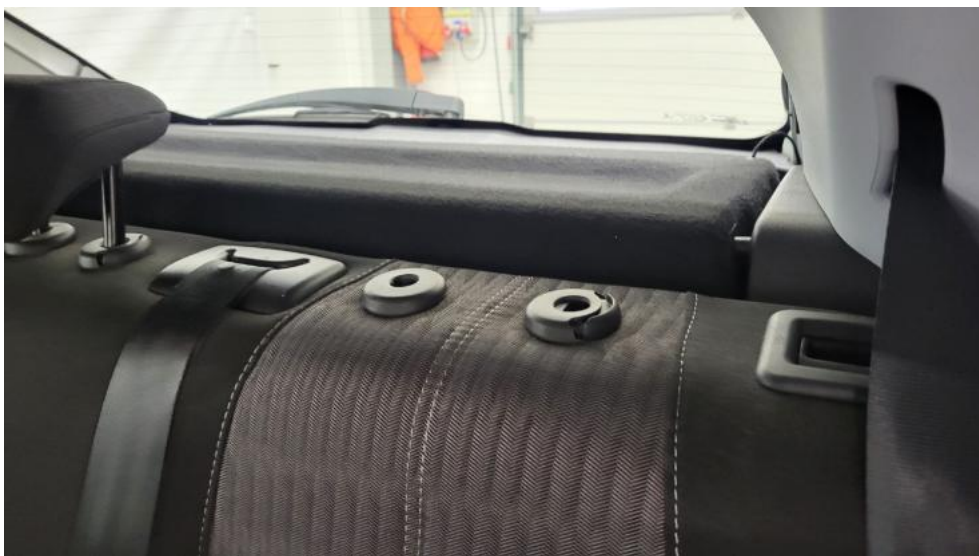
Photo 76.

Zaglówek lew. kanapy tyl. - Inne 1

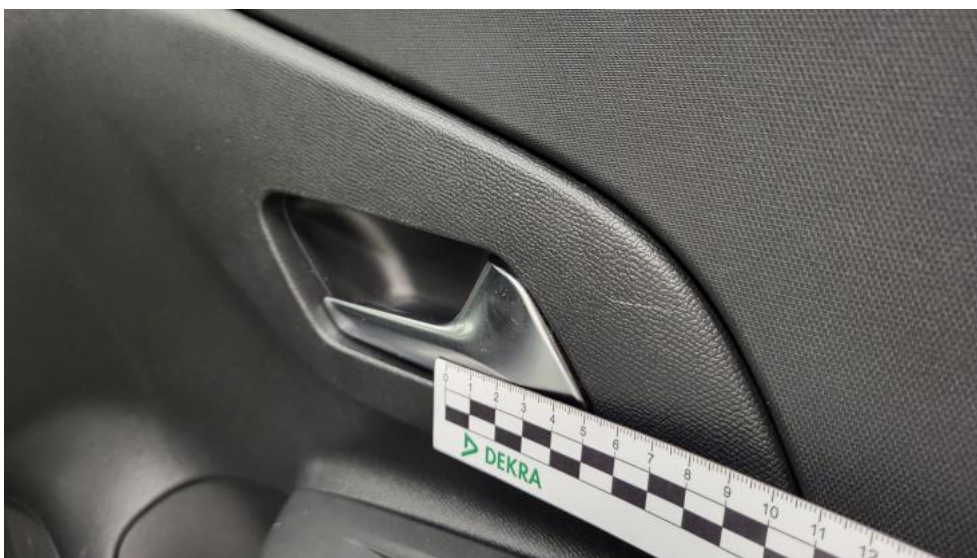
Photo 78.
Tapicerka drzwi przednich P - Rysa/odprysk 1

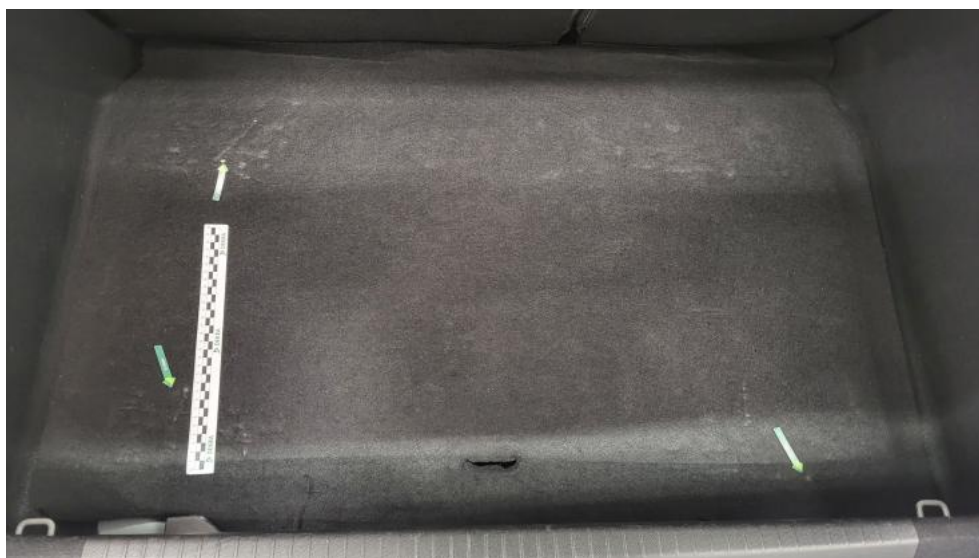
Photo 84.
Wykładzina podłogi bagażnika - zdjęcie poglądowe 1

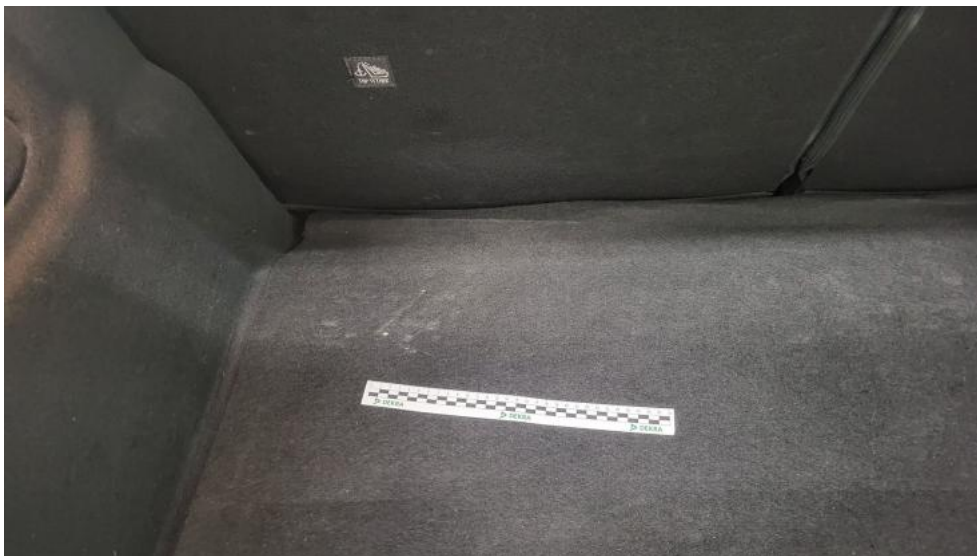
Photo 85.

Wykładzina podłogi bagażnika - Inne 1

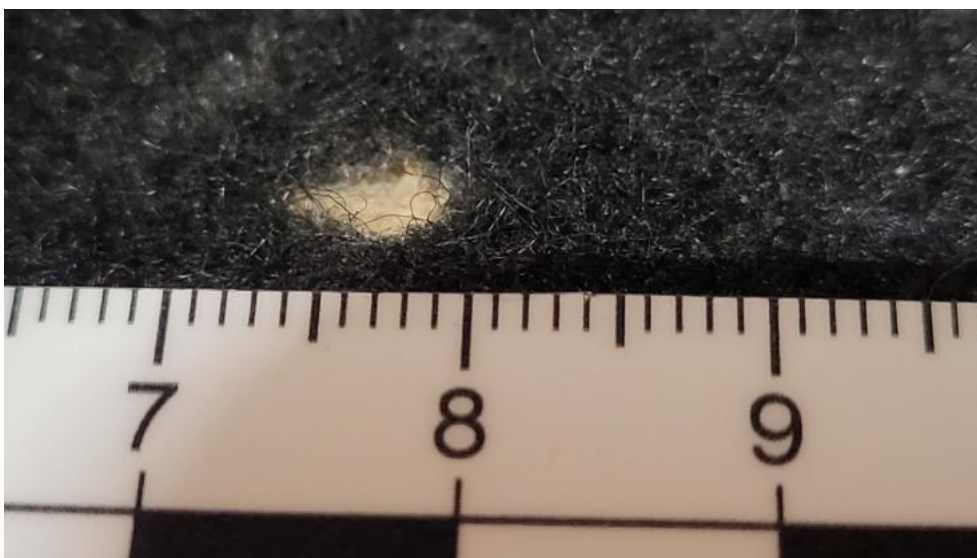
Photo 86.

Wykładzina podłogi bagażnika - Inne 2

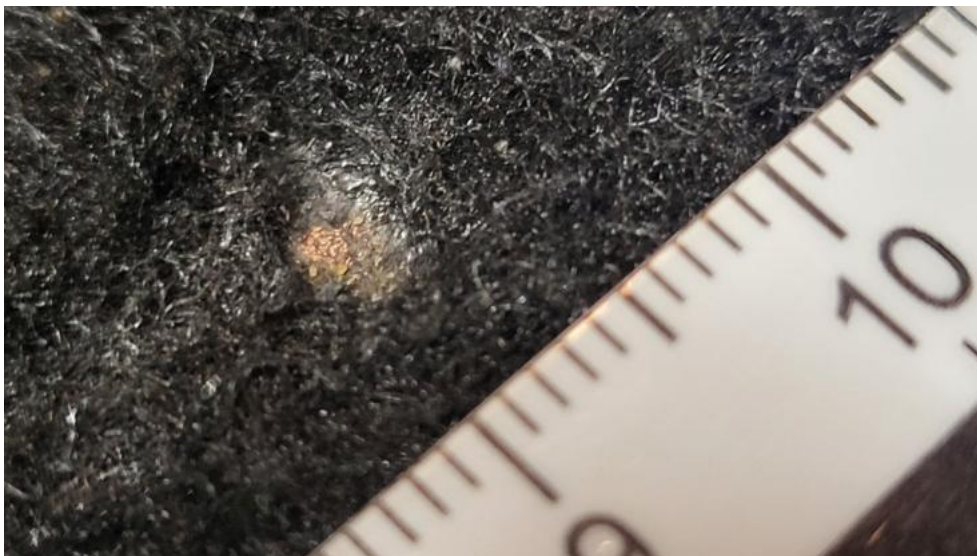
Photo 87.

Wykładzina podłogi bagażnika() - Inne 3
