DEKRA's commission No. : PKOL(W)/LODZ/33757/25/05/12  
commission/ damage No. : 24/008703  
Date of commission: 12-05-2025

**DEKRA Poland - Headquarters**  
02-673 Warszawa, ul. Konstruktorska 12A

| Manufacturer | JEEP |
| Model | Grand Cherokee 16-20 |

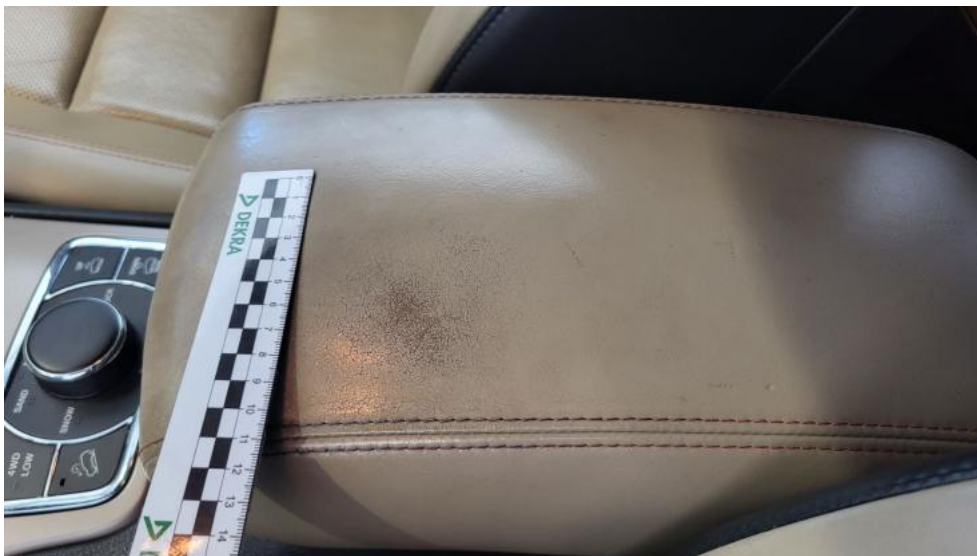
**Photo 63.**

Podłokietnik środkowy przedni - Inne 1
