DEKRA's commission No. : PKOL(W)/LODZ/95213/26/10/12  
commission/ damage No. : 22/038660  
Date of commission: 12-10-2026

**DEKRA Poland - Headquarters**  
02-673 Warszawa, ul. Konstruktorska 12A

| Model | Musso Grand 19-23 |
| Type / version | Musso Grand 2.2 e-XDi Sapphire 4WD aut |

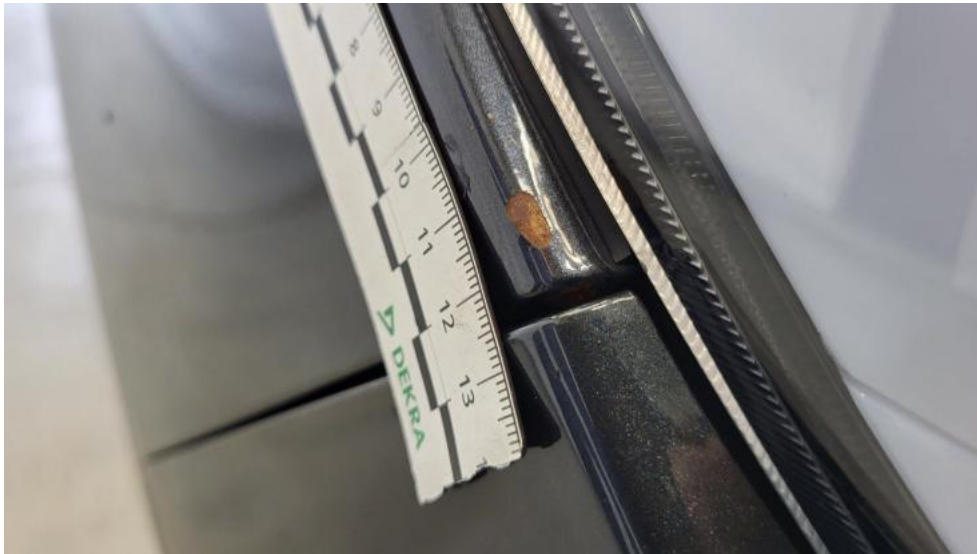
**Photo 49.**

Błotnik przedni P - Inne 1

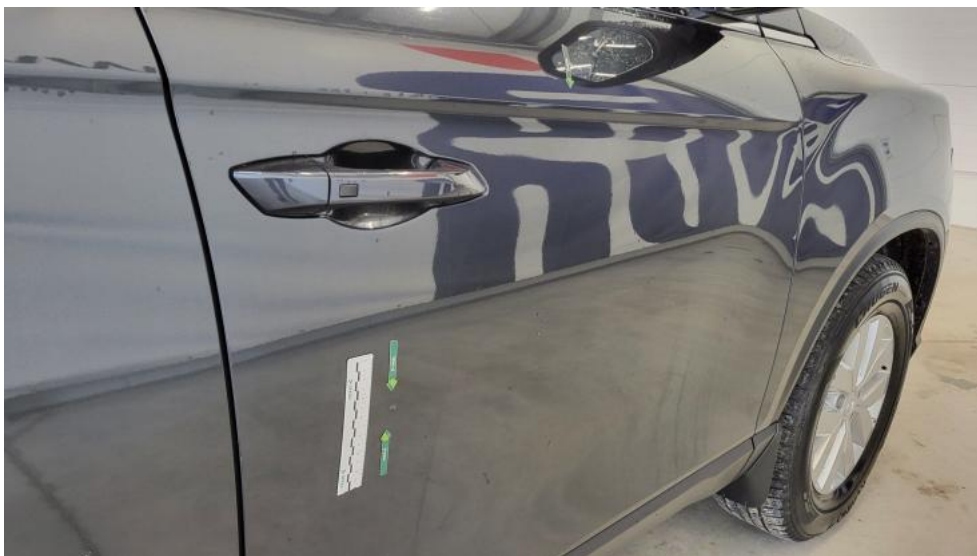
**Photo 50.**

Drzwi przednie P - zdjęcie poglądowe 1

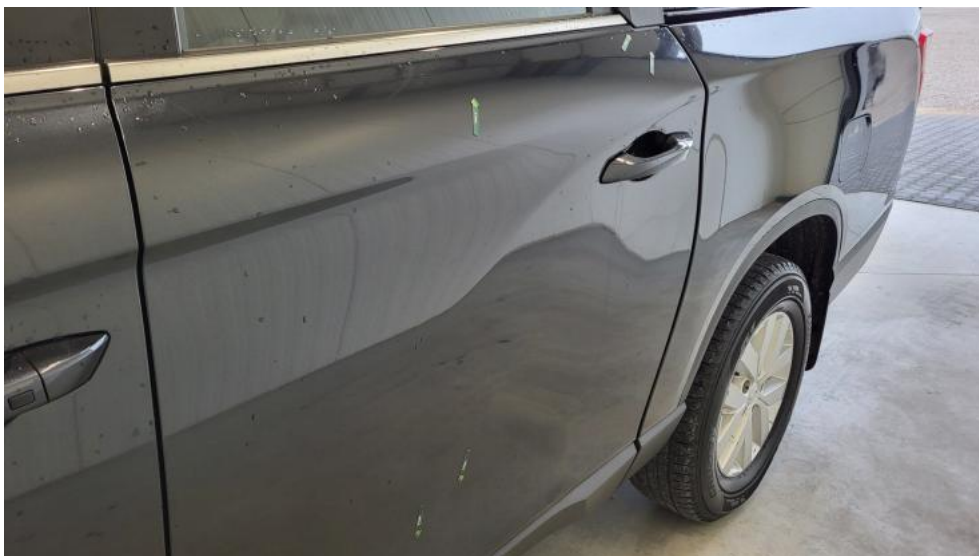
**Photo 62.**

Drzwi tylne L - zdjęcie poglądowe 1

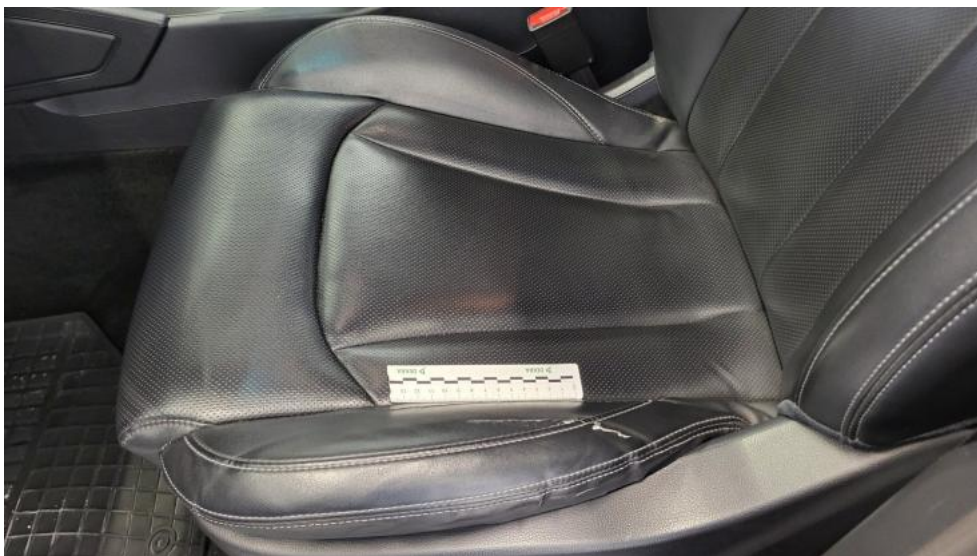
**Photo 67.**

Fotel prz. lew. - zdjęcie pogładowe 1
