DEKRA's commission No. : PKOL(W)/LODZ/14695/25/02/26
 commission/ damage No. : 24/009168
 Date of commission: 26-02-2025

PKO Leasing SA
 Świętokrzyska 36
 00-116 Warszawa

Vehicle data

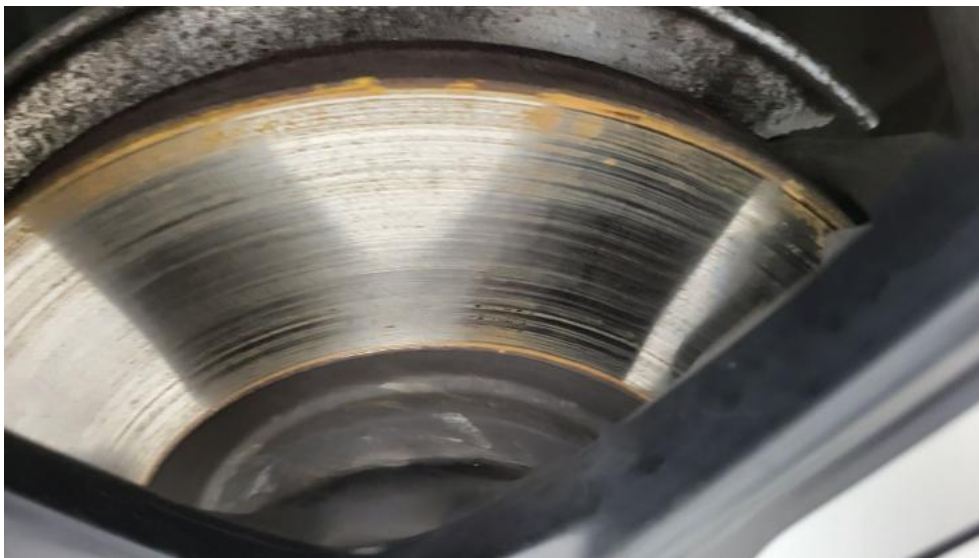
Photo 15.

Tarcza hamulcowa przednia prawa

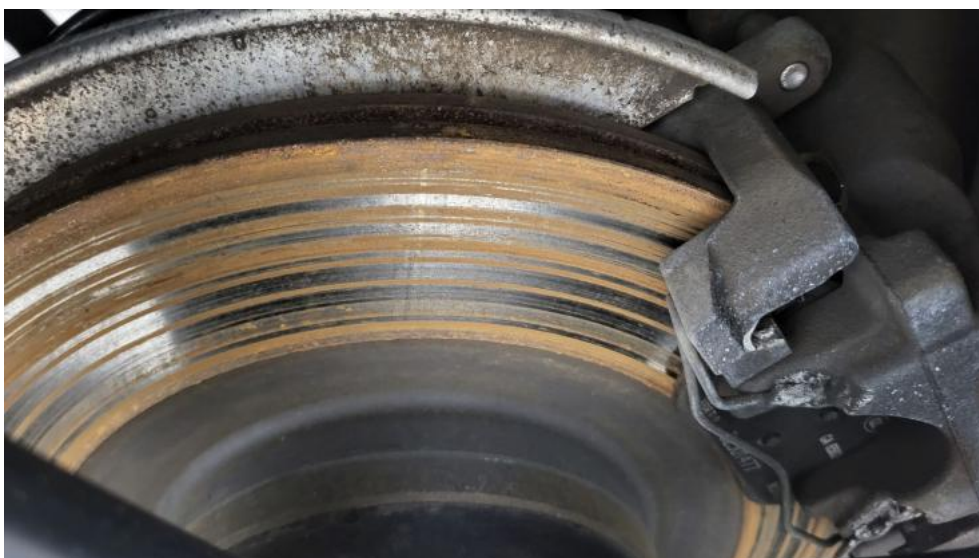
Photo 16.

Tarcza hamulcowa tylna prawa

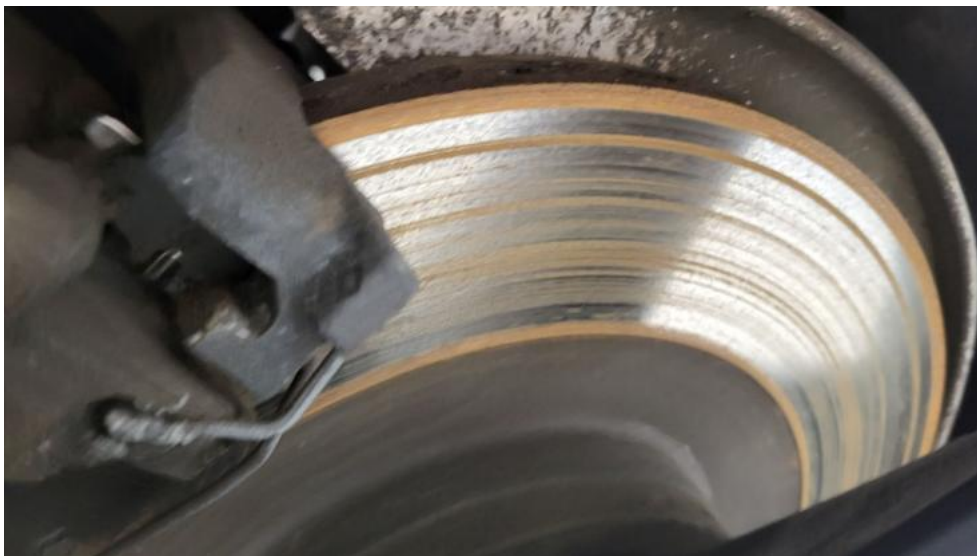
Photo 17.

Tarcza hamulcowa tylna lewa

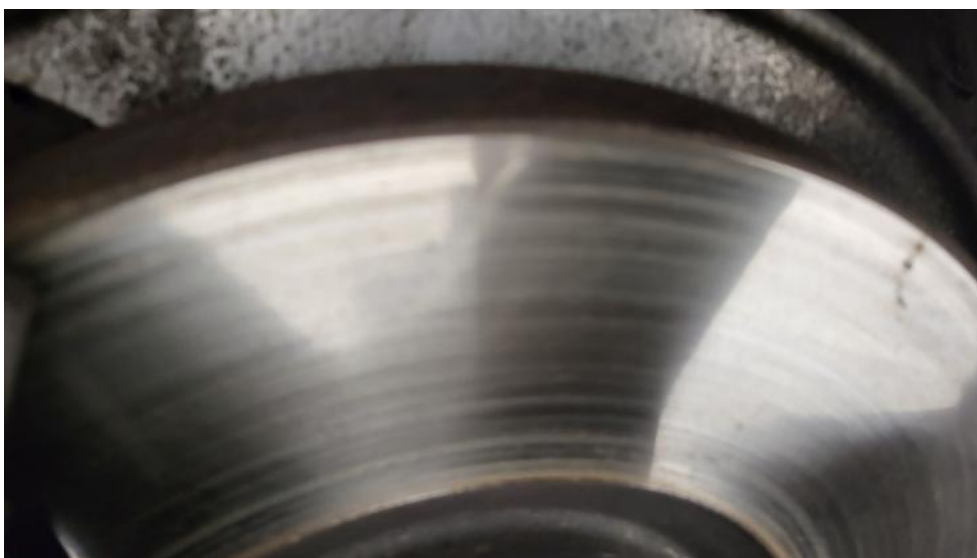
Photo 18.

Tarcza hamulcowa przednia lewa

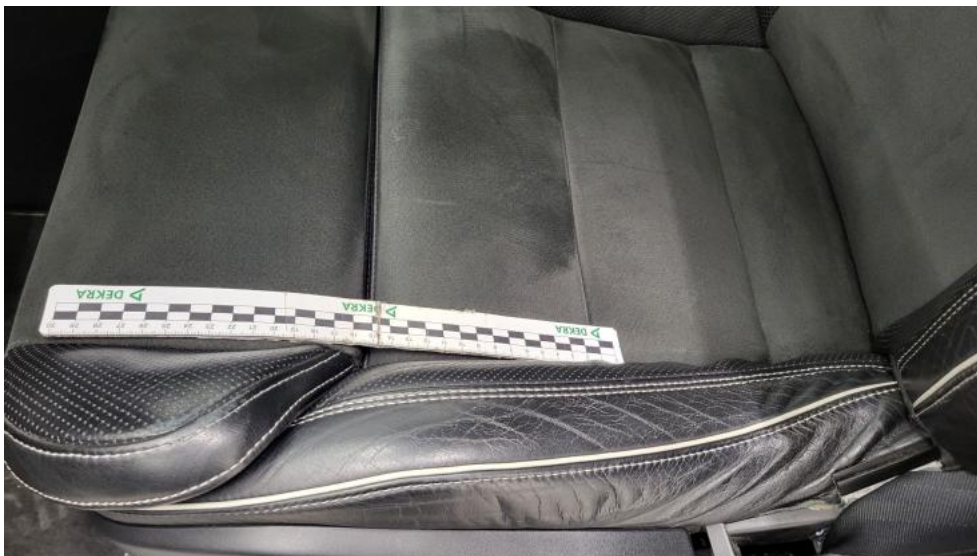
Photo 67.
Fotel prz. lew. - Inne 1
