DEKRA's commission No. : PKOL(W)/LODZ/84505/24/10/31
commission/ damage No. : 22/033947
Date of commission: 31-10-2024

Vehicle data

Measurement of thickness of the vehicle lacquer coating

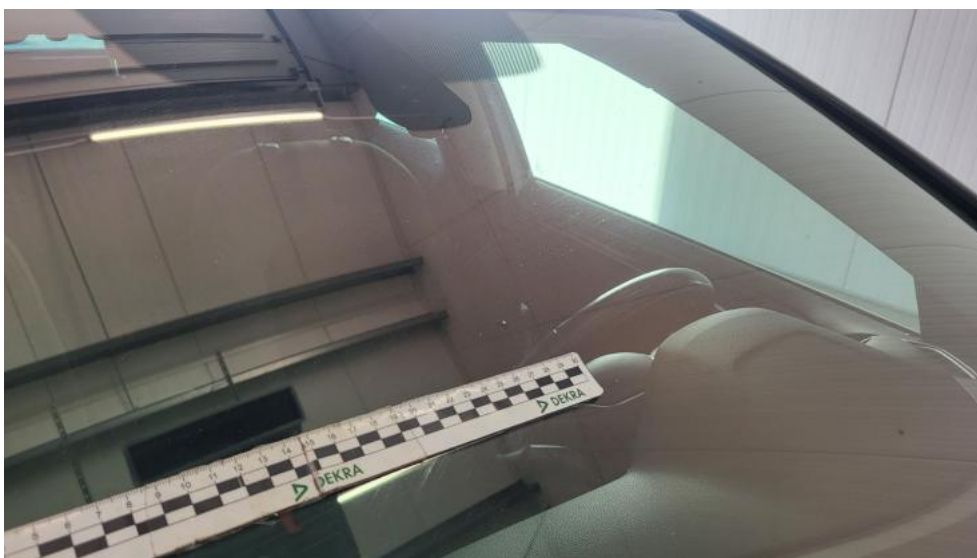
Photo 52.

Szyba czołowa - zdjęcie poglądowe 1

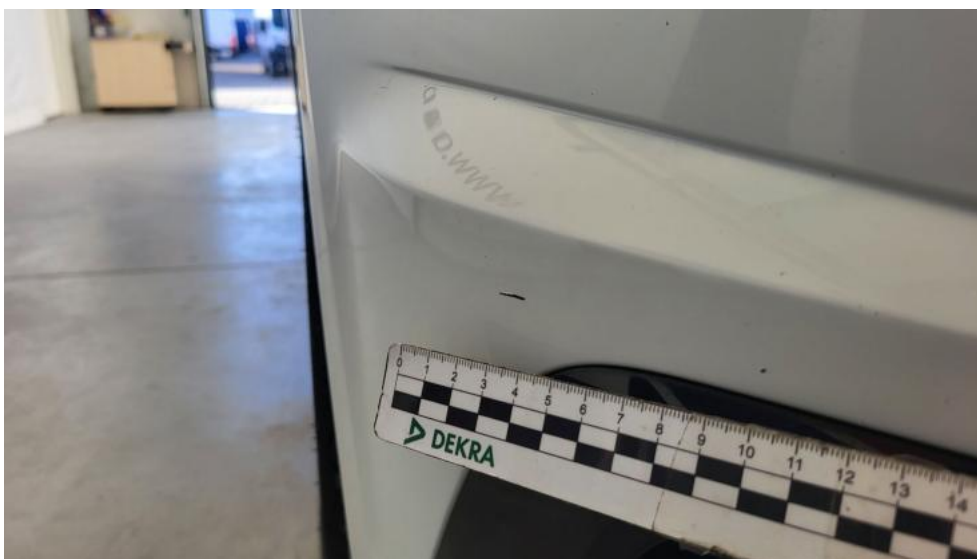
Photo 55.

Zderzak - zdjęcie poglądowe 1

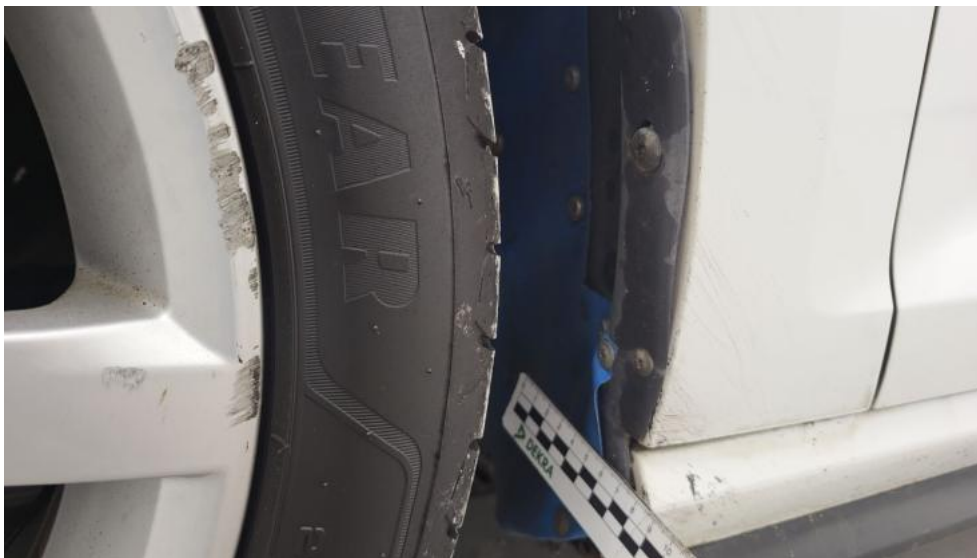
Photo 89.
Nadkole przednie L - Inne 1

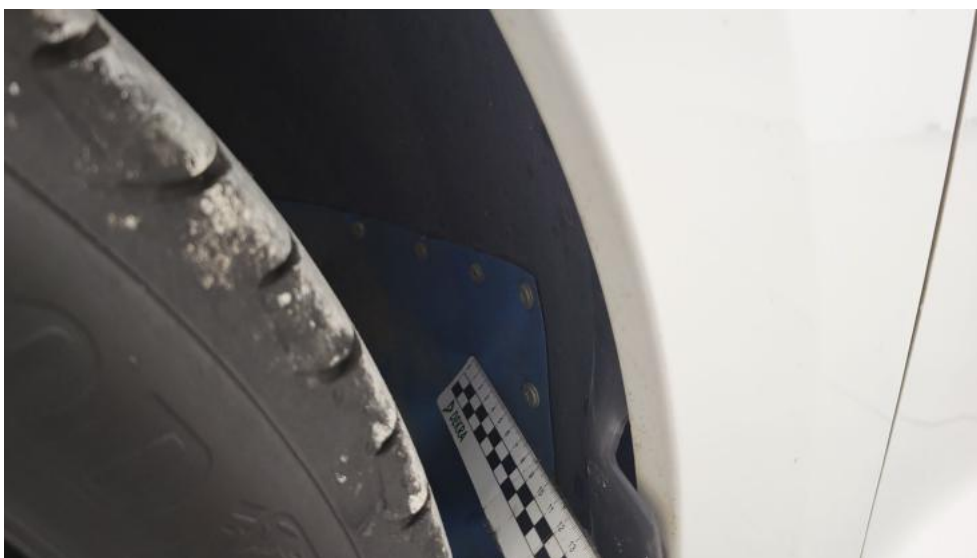
Photo 90.
Nadkole przednie L - Inne 2

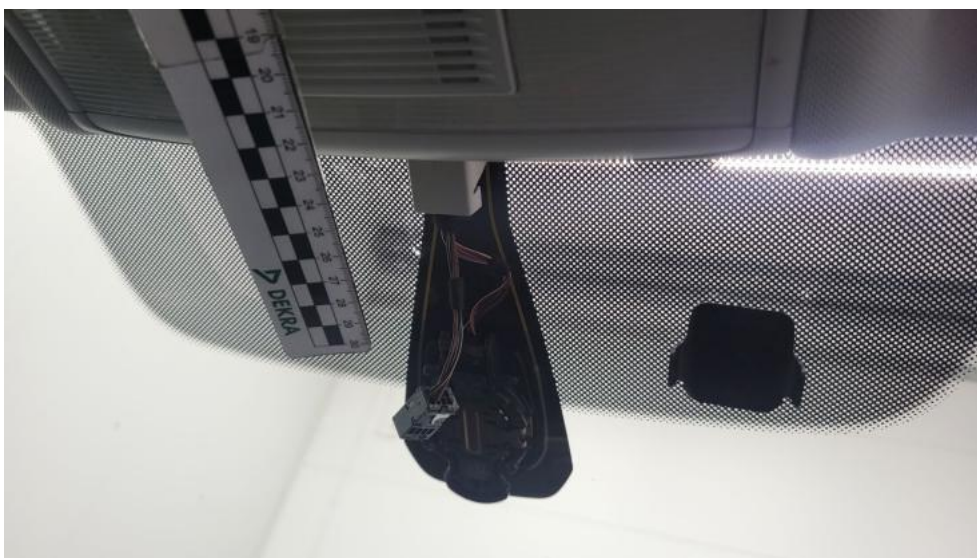
Photo 94.

Lusterko wsteczne wew - Inne 1

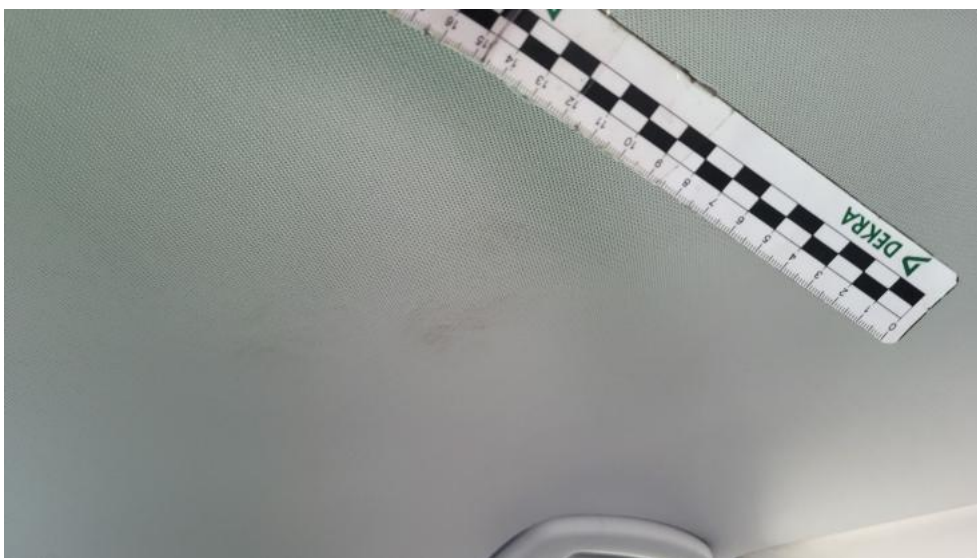
Photo 96.
Podsufitka - Inne 2
