DEKRA's commission No. : PKOL(W)/LODZ/84092/25/10/31  
commission/ damage No. : 23/010216  
Date of commission: 31-10-2025

| Model | X6 [G06] 19-23 |
| Type / version | X6 M Competition |
| Registration /record No. | KK80767 |

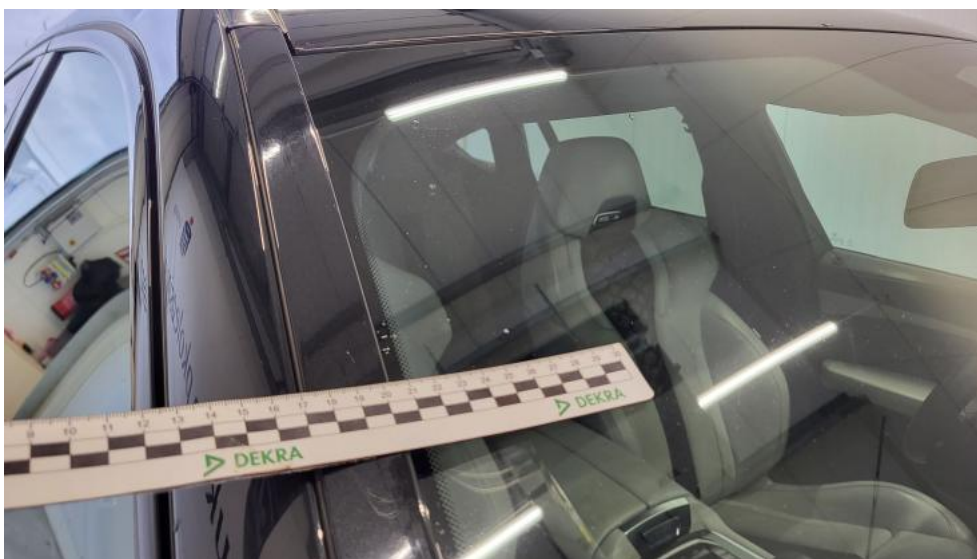
**Photo 51.**

Szyba czołowa - zdjęcie poglądowe 1

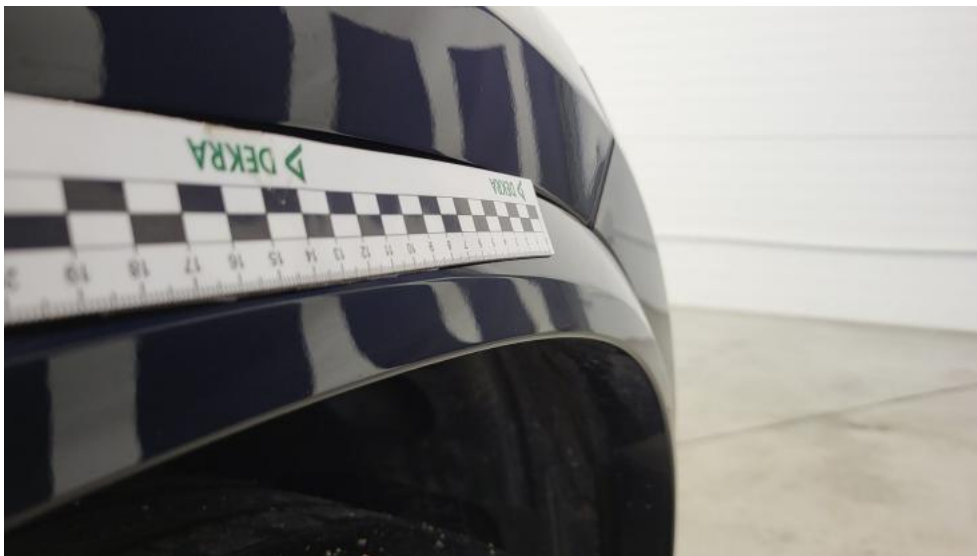
**Photo 55.**

Listwa błotnika przedniego P - Wgniecenie/odkształcenie 1

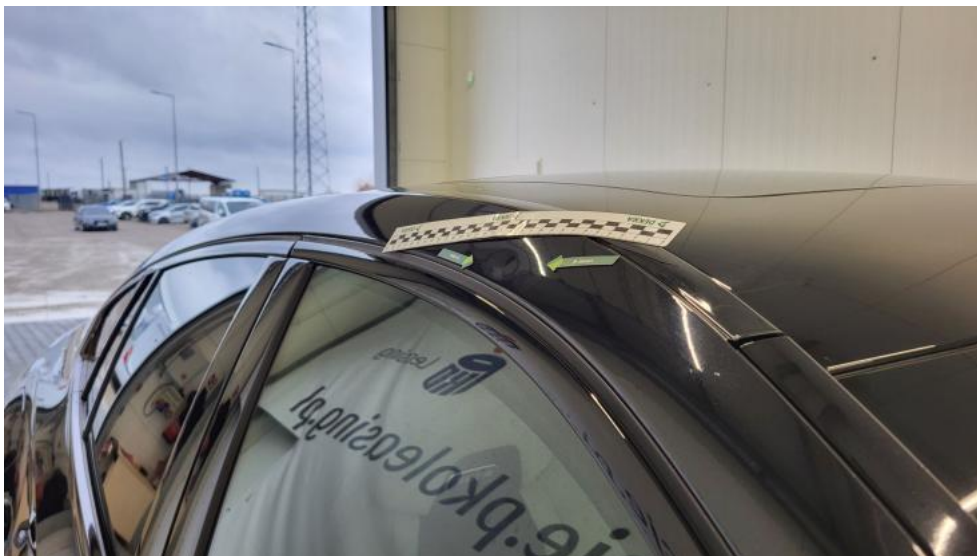
**Photo 61.**

Słupek przedni P - Wgniecenie/odkształcenie 1

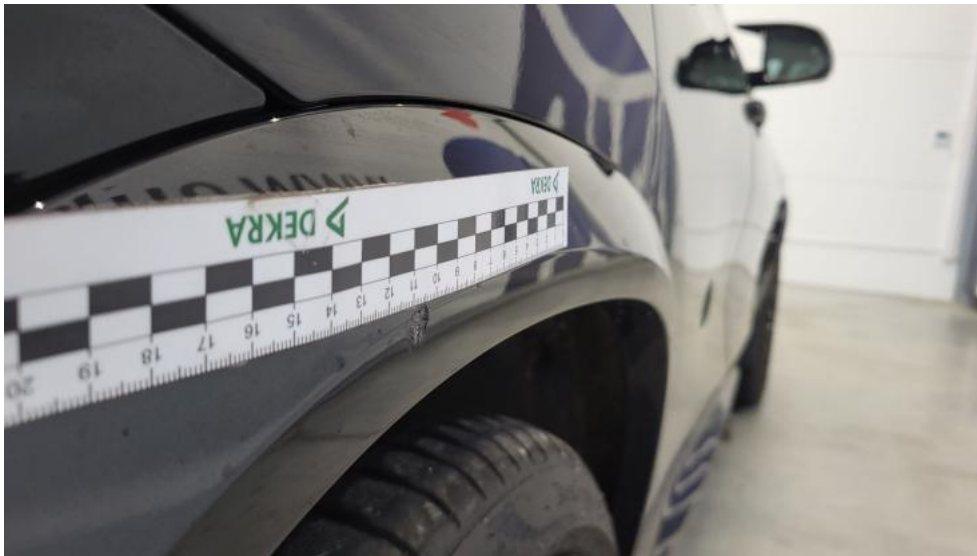
**Photo 65.**

Listwa krawędzi błotnika tyl P - Wgniecenie/odkształcenie 1

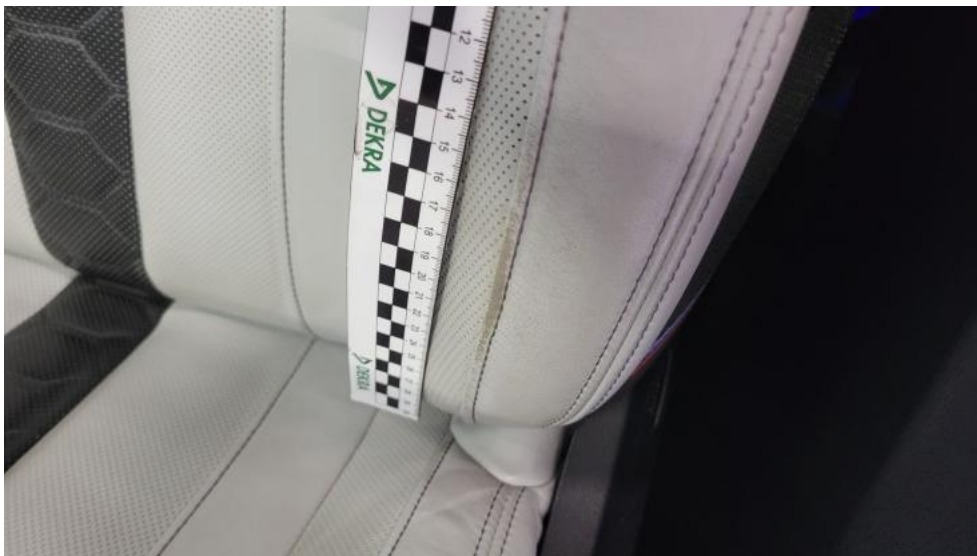
**Photo 81.**

Fotel prz. lew. - Inne 1
