DEKRA's commission No. : PKOL(W)/LODZ/77426/25/10/09  
commission/ damage No. : 21/035102  
Date of commission: 09-10-2025

| Manufacturer | FORD |
| Model | Mondeo Kombi 14-19 |
| Type / version | Mondeo 2.0 TDCi Titanium |

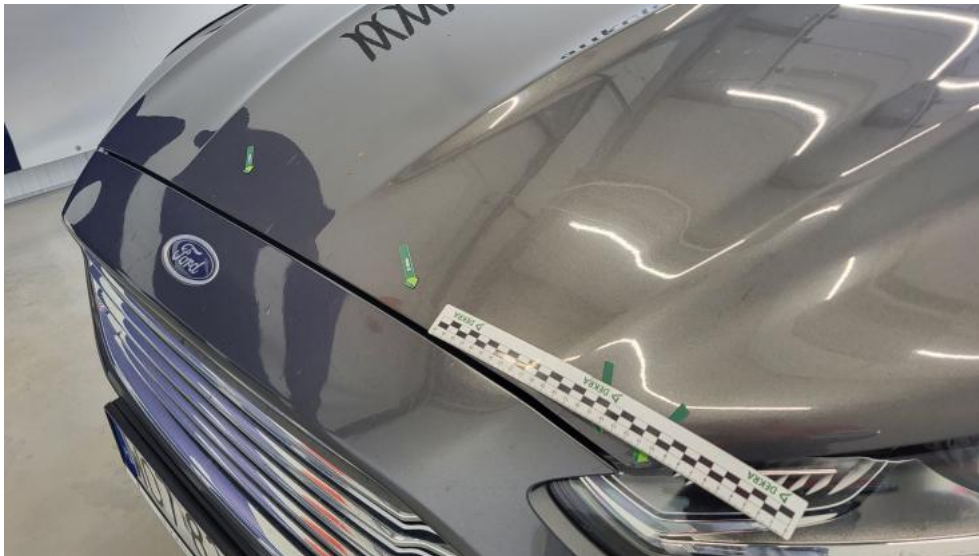
**Photo 35.**

Pokrywa komory silnika - zdjęcie poglądowe 1

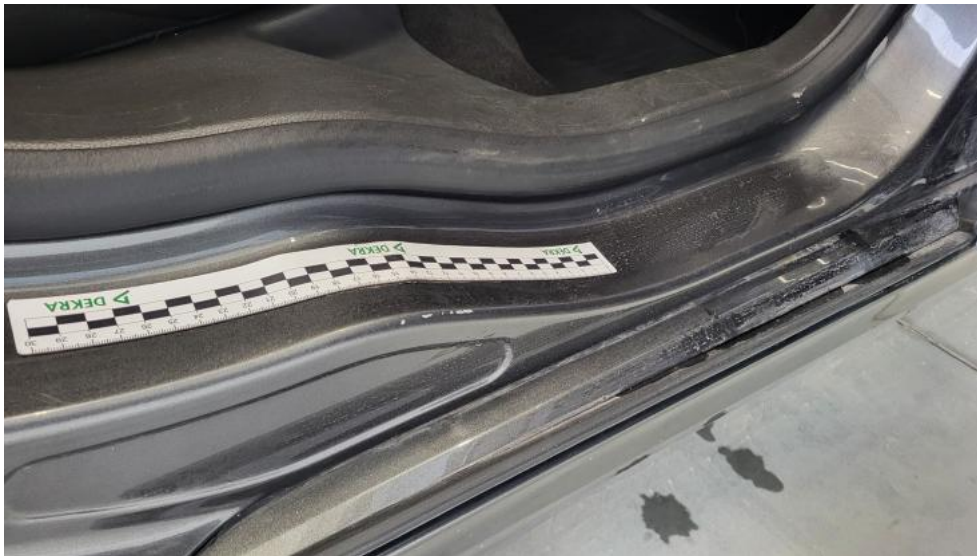
**Photo 45.**

Próg P - Rysa/odprysk 1

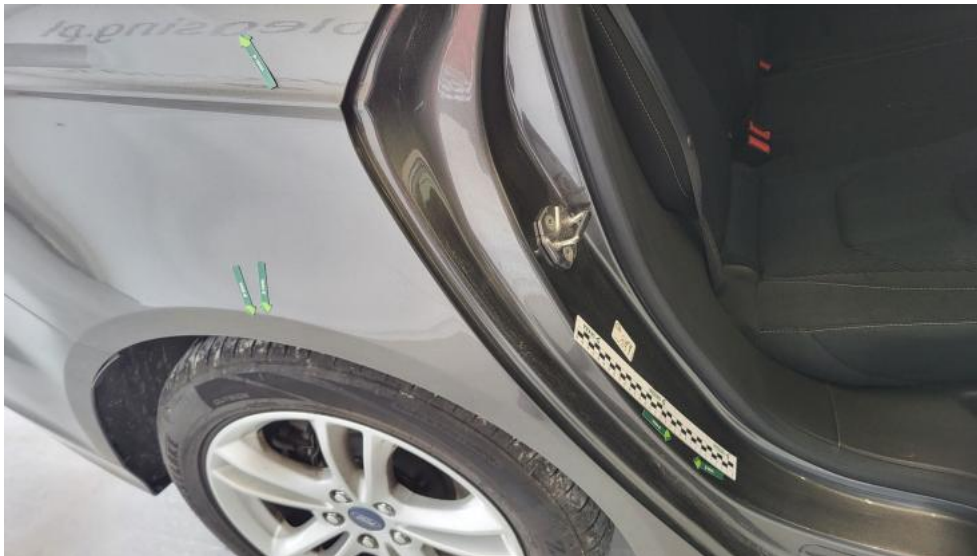
**Photo 49.**

Błotnik tylny P / Ściana boczna P - Wgniecenie/odkształcenie 2

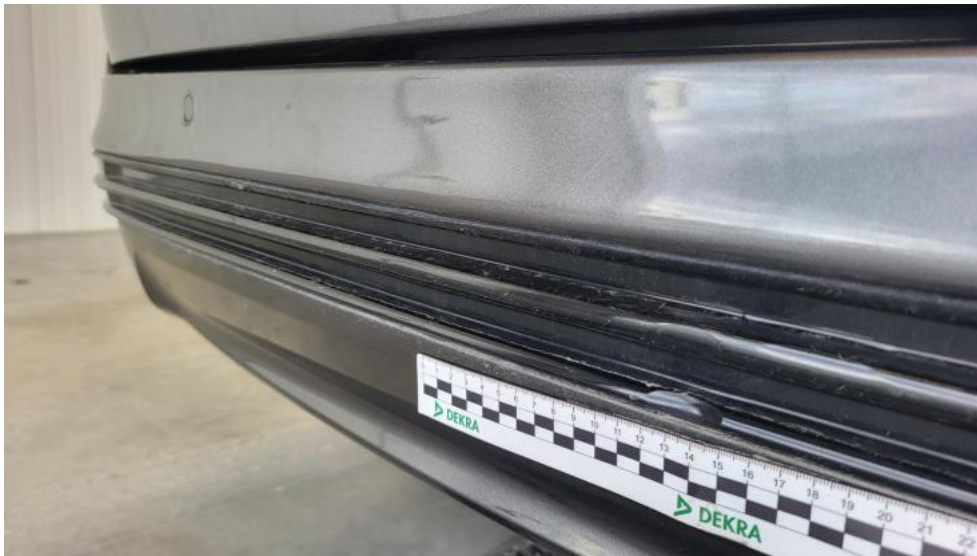
**Photo 51.**

Listwa śr zderzaka tylnego - Wgniecenie/odkształcenie 1

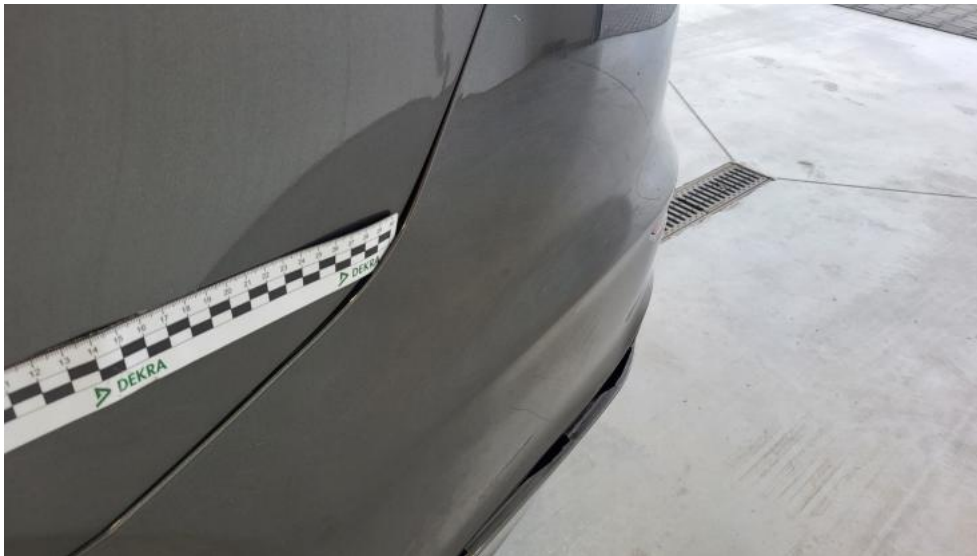
**Photo 55.**

Zderzak tylny - Inne 1

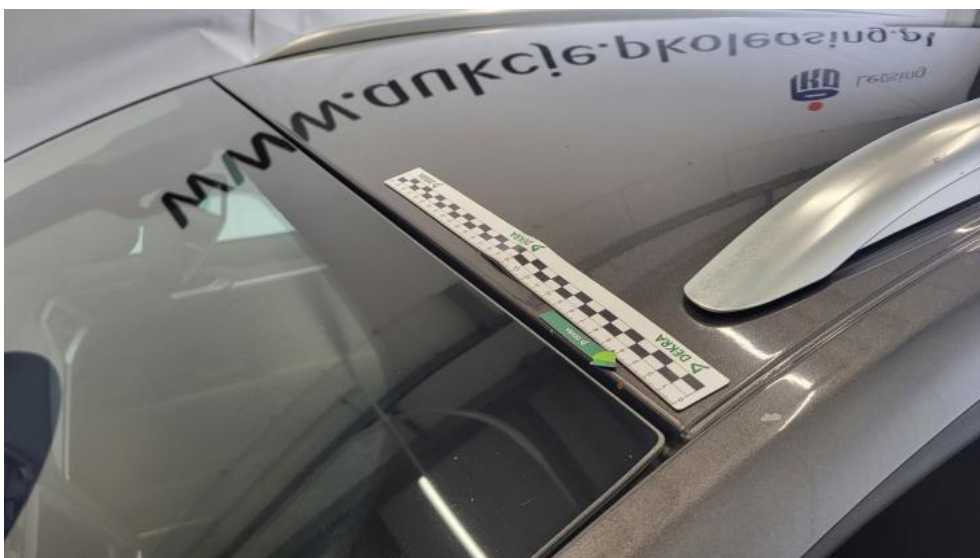
**Photo 58.**

Dach - zdjęcie poglądowe 1

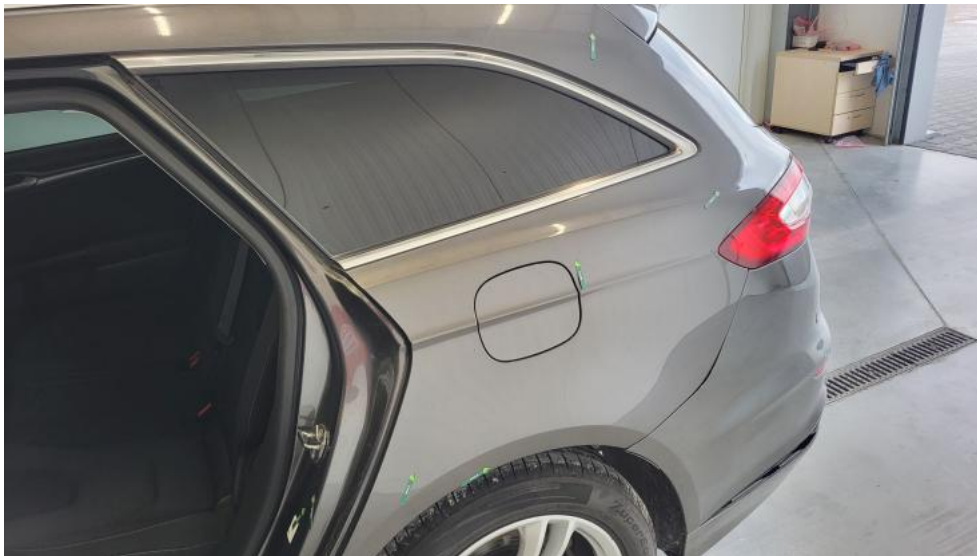
**Photo 61.**

Błotnik tylny L / Ściana boczna L - Wgniecenie/odkształcenie 1

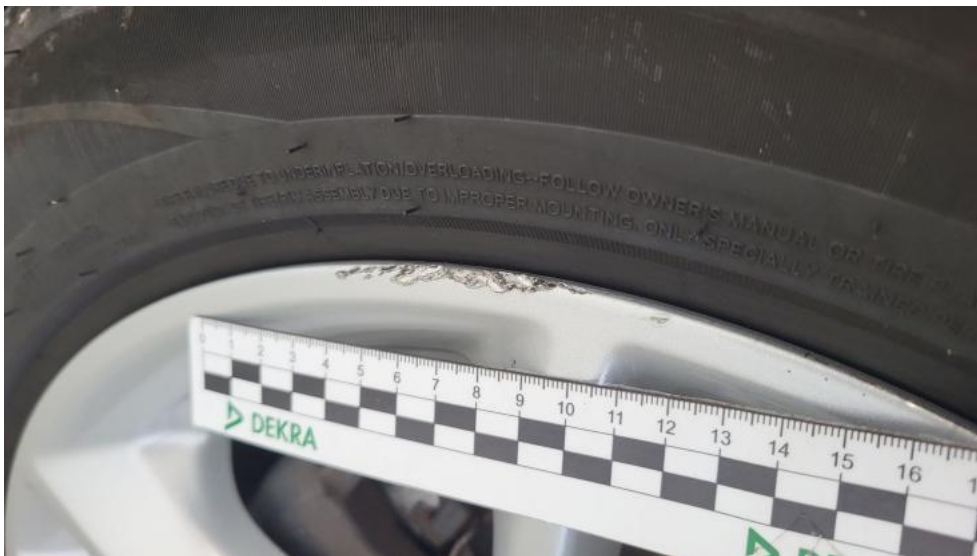
**Photo 69.**

Felga Aluminiowa przednia L - Rysa/odprysk 1

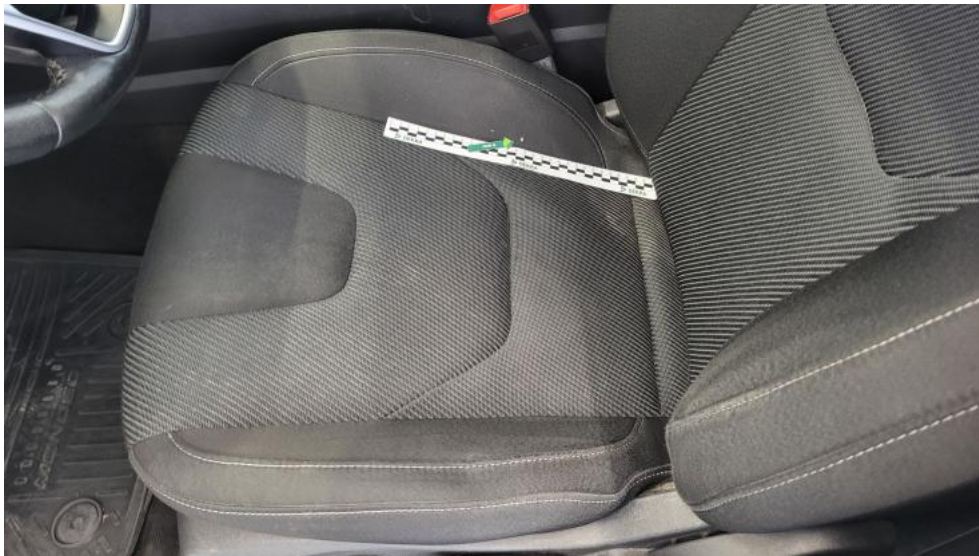
**Photo 71.**

Fotel prz. lew. - zdjęcie poglądowe 1

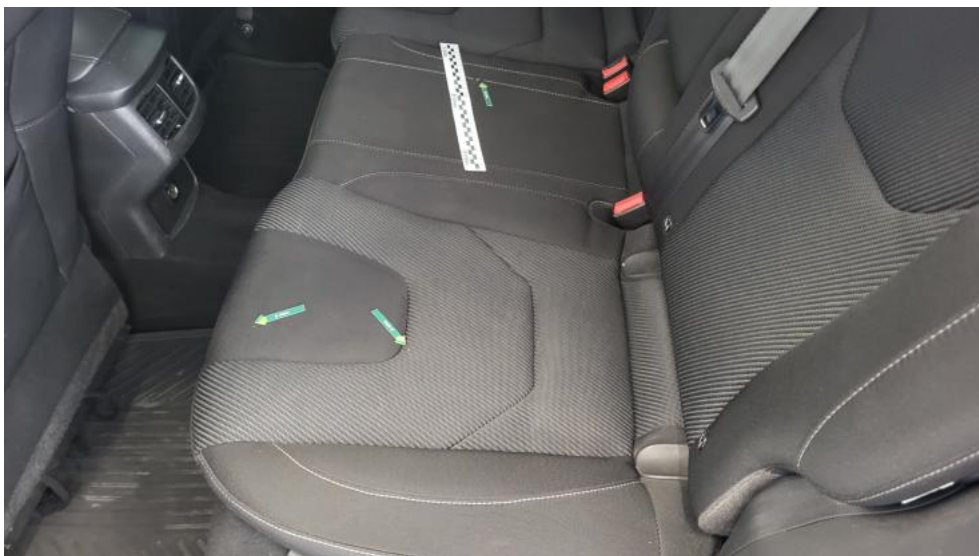
**Photo 74.**

Kanapa tyl. - zdjęcie poglądowe 1

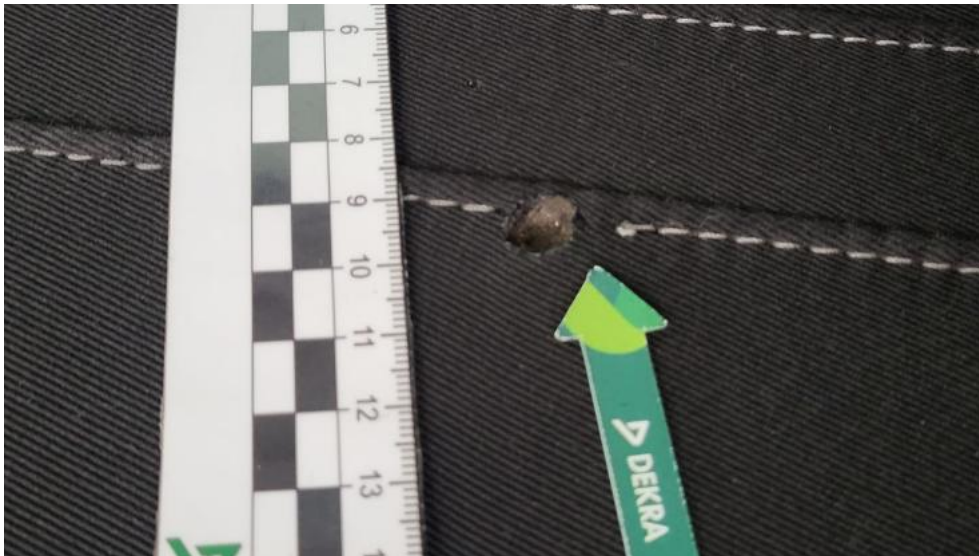
**Photo 75.**  
Kanapa tyl. - Inne 1

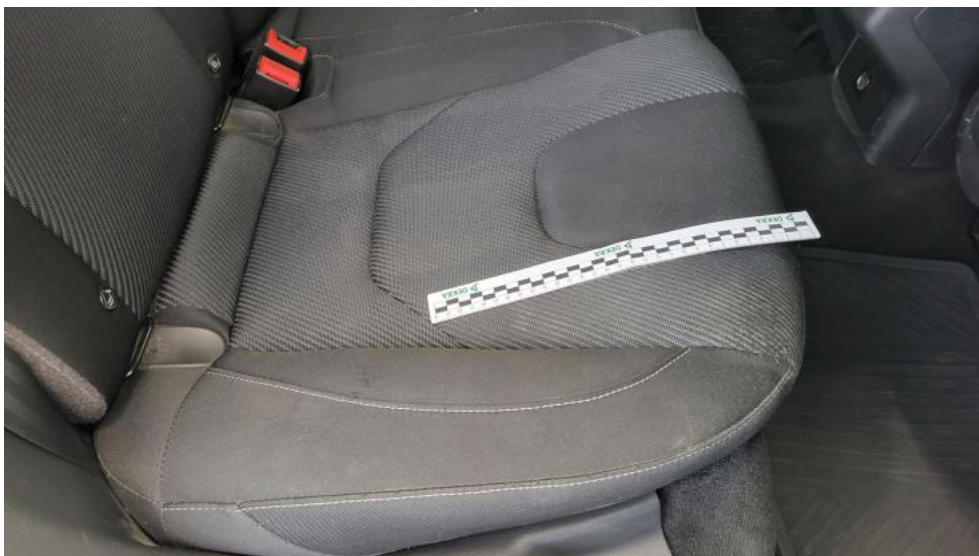
**Photo 76.**  
Kanapa tyl. - Inne 2

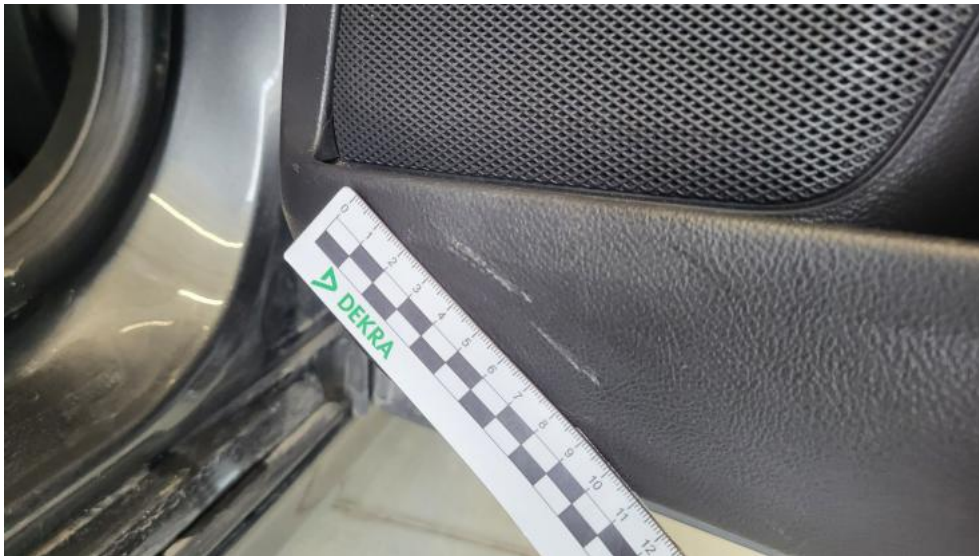
**Photo 79.**

Tapicerka drzwi tylnych P - Rysa/odprysk 1

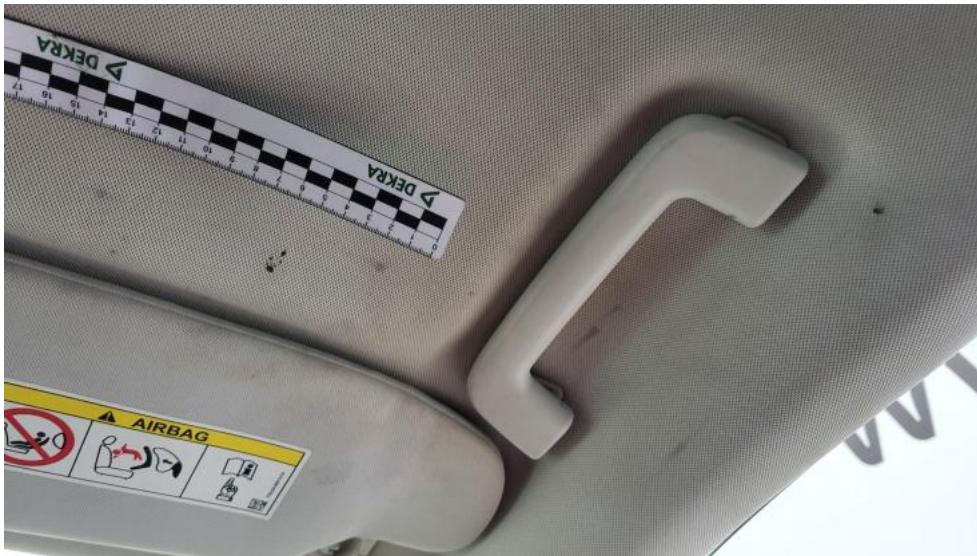
**Photo 83.**  
Podsufitka - Inne 2

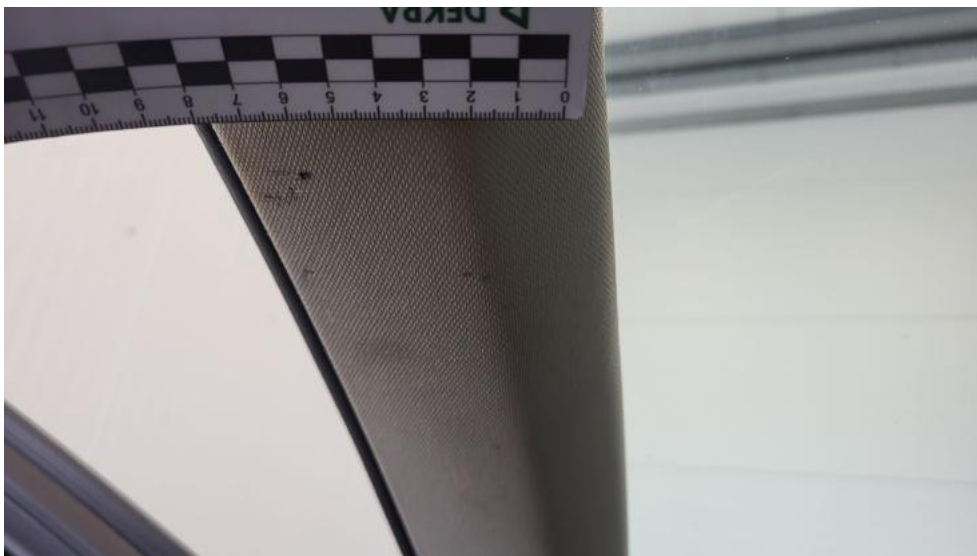
**Photo 84.**  
Wykładzina(y) słupka przedniego L - Inne 1

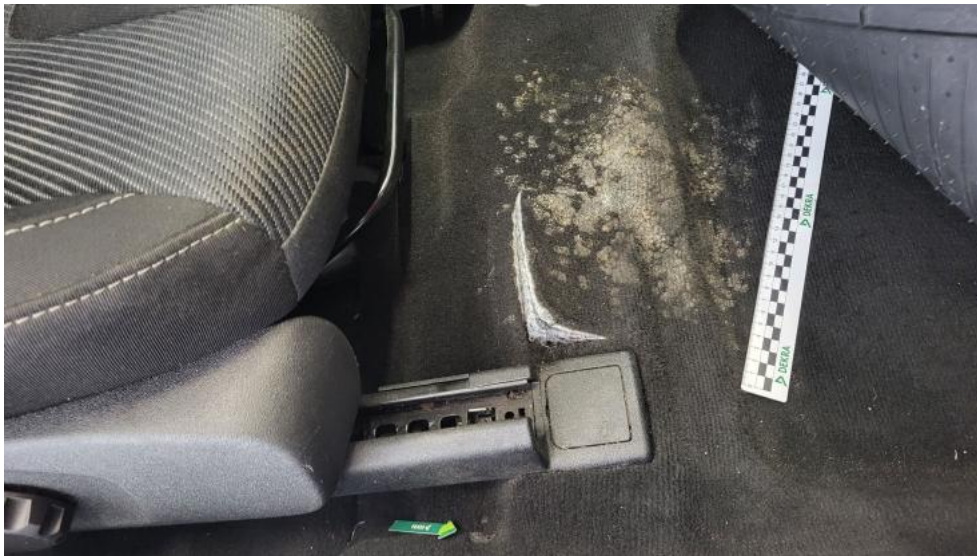
**Photo 87.**

Wykładzina podłogi - Inne 2
