DEKRA's commission No. : PKOL(W)/LODZ/04398/25/01/20
commission/ damage No. : 20/055859
Date of commission: 20-01-2025

Vehicle data

Group of objects (Eurotax)	jeeps
EC code (Eurotax)	0134506
Manufacturer	VOLVO
Model	XC60 17-21
Type / version	XC60 T4 Momentum aut
Body type	KOM
Number of doors / seats	5/5
Curb weight [kg]	1804
Gross vehicle weight [kg]	2390
Wheelbase 1/2	2865
Engine type	spark ignition
Pollution reduction system	three-way catalytic converter
Engine capacity [ccm]	1969
Engine Power [hp/kW]	190/140
Gearbox	automatic 8- gear
Registration /record No.	PO5SM79
VIN / serial number	LYVUZAKVDLB607362
Date of first registration	29-12-2020
Date of next. tech. test	29-12-2025
Year of manufacture	2020 (year has been verified with the manufacturer's base)
Readout [km]	105 257 (read)
Body color / type of coating	grafitowy/METALIK

Measurement of thickness of the vehicle lacquer coating

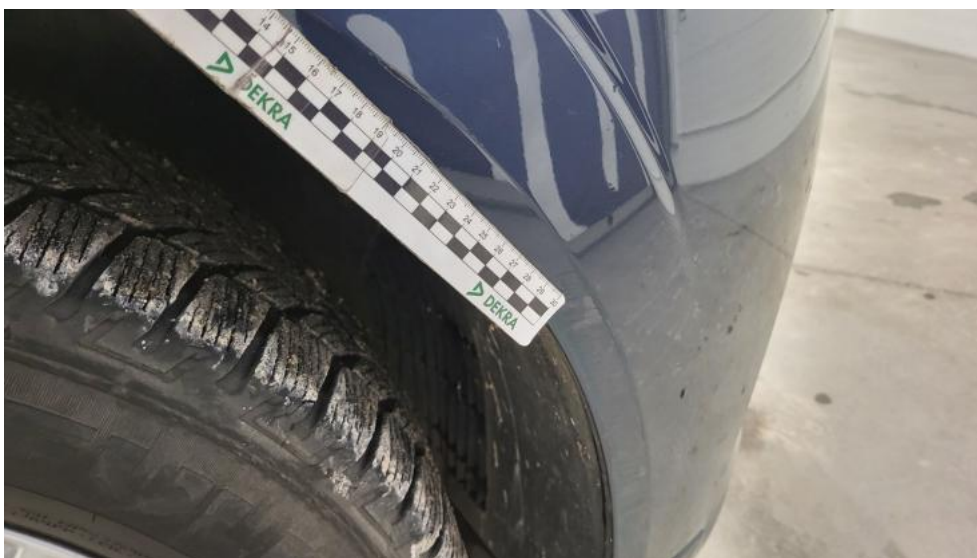
Photo 44.
Zderzak - zdjęcie pogładowe 1
