DEKRA's commission No. : PKOL(W)/LODZ/88562/26/09/21  
commission/ damage No. : 23/032489  
Date of commission: 21-09-2026

| Manufacturer | HYUNDAI |
| Model | Tucson 18-21 |
| Type / version | Tucson 1.6 T-GDi Premium 4WD DCT |

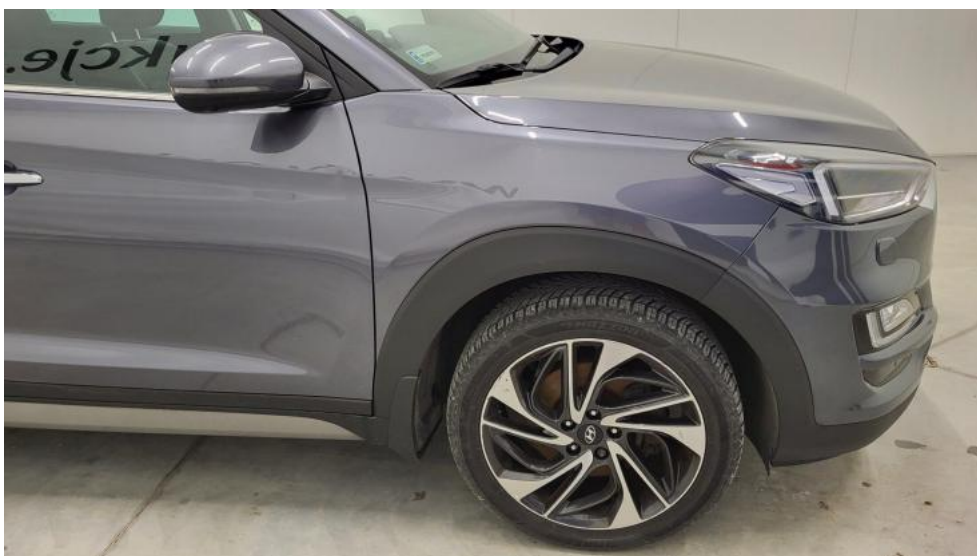
**Photo 4.**

Bok prawy z przodu

Drzwi przednie P - Rysa/odprysk 2

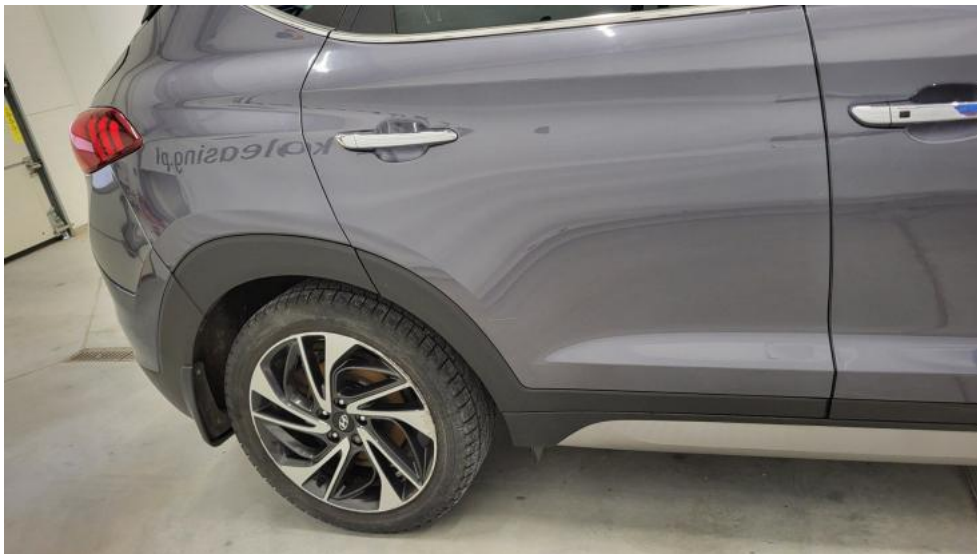
**Photo 5.**  
Bok prawy z tyłu

Drzwi tylne P - Rysa/odprysk 2

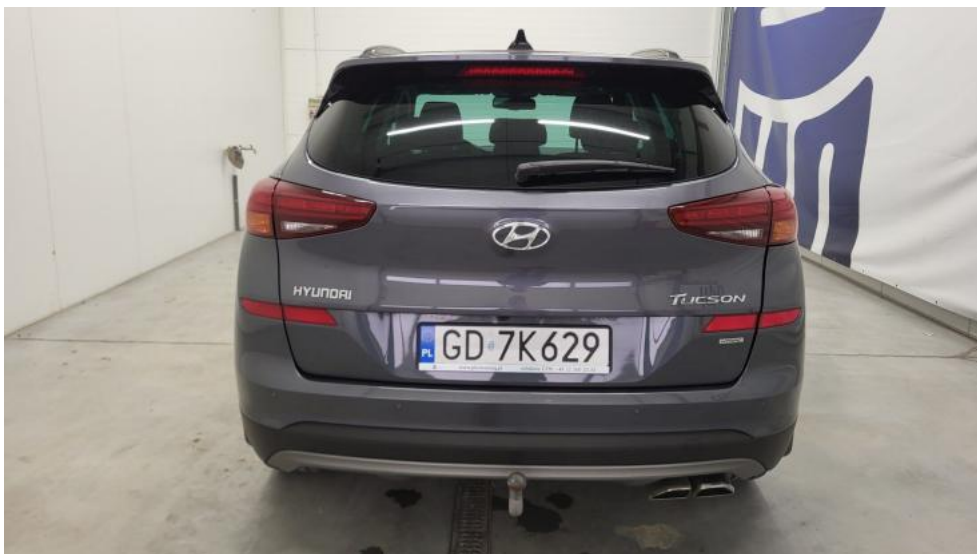
**Photo 7.**

Tył

Zderzak tylny - Rysa/odprysk 2

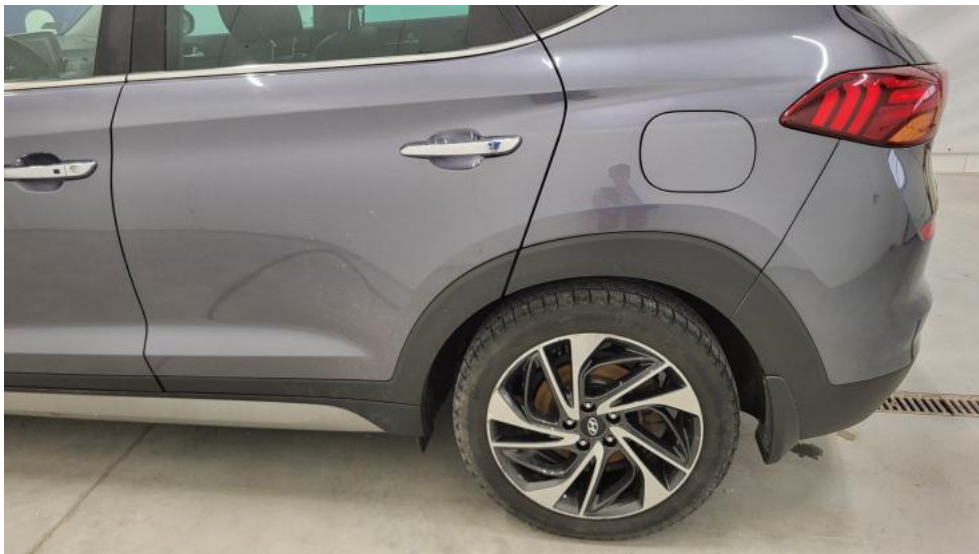
**Photo 9.**

Bok lewy z tyłu

Drzwi tylne L - Rysa/odprysk 2

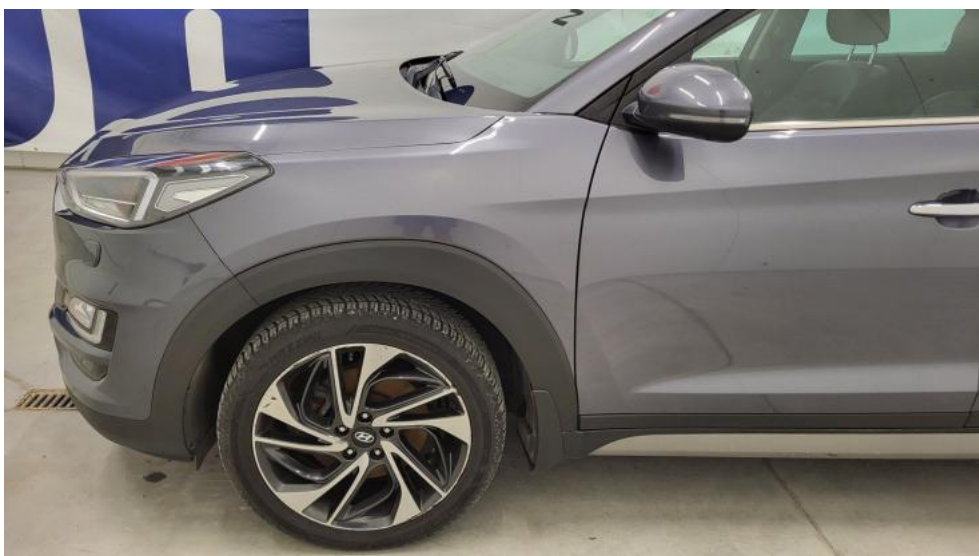
**Photo 10.**

Bok lewy z przodu

Drzwi przed L - Rysa/odprysk 2

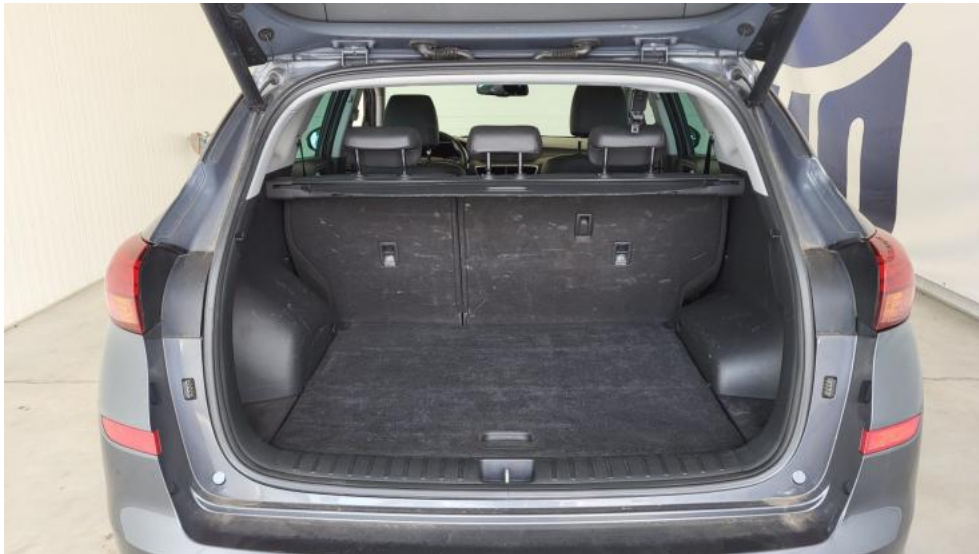
**Photo 19.**  
Bagażnik

Wykładzina przestrzeni bagażowej - Rysa/odprysk 2

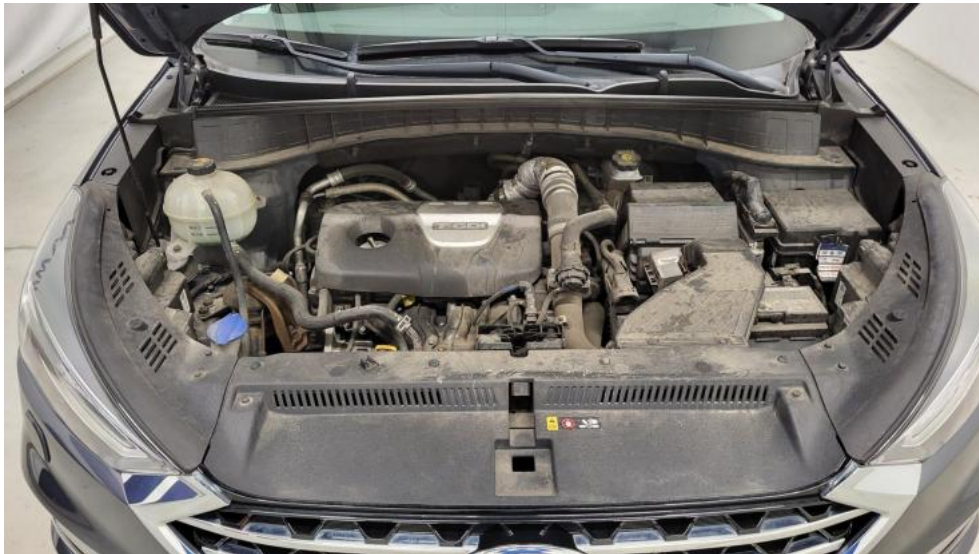
Rysy na samochodzie. Brak aktualnych badań technicznych. Aktywna kontrolka silnika. Niesprawny akumulator. Poziom płynu układu chłodniczego poniżej minimum. Odpryski na szybie czołowej. Widoczne ślady wycieków.

**Photo 21.**  
Komora silnika

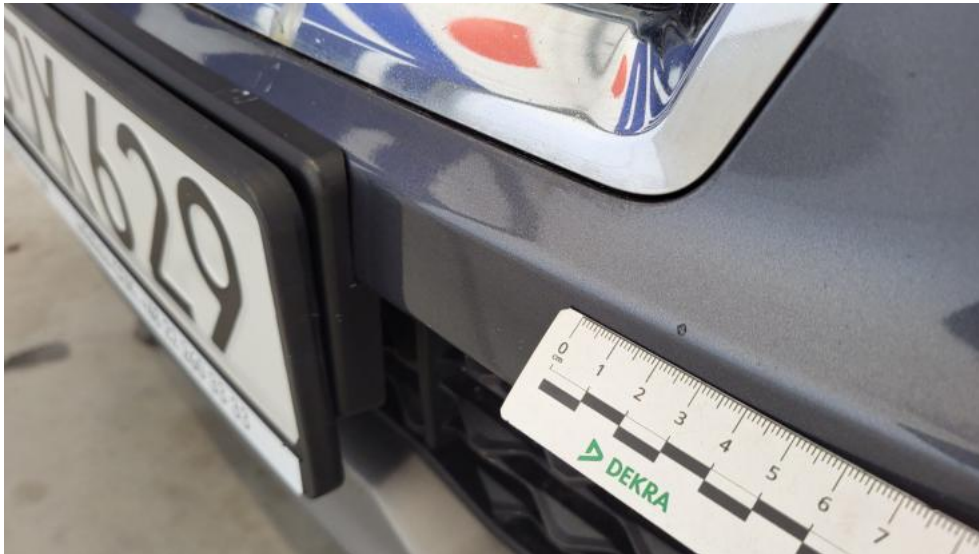
**Photo 45.**

Zderzak - Rysa/odprysk 1

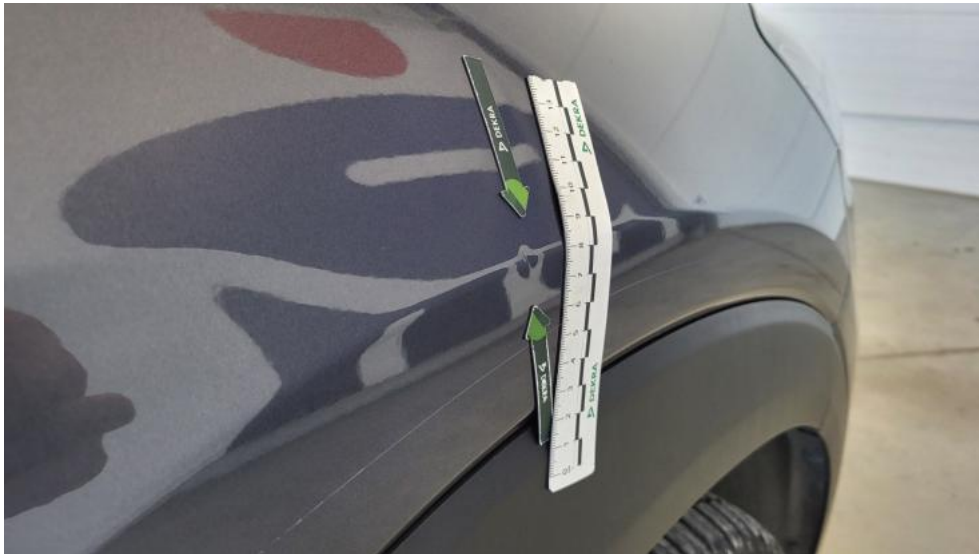
**Photo 47.**

Błotnik przedni P - Wgniecenie/odkształcenie 1

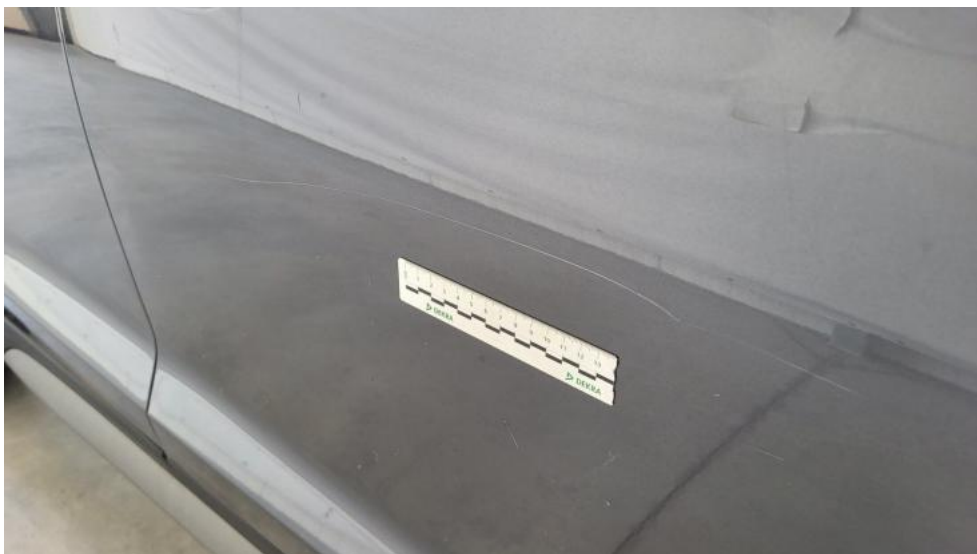
**Photo 51.**

Drzwi przednie P - Rysa/odprysk 1

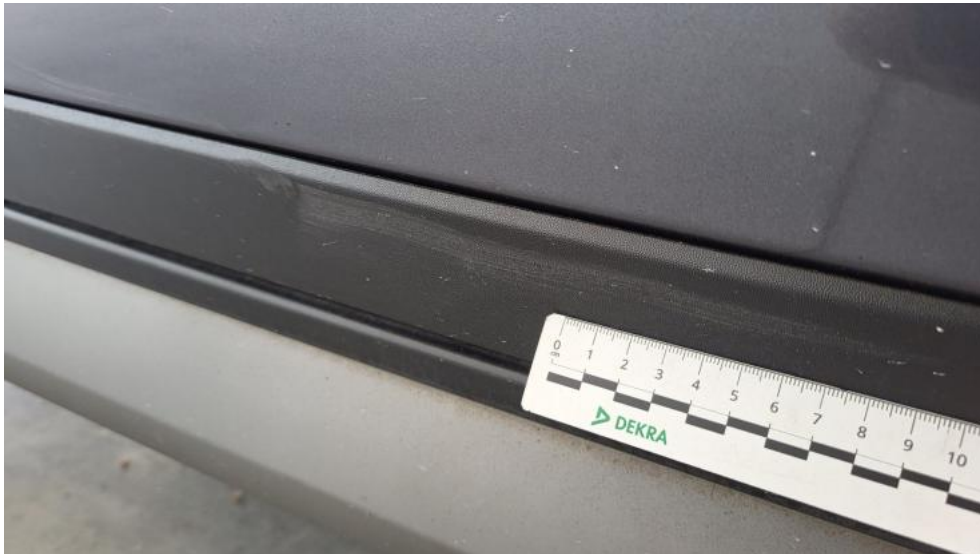
**Photo 57.**

Listwa drzwi przednich P - Rysa/odprysk 1

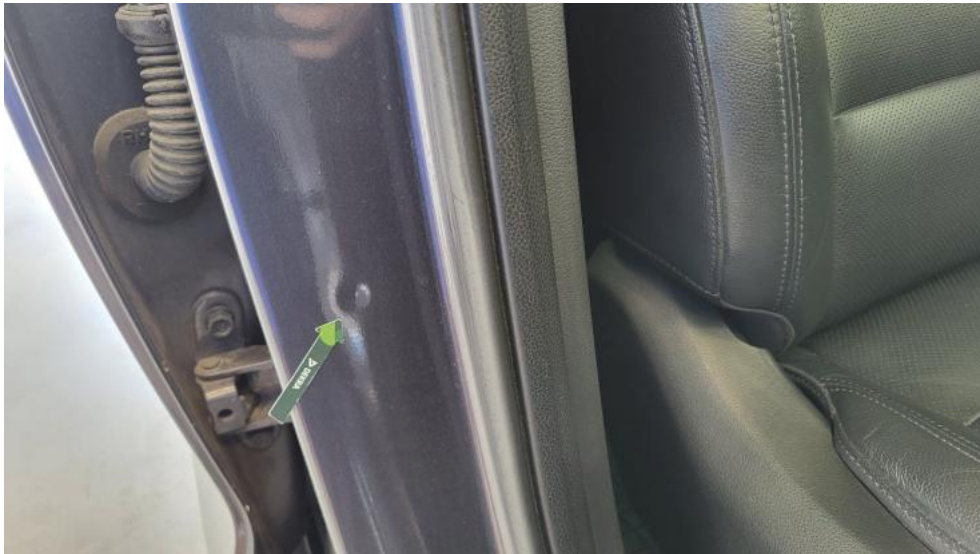
**Photo 61.**

Słupek środkowy P - Wgniecenie/odkształcenie 1

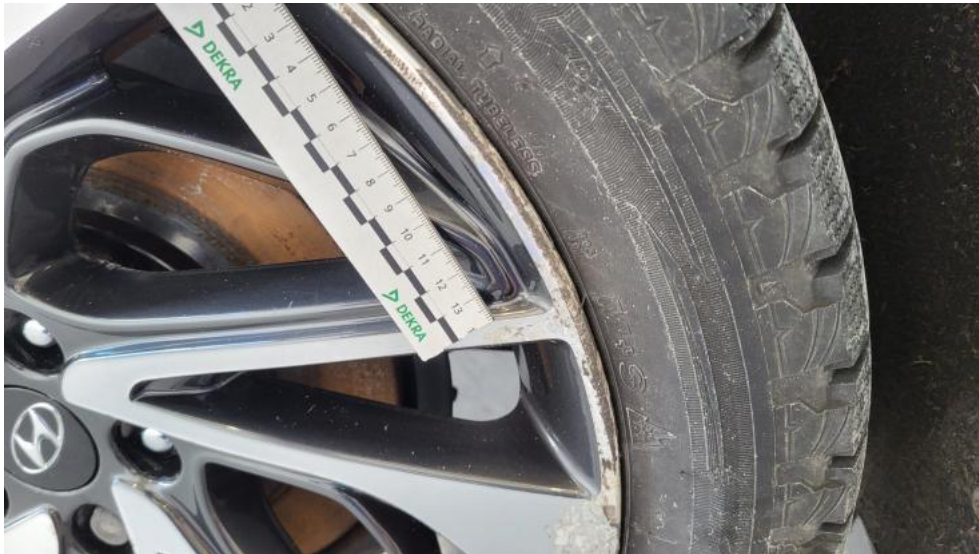
**Photo 65.**

Felga aluminiowa tylna P - Rysa/odprysk 1

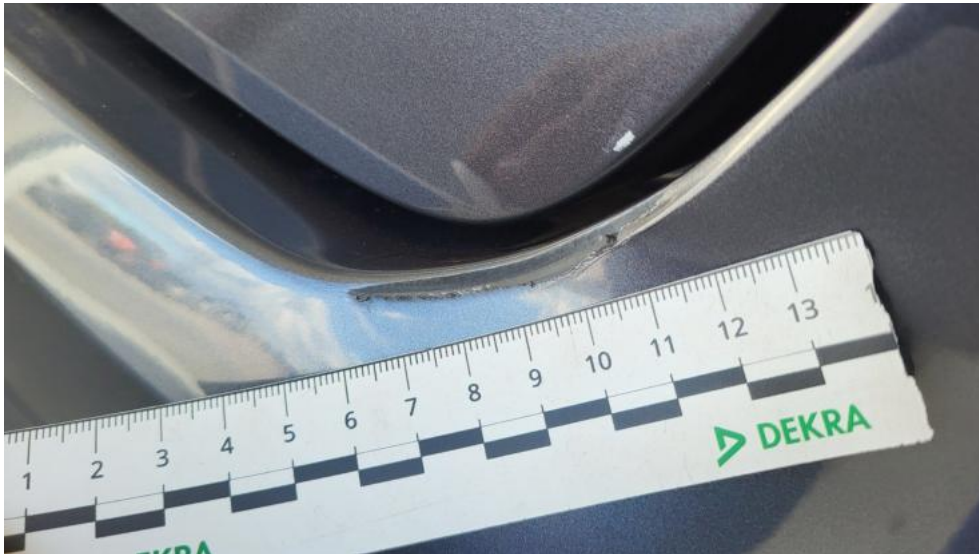
**Photo 71.**

Zderzak tylny - Rysa/odprysk 1

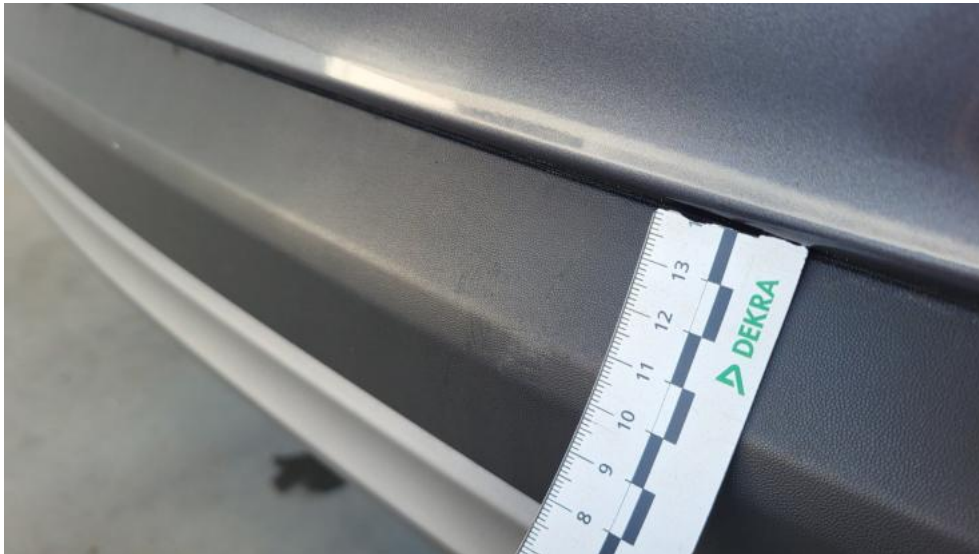
**Photo 75.**

Zderzak tylny cz dolna - Rysa/odprysk 1

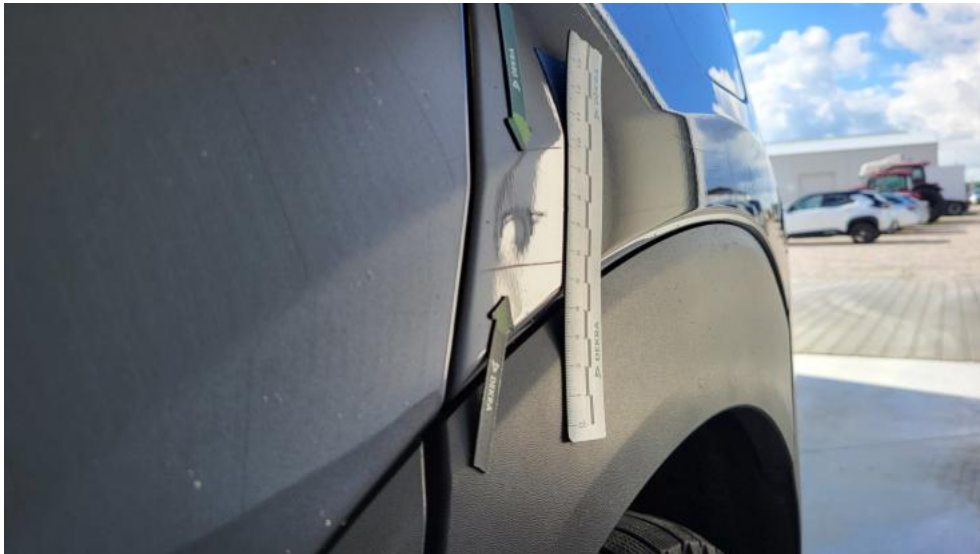
**Photo 77.**

Błotnik tylny L / Ściana boczna L - Wgniecenie/odkształcenie 1

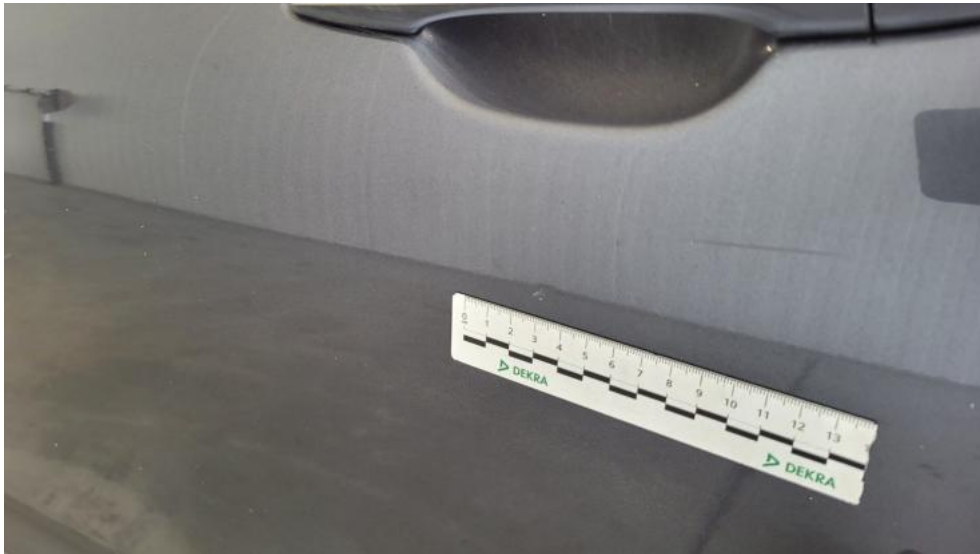
**Photo 83.**

Drzwi przed L() - Rysa/odprysk 3

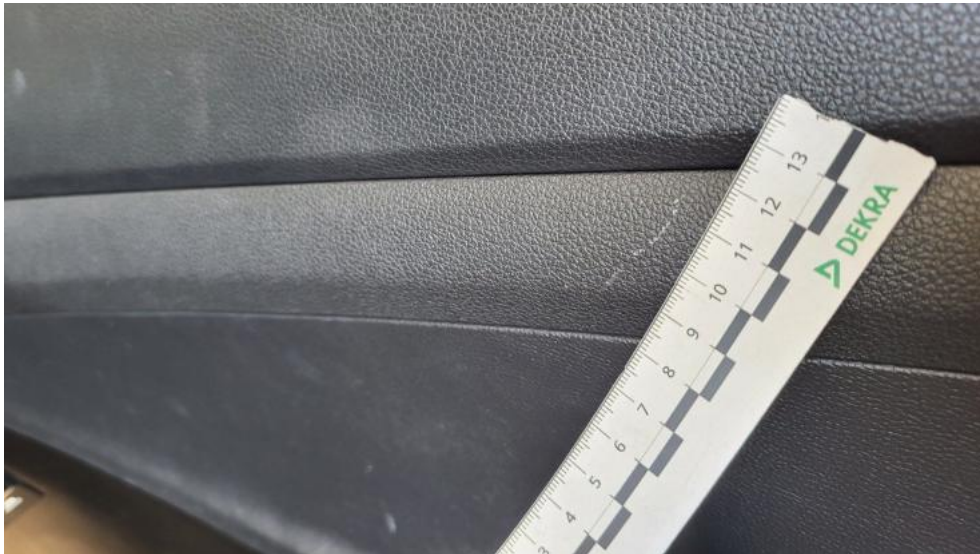
**Photo 95.**

Tapicerka drzwi przednich P - Rysa/odprysk 1

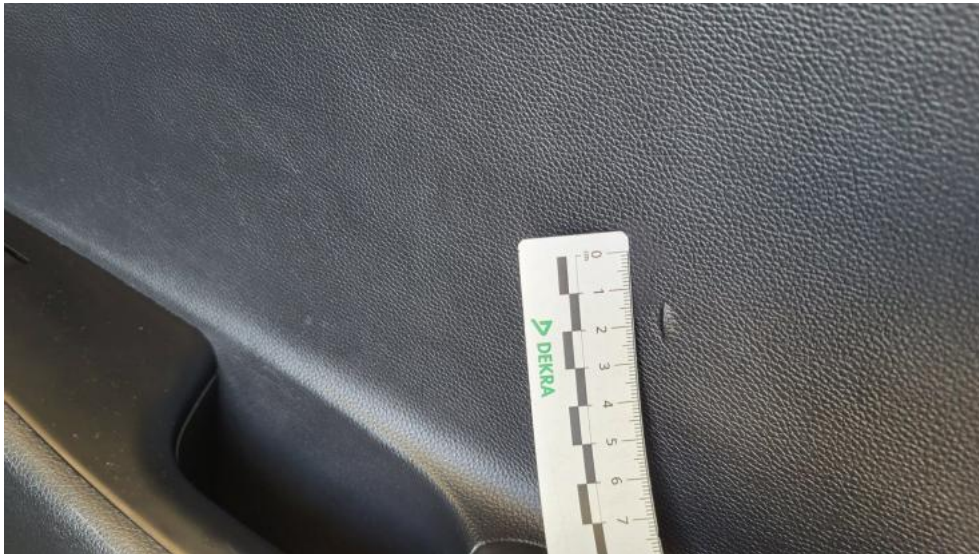
**Photo 97.**

Tapicerka drzwi tylnych P - Wgniecenie/odkształcenie 1

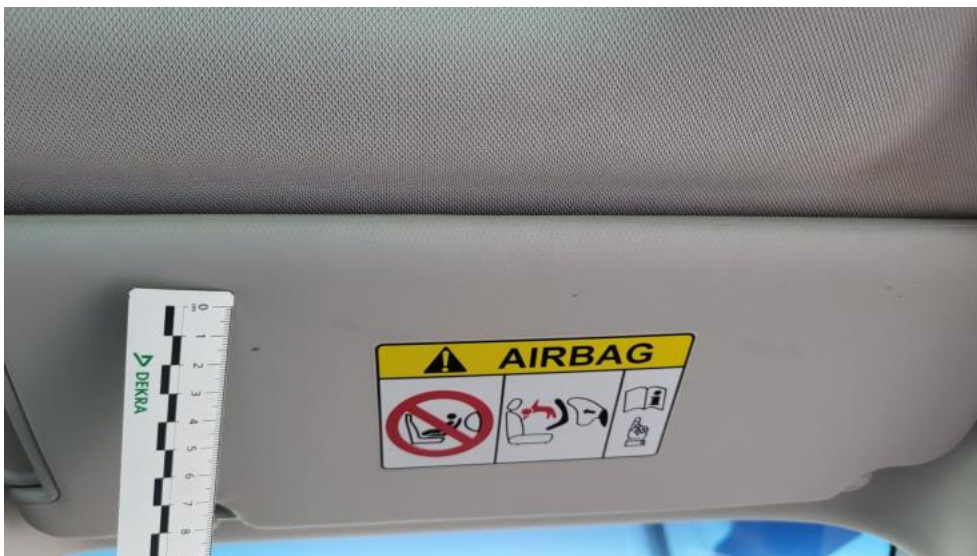
**Photo 99.**

Osłona p/słoneczna prawa - Inne 1

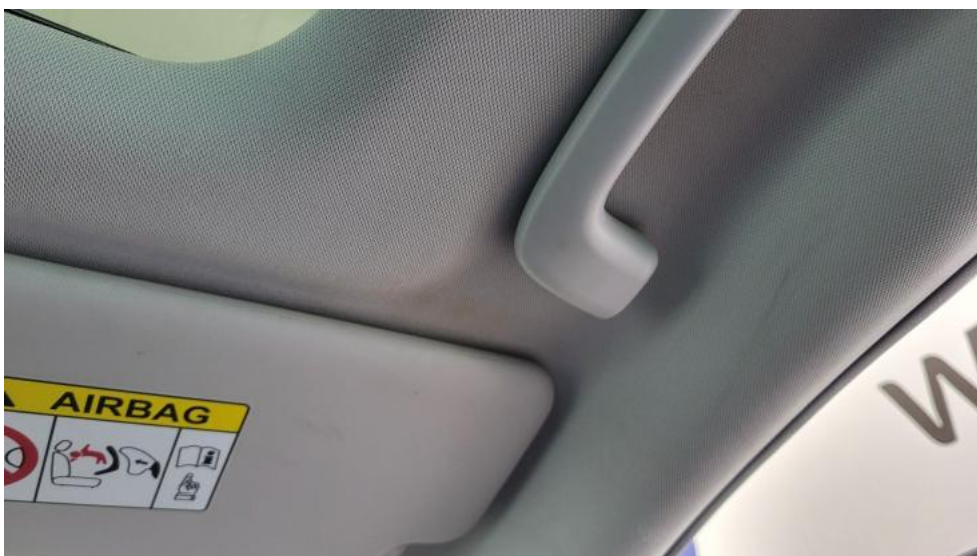
**Photo 100.**

Podsufitka - Inne 1

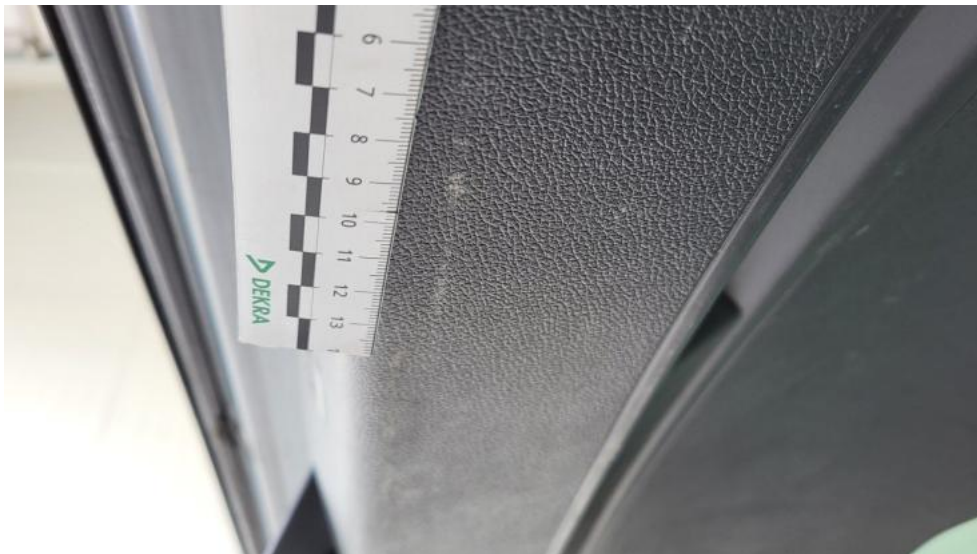
**Photo 101.**

Wykładzina pokrywy tylnej - Rysa/odprysk 1

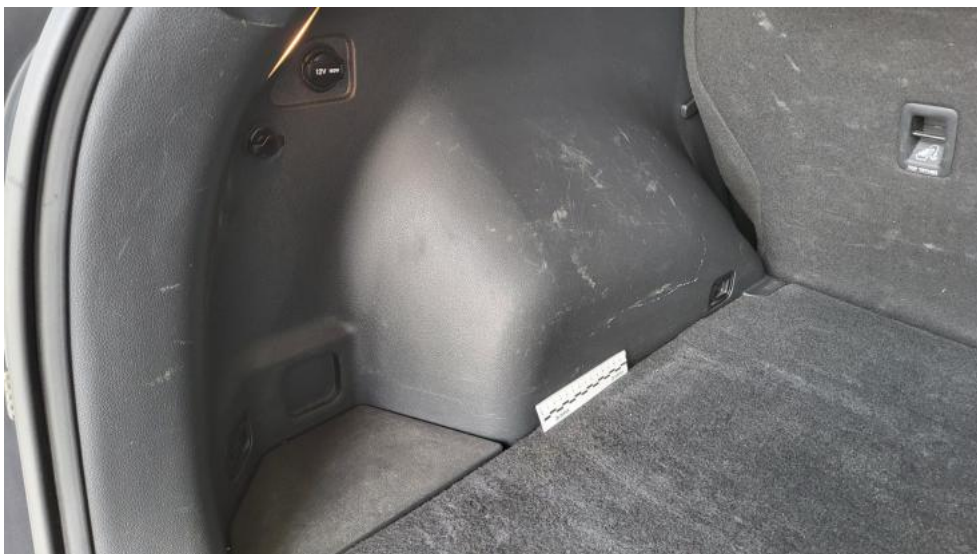
**Photo 102.**

Wykładzina przestrzeni bagażowej - Rysa/odprysk 1
