DEKRA's commission No. : PKOL(W)/LODZ/40068/26/05/07  
 commission/ damage No. : 24/029865  
 Date of commission: 07-05-2026

**Vehicle data**

Group of objects (Eurotax)	cars
EC code (Eurotax)	0134478
Manufacturer	BMW
Model	Seria 8 Coupe [G15] 18-22
Type / version	M850i xDrive
Body type	CPE
Number of doors / seats	2/4
Curb weight [kg]	1890
Gross vehicle weight [kg]	2395
Wheelbase 1/2	2822
Engine type	spark ignition
Pollution reduction system	GPF
Engine capacity [ccm]	4395
Engine Power [hp/kW]	530/390
Gearbox	automatic 8- gear
Registration /record No.	GD3R179
VIN / serial number	WBABC41010CD03342
Date of first registration	09-10-2019
Year of manufacture	2019
Readout [km]	177 292 (read)
Body color / type of coating	black/METALIK

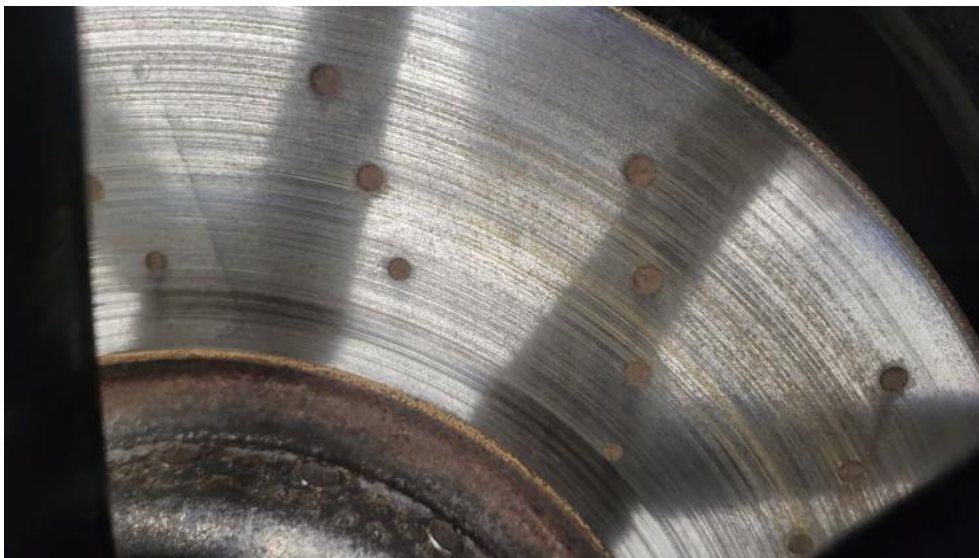
**Photo 15.**

Tarcza hamulcowa przednia prawa

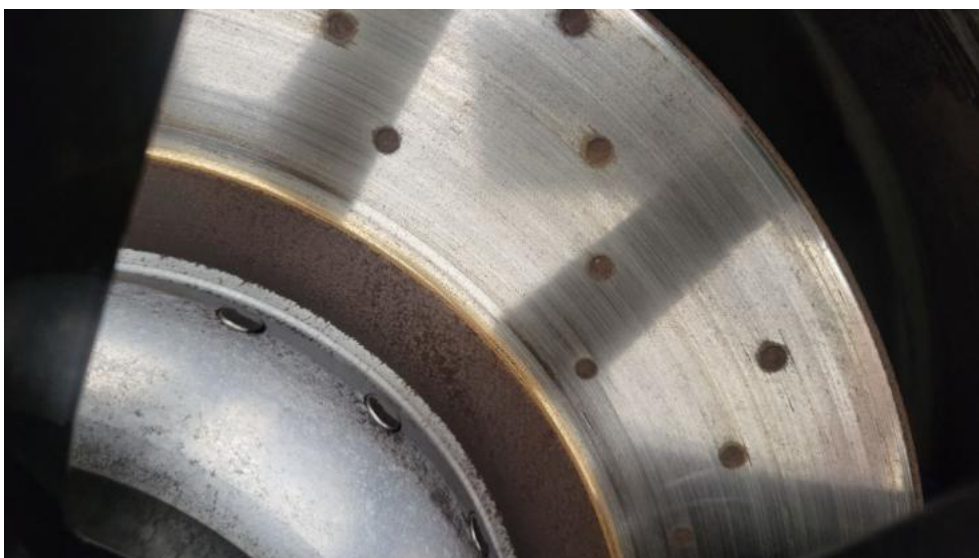
**Photo 16.**

Tarcza hamulcowa tylna prawa

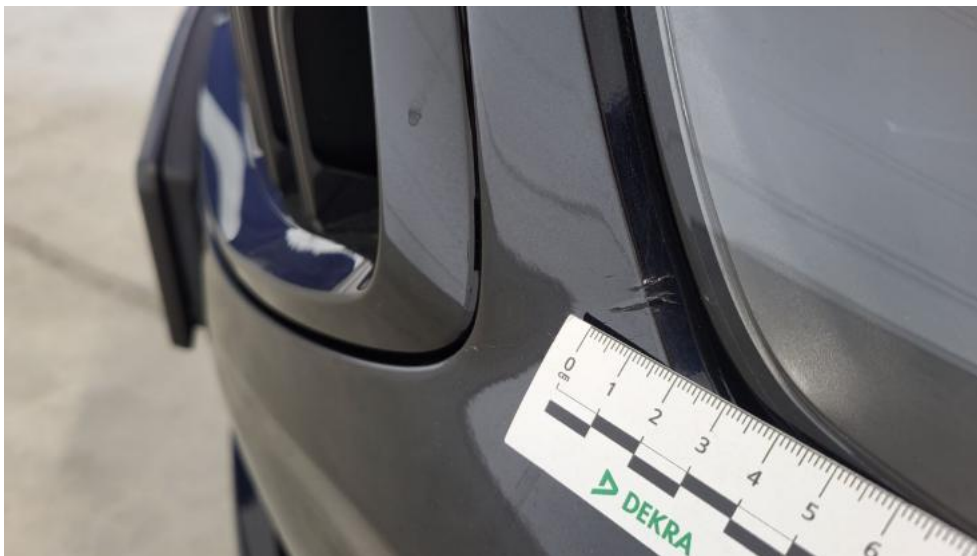
**Photo 49.**

Zderzak - Wgniecenie/odkształcenie 1
