DEKRA's commission No. : PKOL(W)/LODZ/33455/25/05/09  
 commission/ damage No. : 23/021318  
 Date of commission: 09-05-2025

| Manufacturer | JAGUAR |
| Model | XE 19-24 |
| Type / version | XE 2.0 D180 R-Dynamic SE aut |

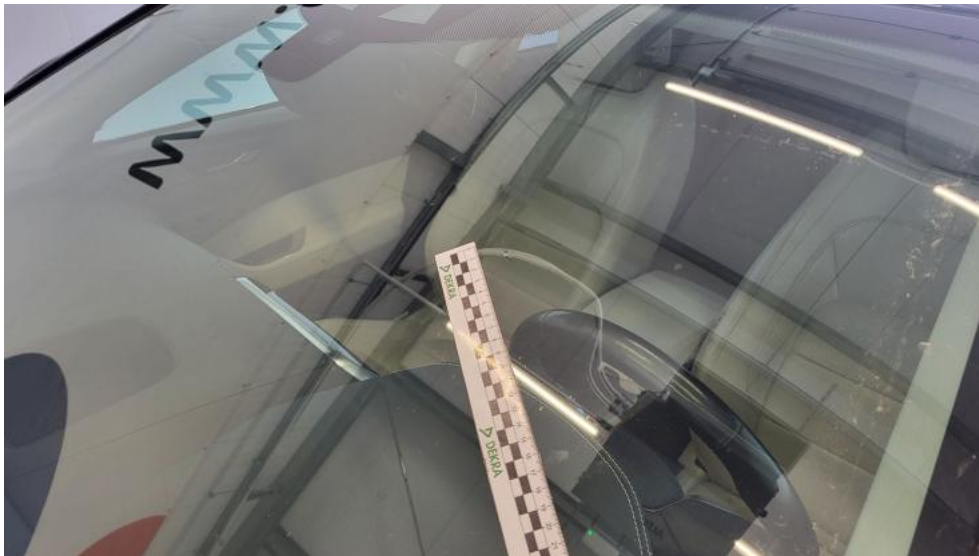
**Photo 41.**

Szyba czołowa - zdjęcie poglądowe 1

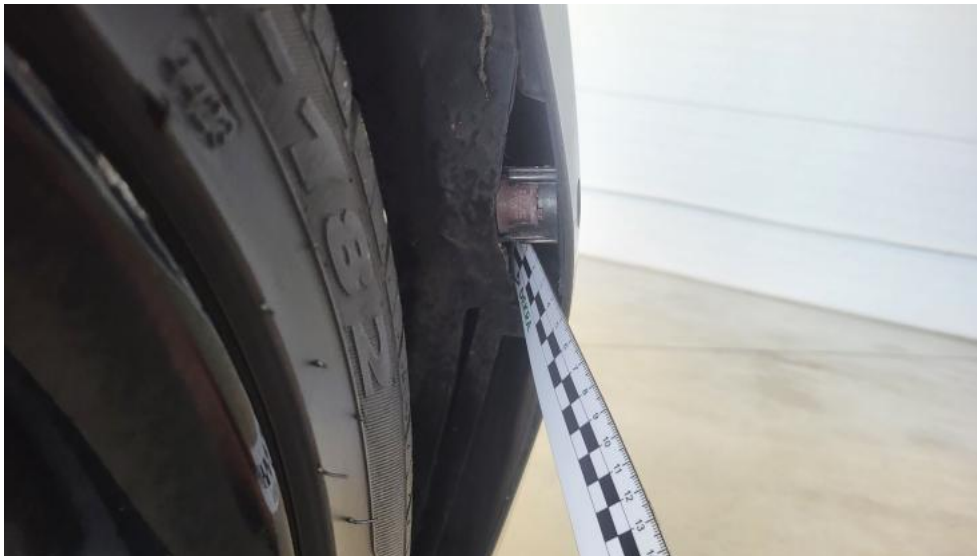
**Photo 49.**

Nadkole przednie P - Inne 1

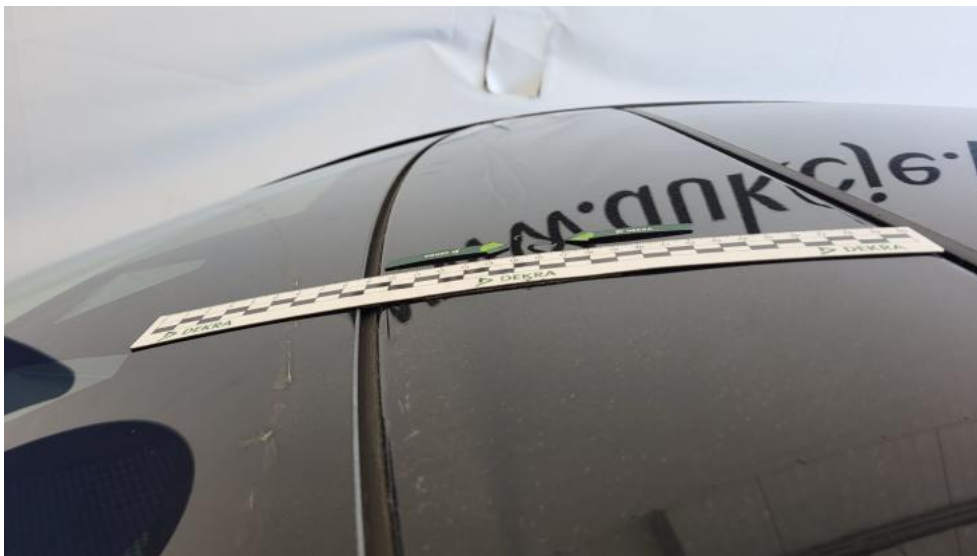
**Photo 65.**

Dach - Wgniecenie/odkształcenie 1

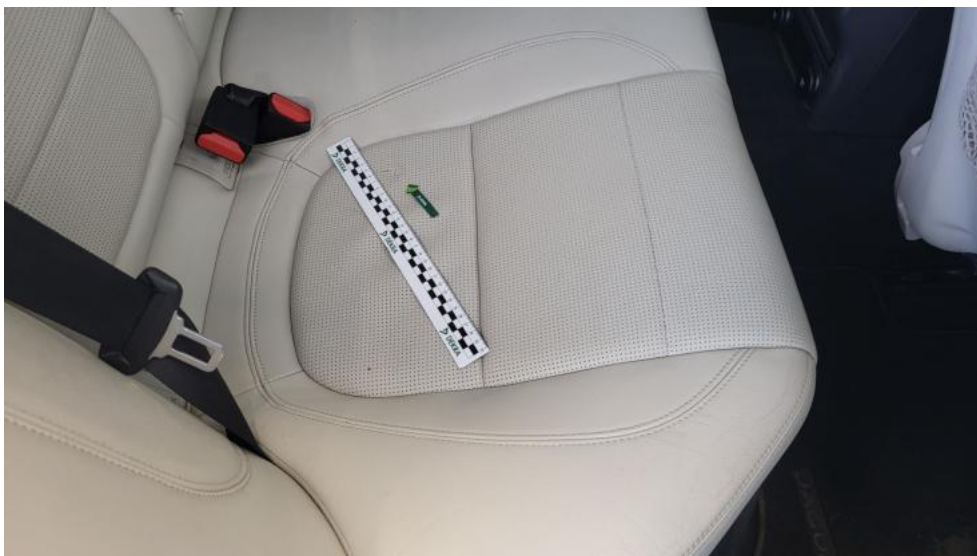
**Photo 80.**

Kanapa tyl. - zdjęcie pogładowe 1

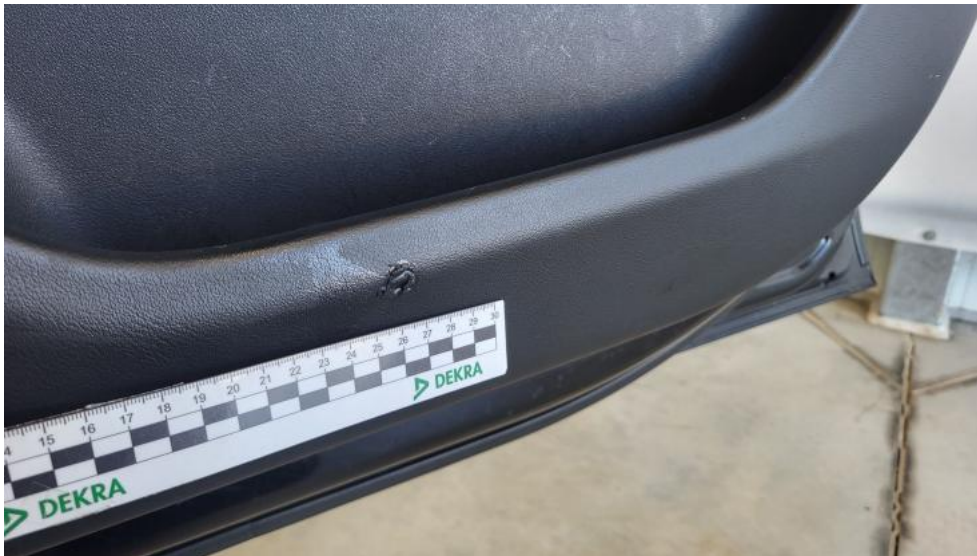
**Photo 83.**

Tapicerka drzwi przednich P - zdjęcie poglądowe 1
